Report #477477

1983 Porsche 930

Summary

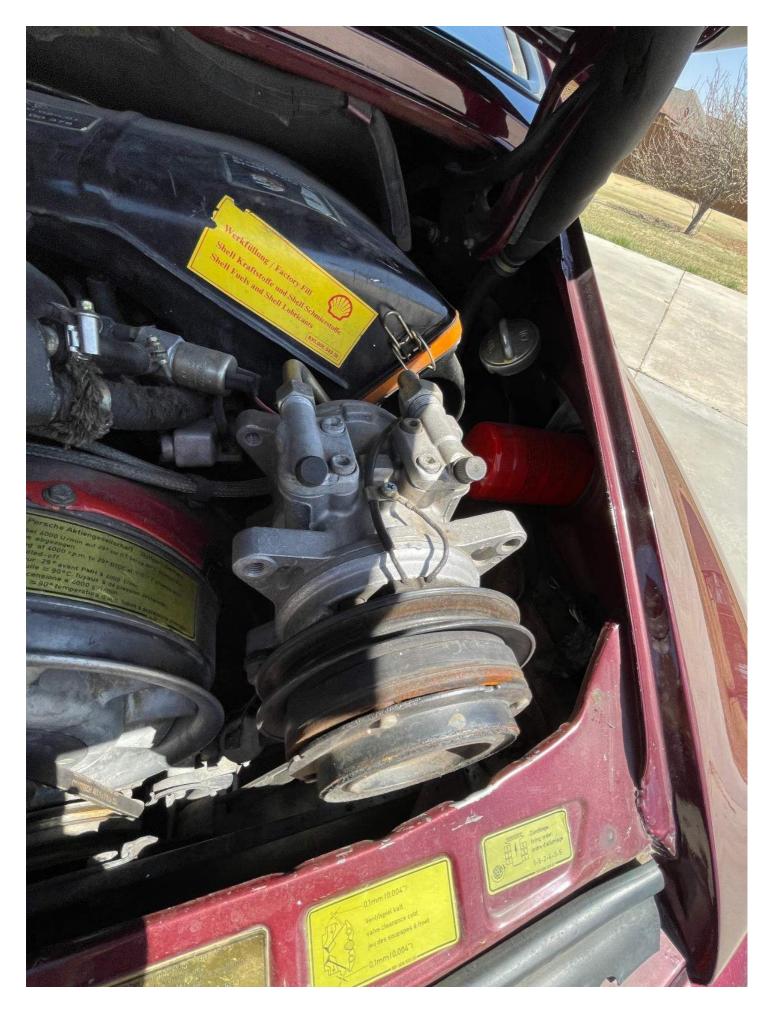
Ac compressor

The interior shows well with only light wear noted. The steering wheel shows a light amount of wear consistent with the age of the vehicle. The seats show a light amount of wear present that is considered normal for the age of the vehicle. The air conditioning does not work. The compressor belt has been removed from the vehicle. The carpet shows a light amount of wear that is appropriate for the age of the vehicle. The headliner shows a light amount of wear that is considered normal for the age of the vehicle. I found that the entertainment system functions as designed along with the interior lighting.
