## 1984 Mercedes-Benz 380SL

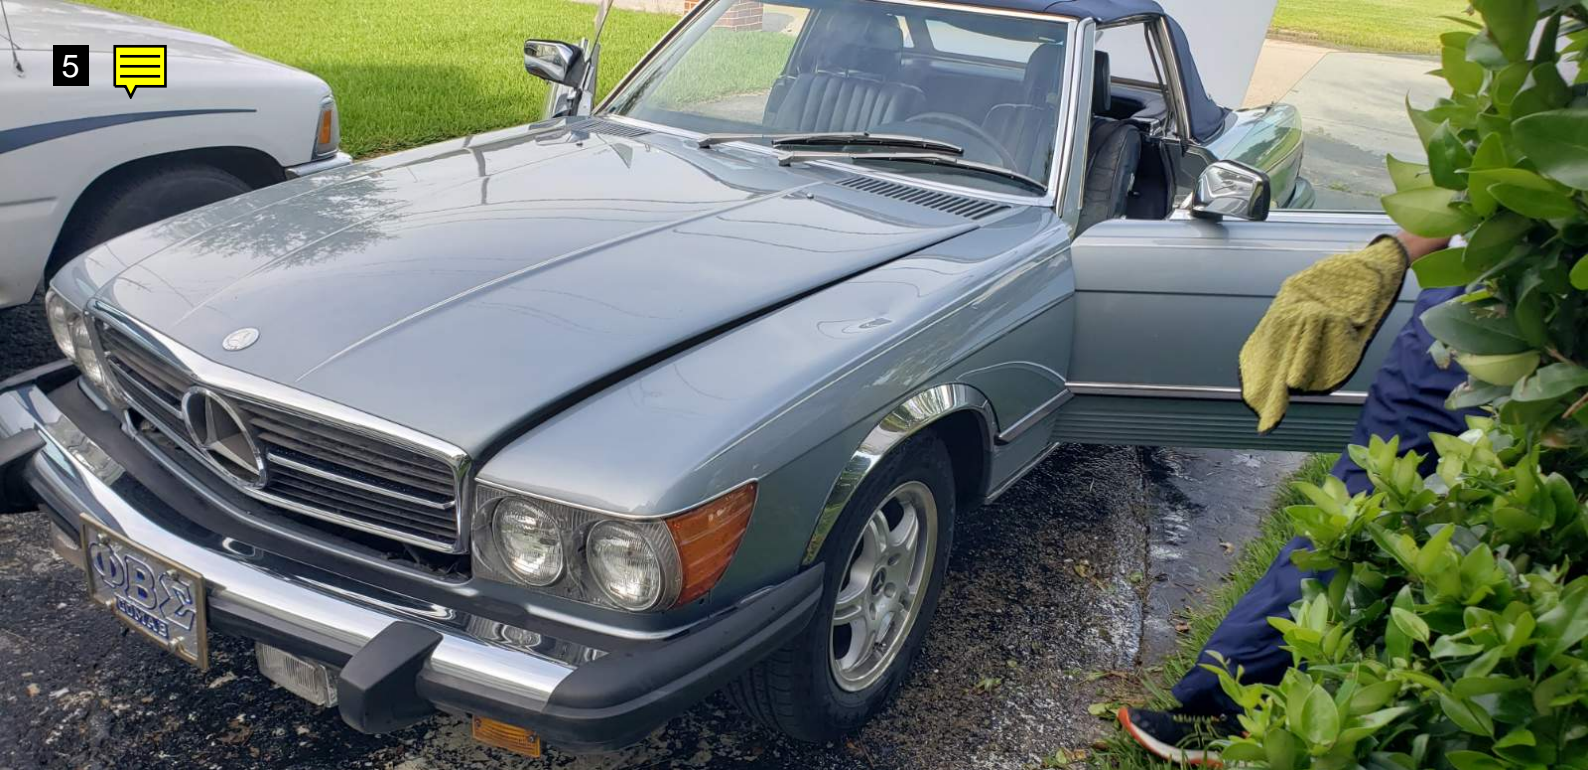
5

This Mercedes ran but was not driven. On the exterior I noted there are minor misc scratches around the vehicle. Most too small to see in photos. Vehicle has some dents on the driver's side fender. The paint shows some wear and tear that is consistent with age. Rust is starting on the passenger side fender. I noted a cracked fog light lens. The wipers and all of the exterior lights worked.

Dents

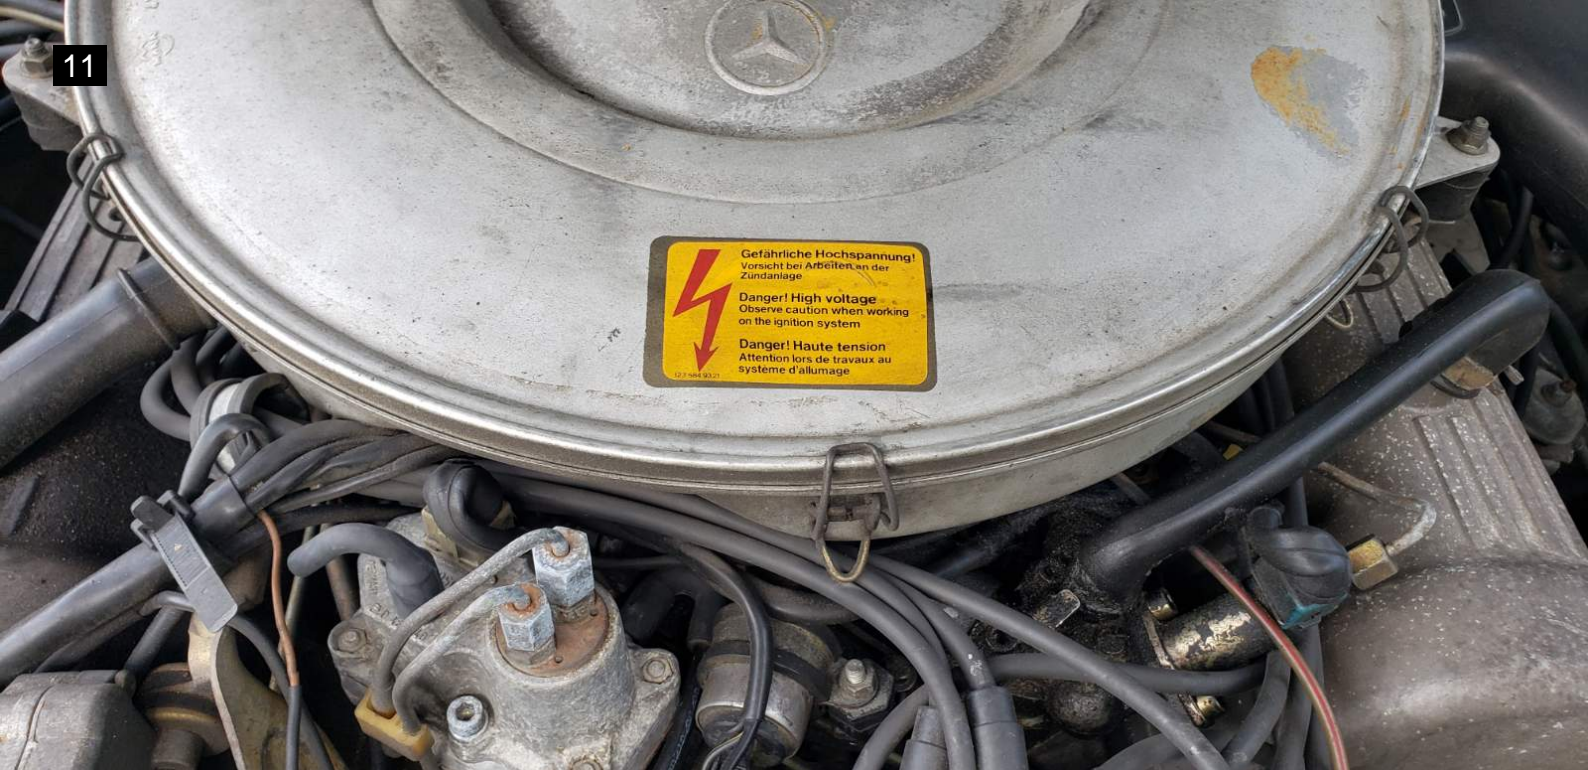
Under the hood the belt is showing wear and cracking from age. The power steering system has a leak. The area should be cleaned off and rechecked to find the source of the leak. The engine bay showed full fluids.

Cracked belts

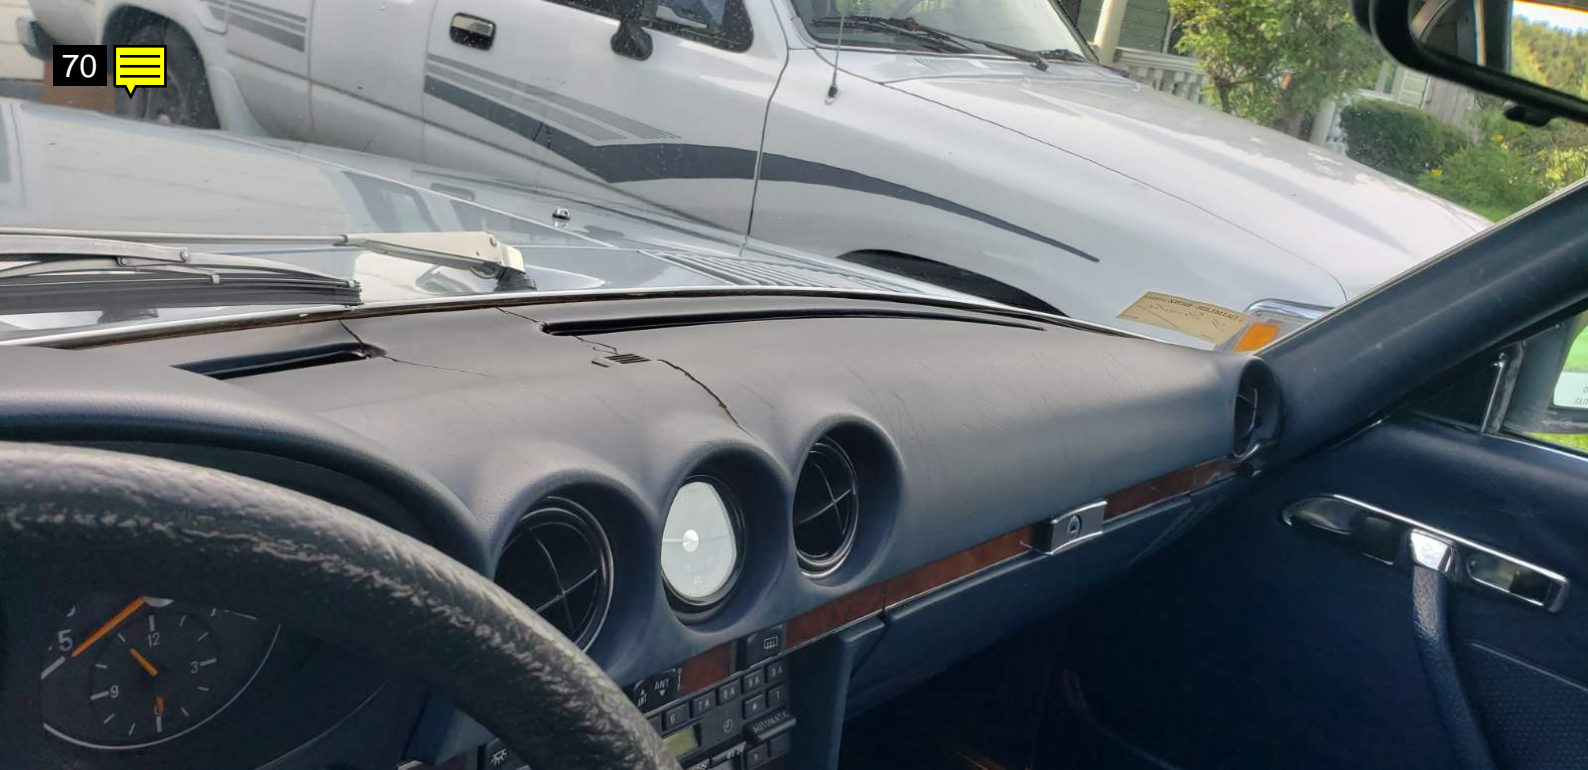
70

Cracked dash
