1971 Chevrolet Camaro

Summary

This vehicle examination was completed on August 8th 2022 at the residence of the owner in Sanbornton, New Hampshire.

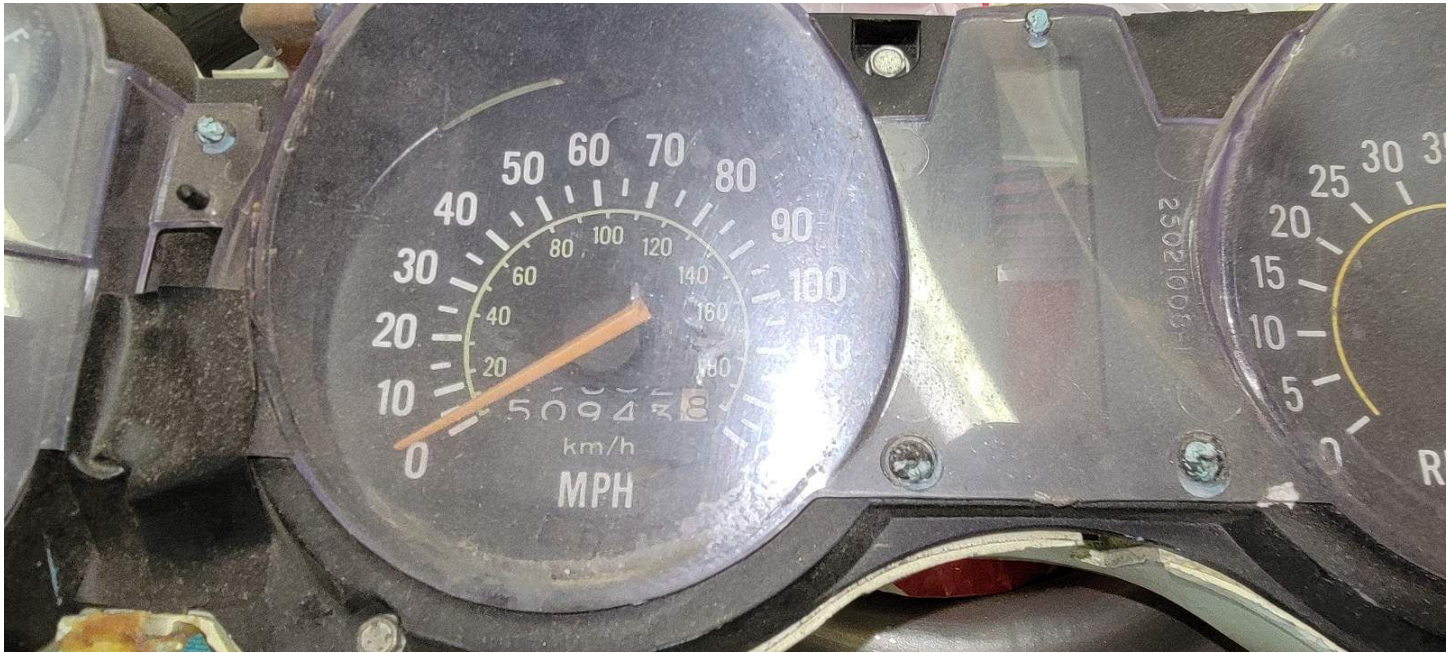
old speedometer

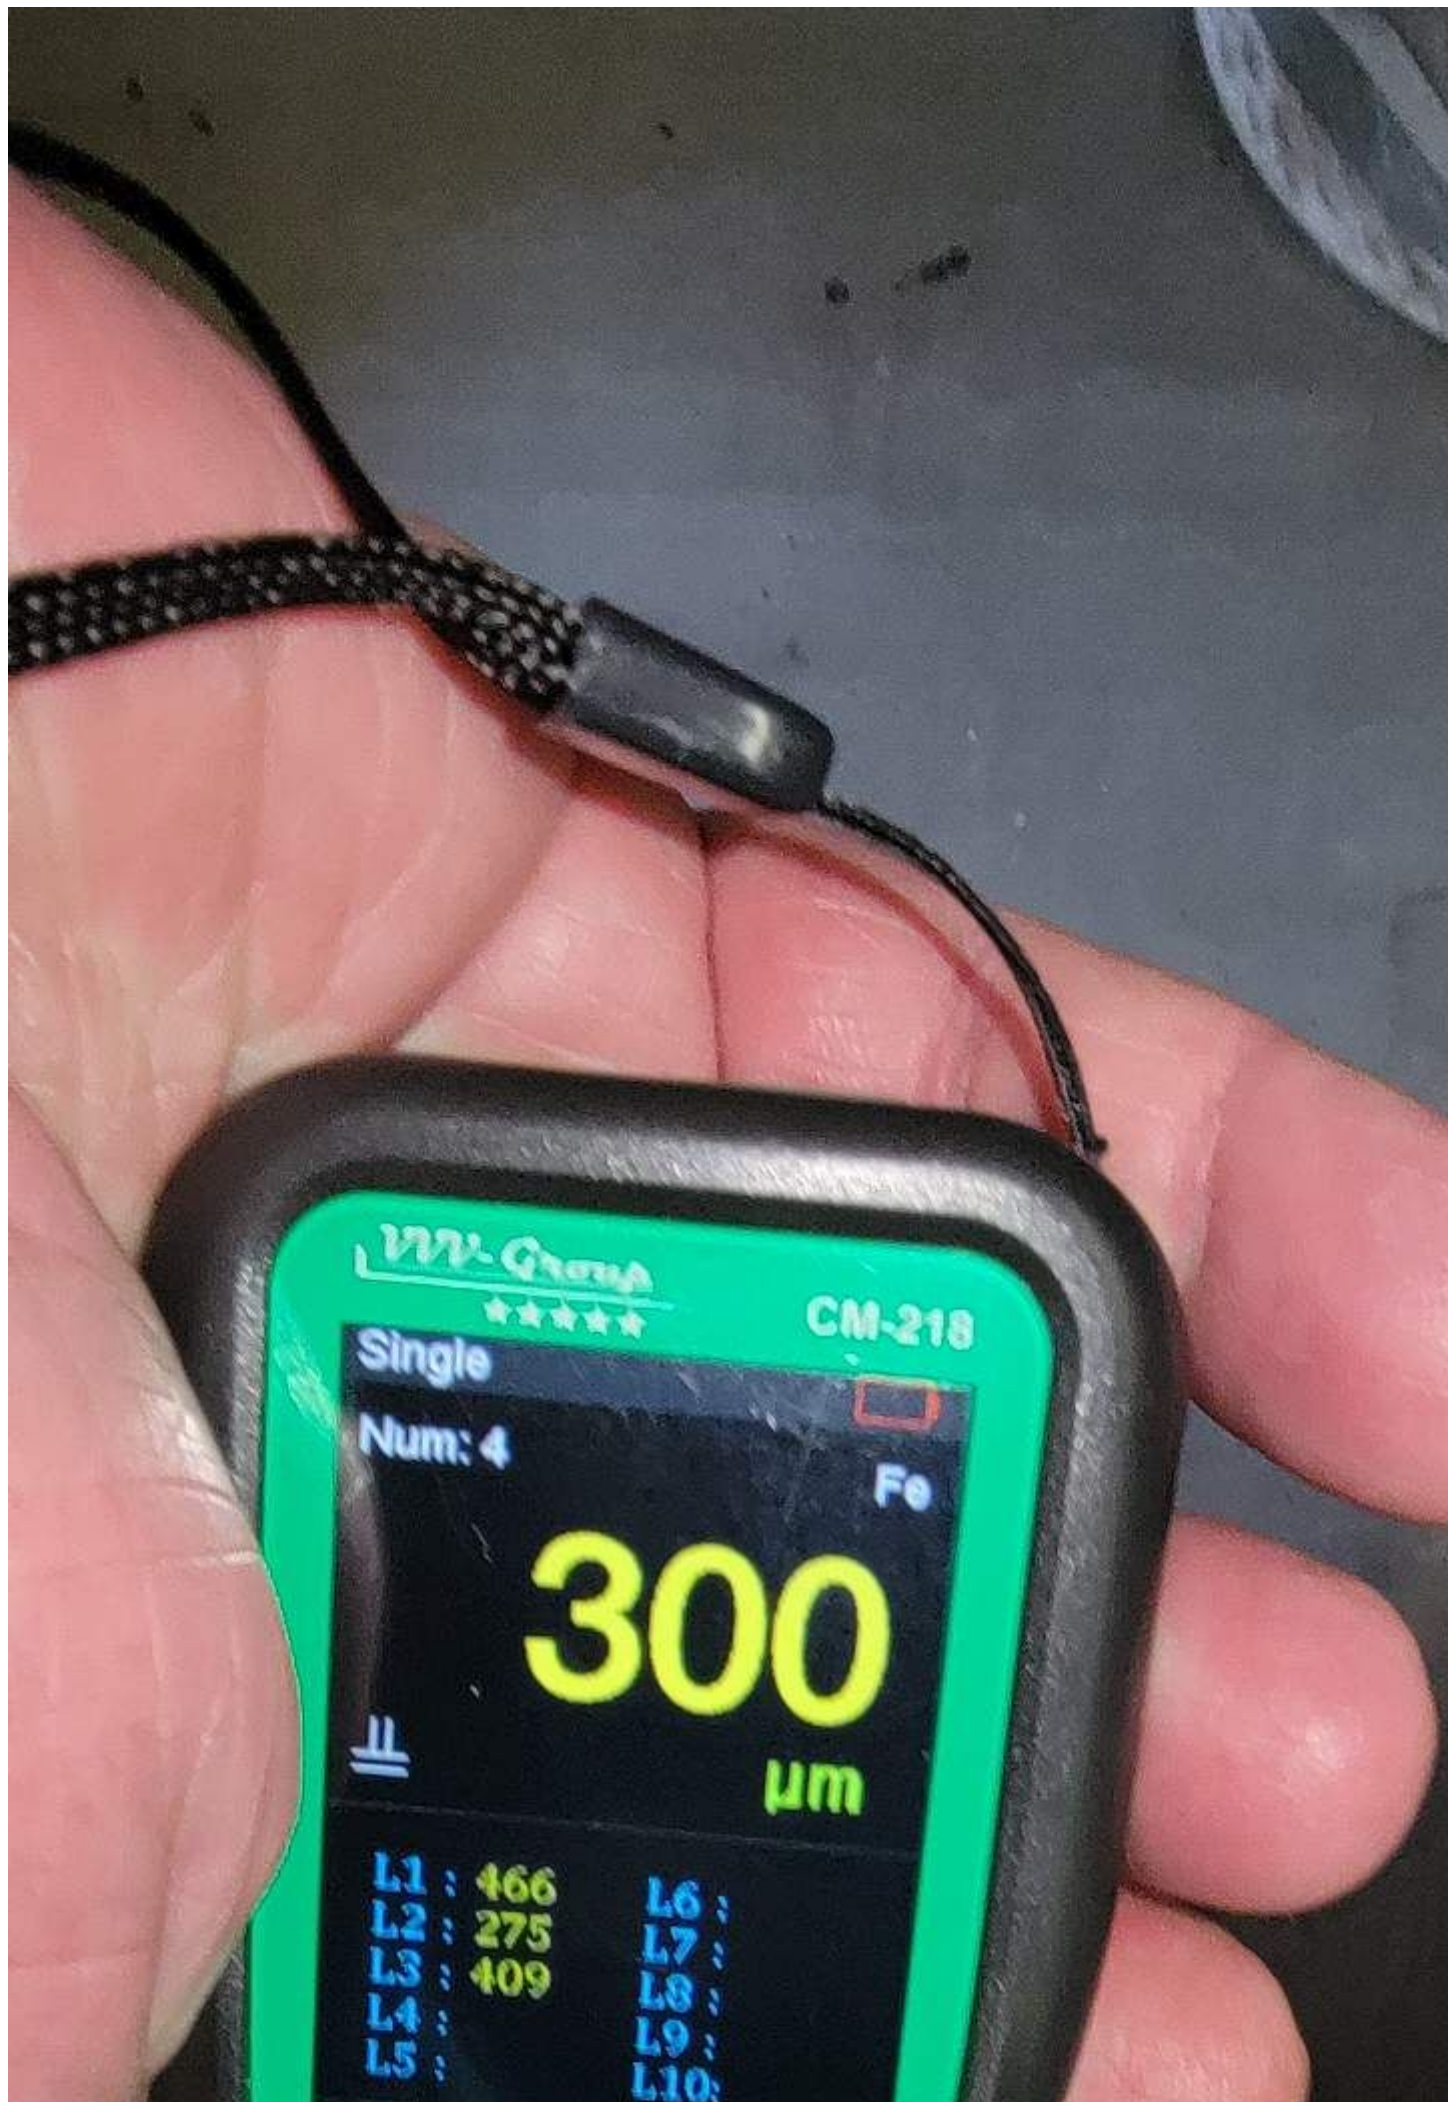
I checked the vehicle with a meter and found some paint thickness variation.

WV-Group
★★★★★

CM-218

Single

Num: 4

Fe

300
μm

L1 :	466	L6 :
L2 :	275	L7 :
L3 :	409	L8 :
L4 :		L9 :
L5 :		L10 :

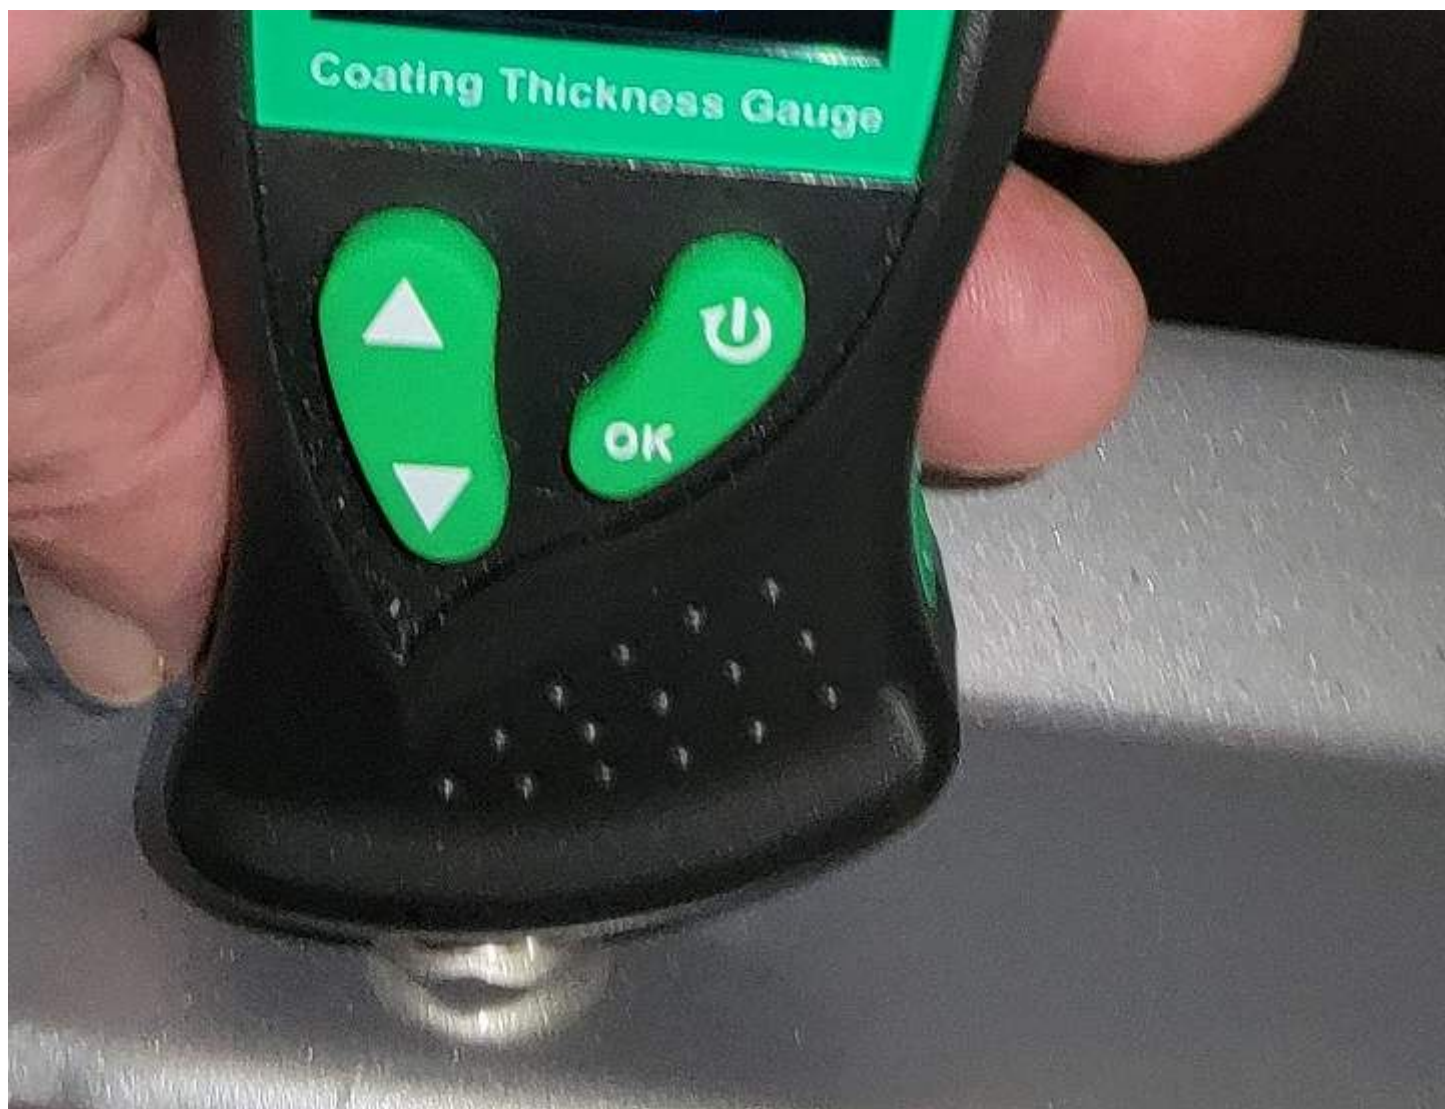
Single
Num: 5

155 μm

L1: 300	L6:
L2: 466	L7:
L3: 275	L8:
L4: 409	L9:
L5:	L10:

Coating Thickness Gauge
