Report #460093

## 1951 Chevrolet Fleetline

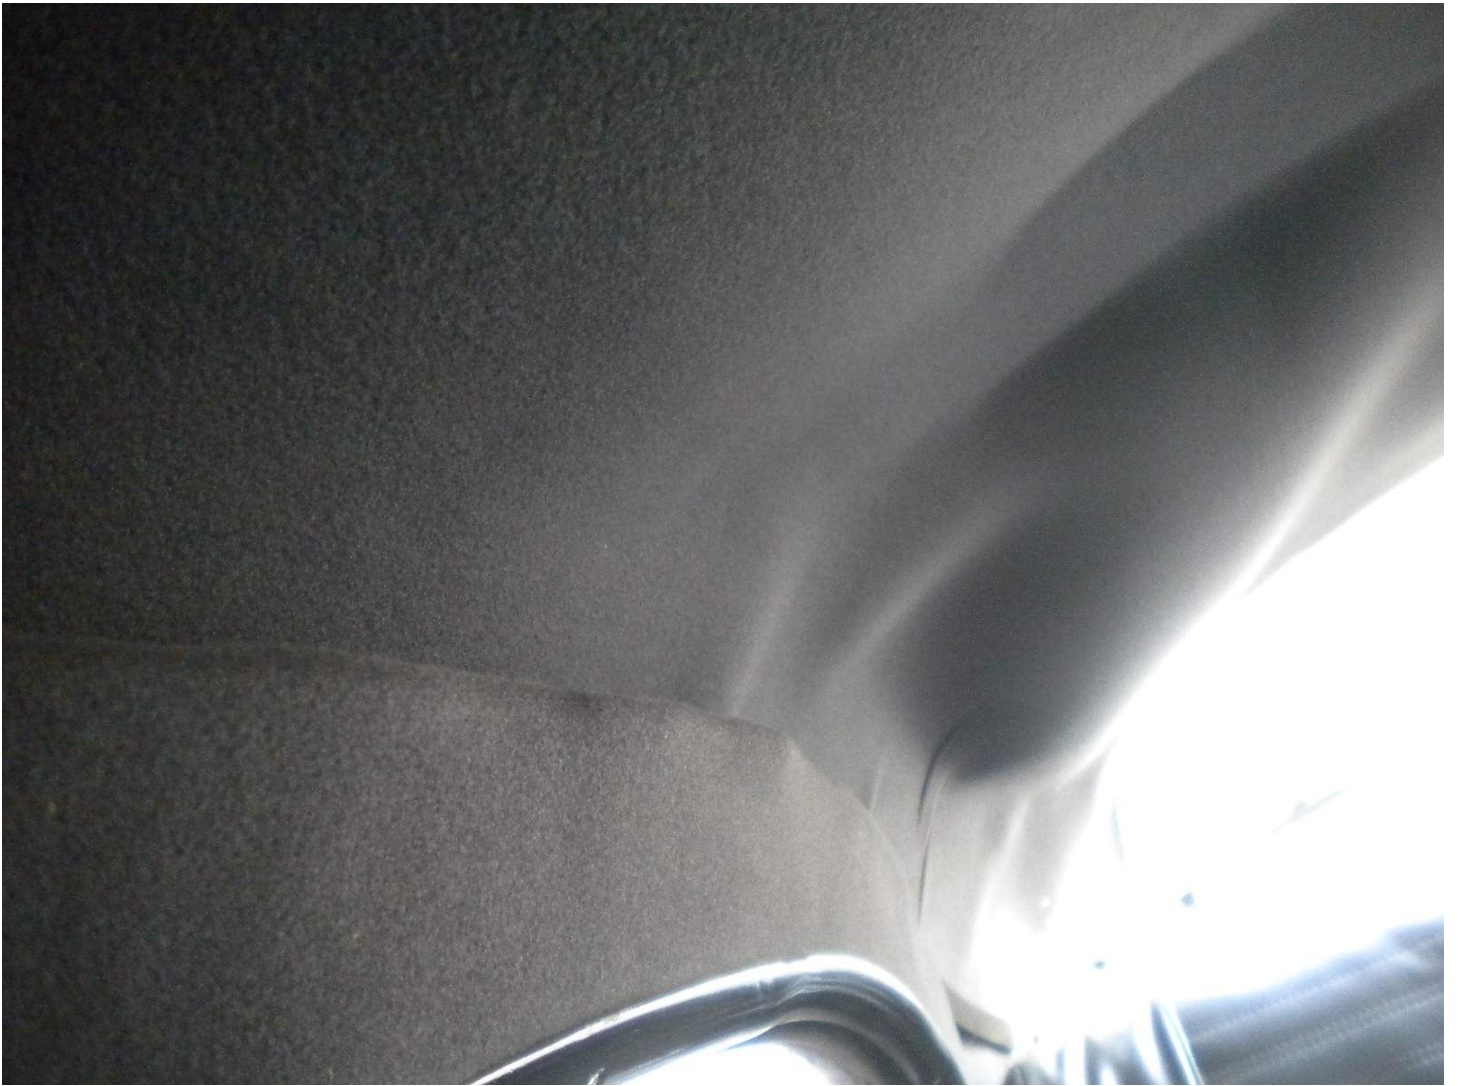
Issues
The headliner shows areas of sagging and will need to be either re-glued or replaced to be fixed.	
Instrument Cluster/Gauges

sagging headliner

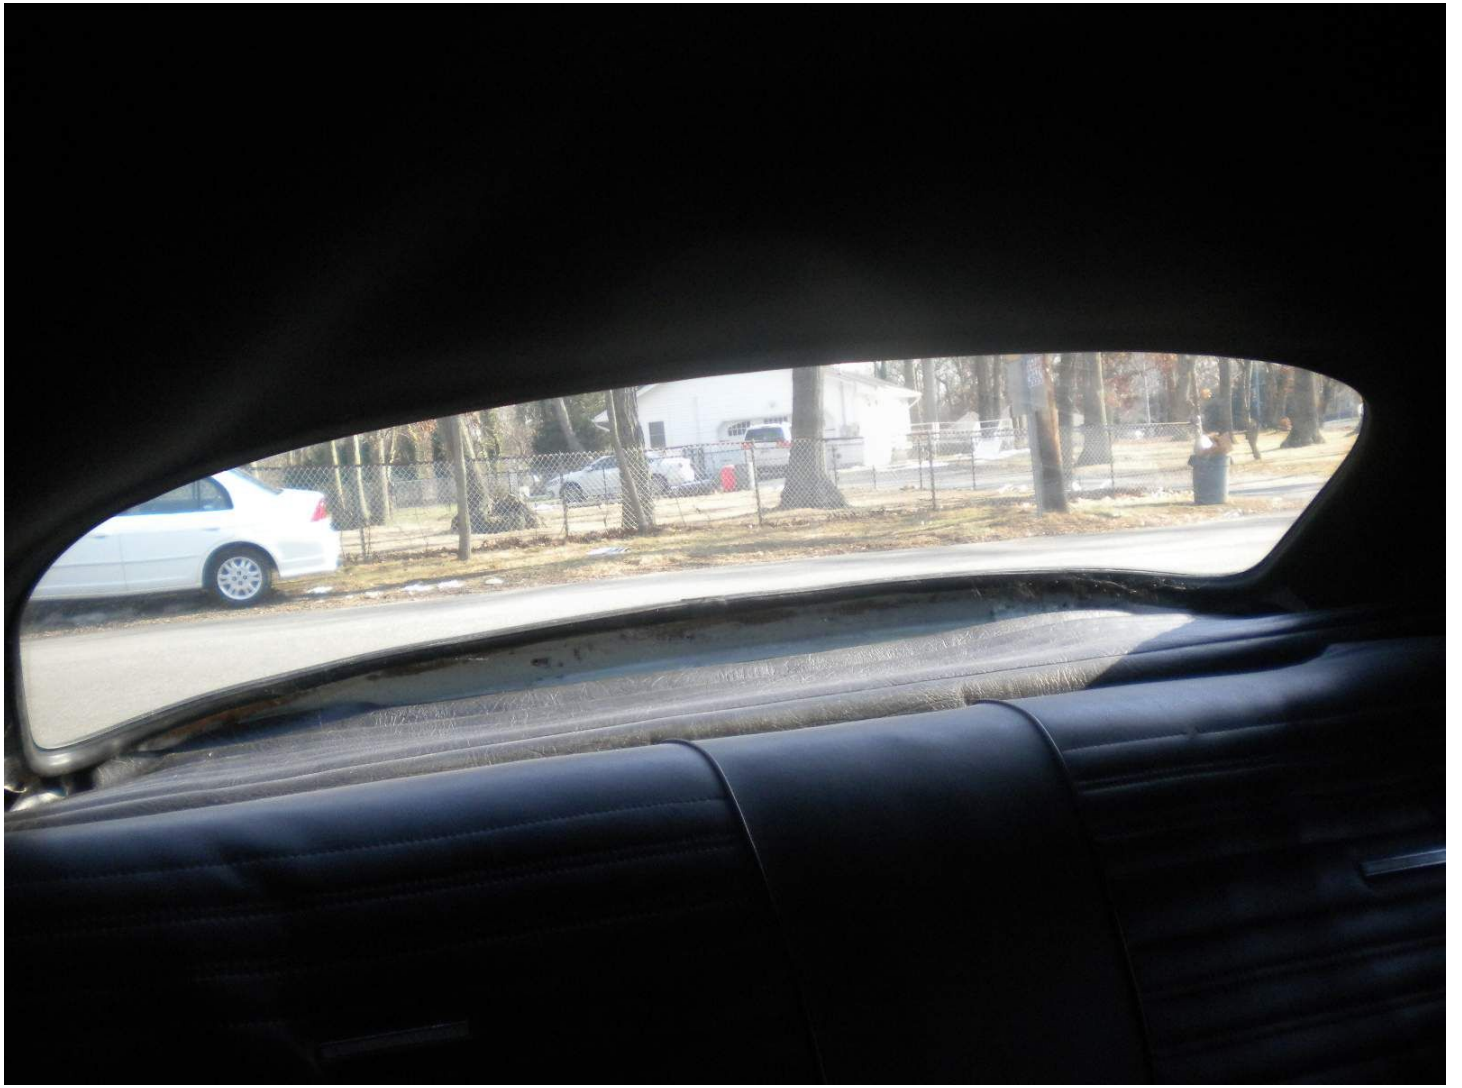
**no back window trim**

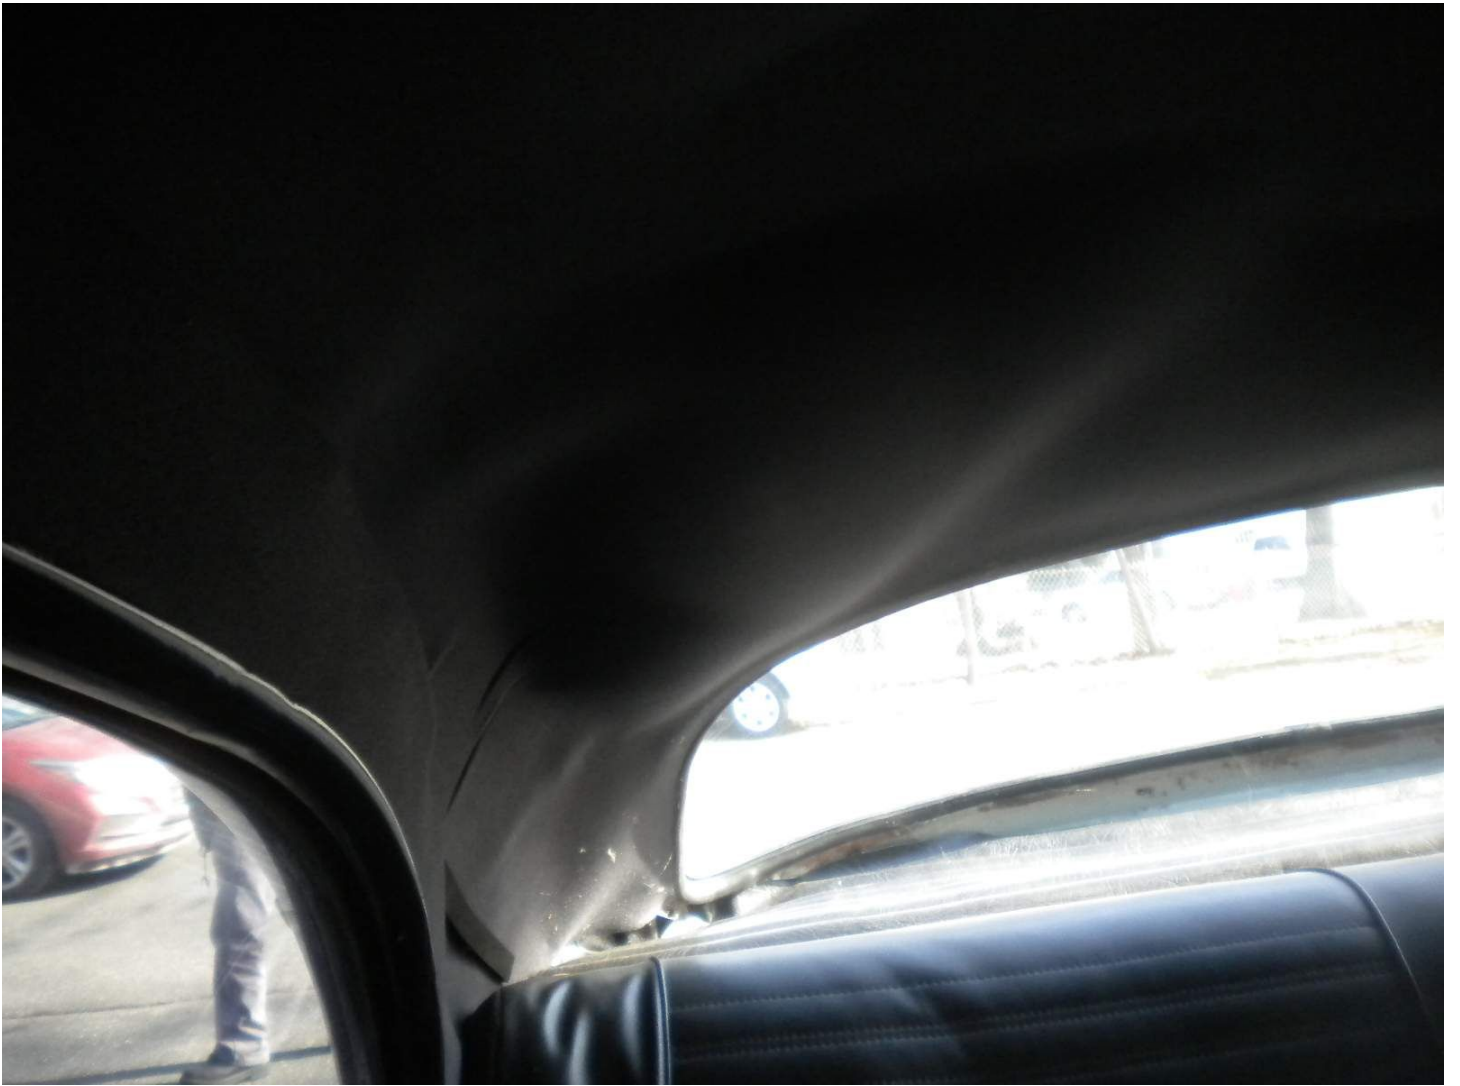
headliner

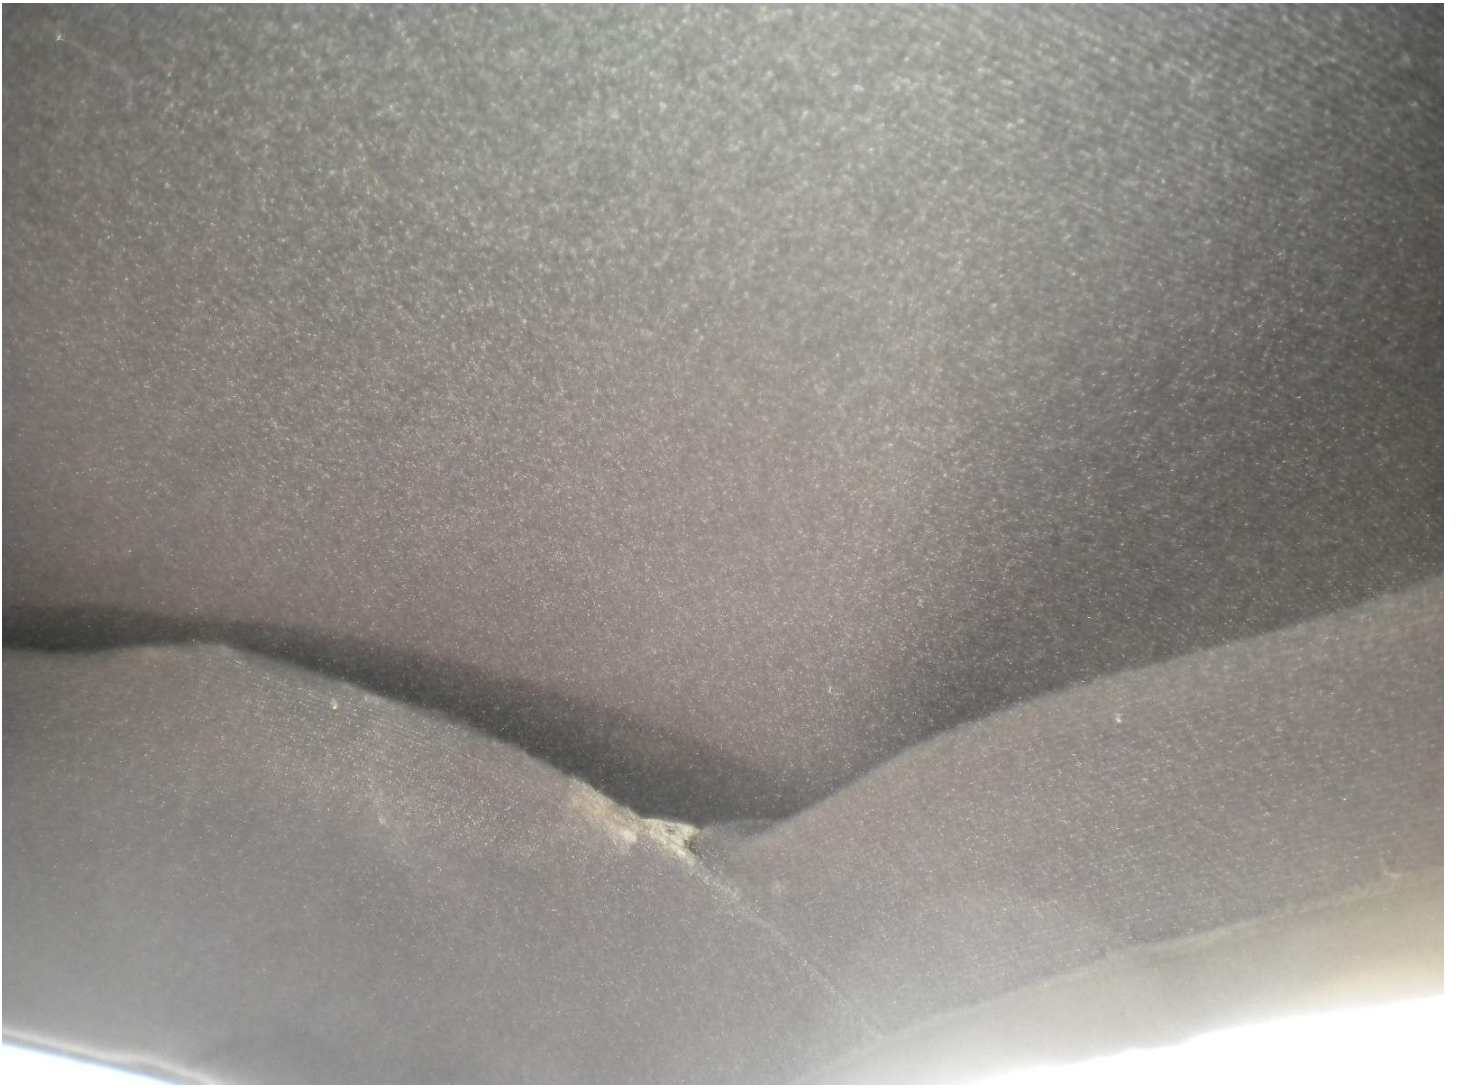
**headliner**

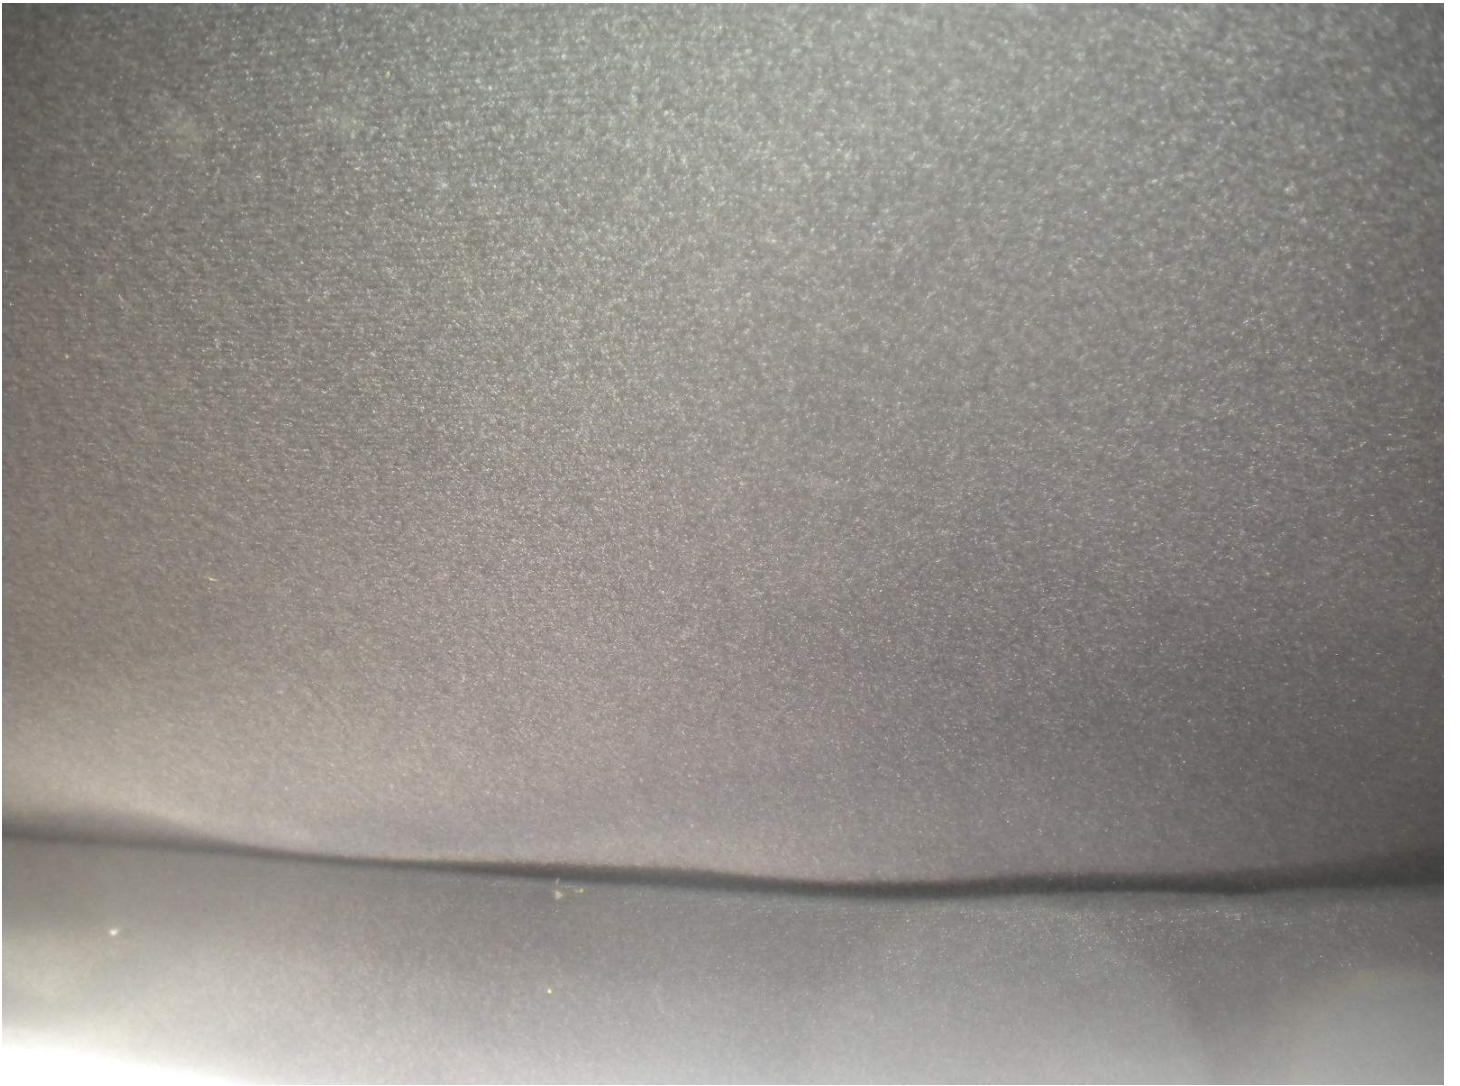
**headliner**

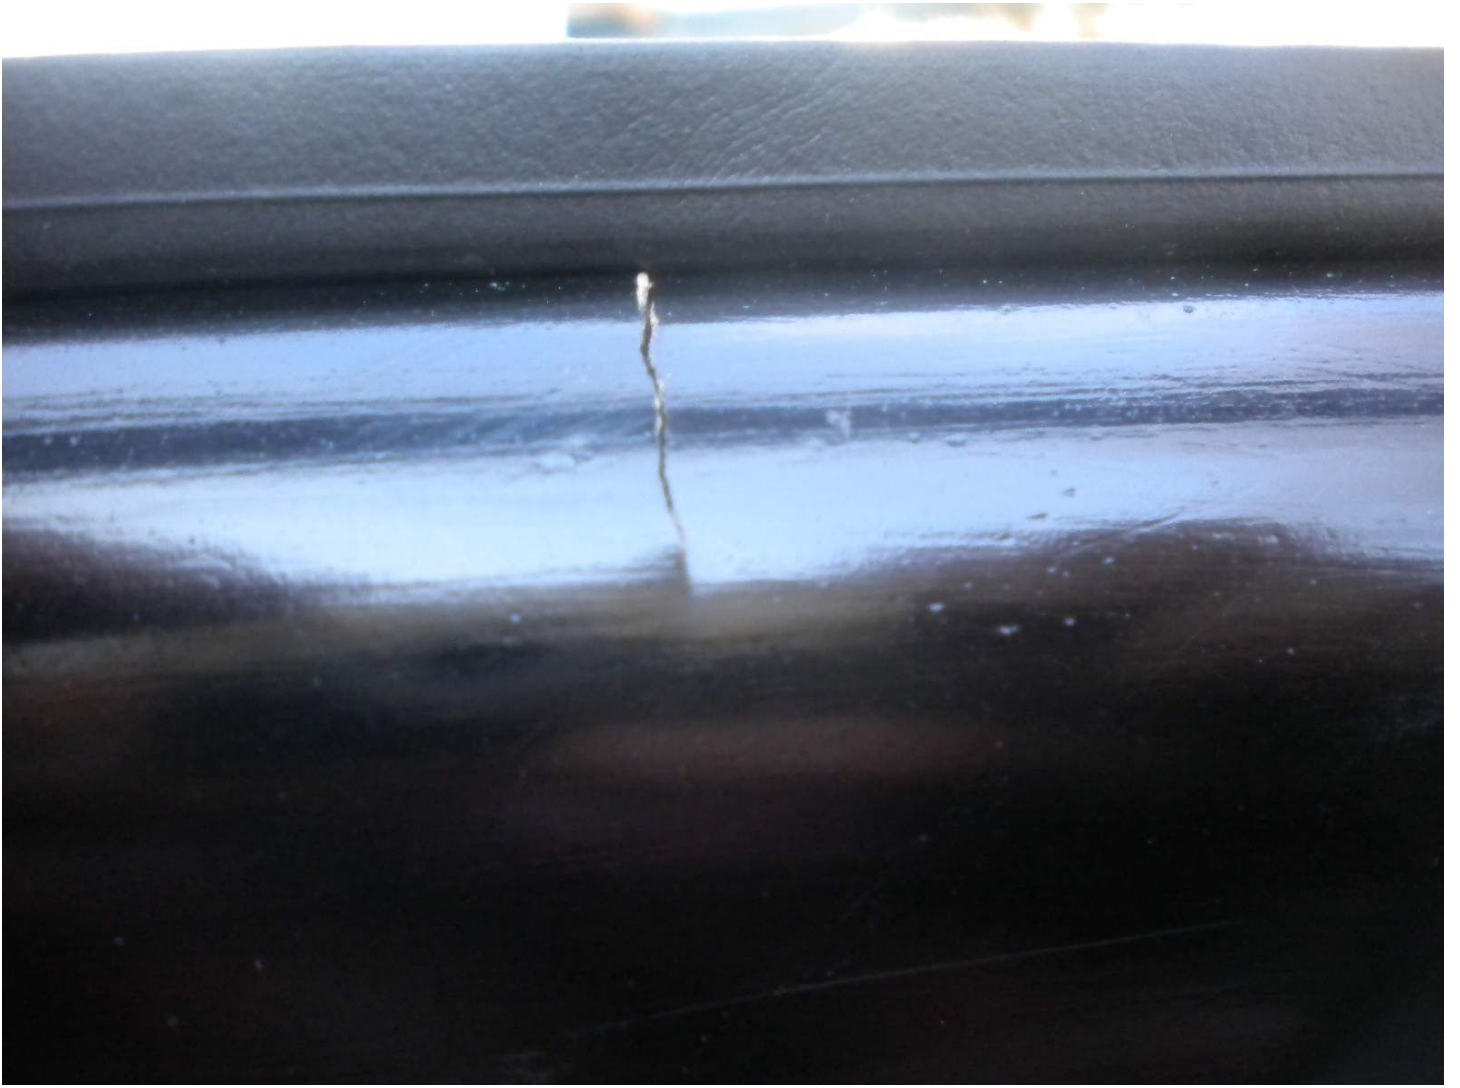
passenger door panel crack

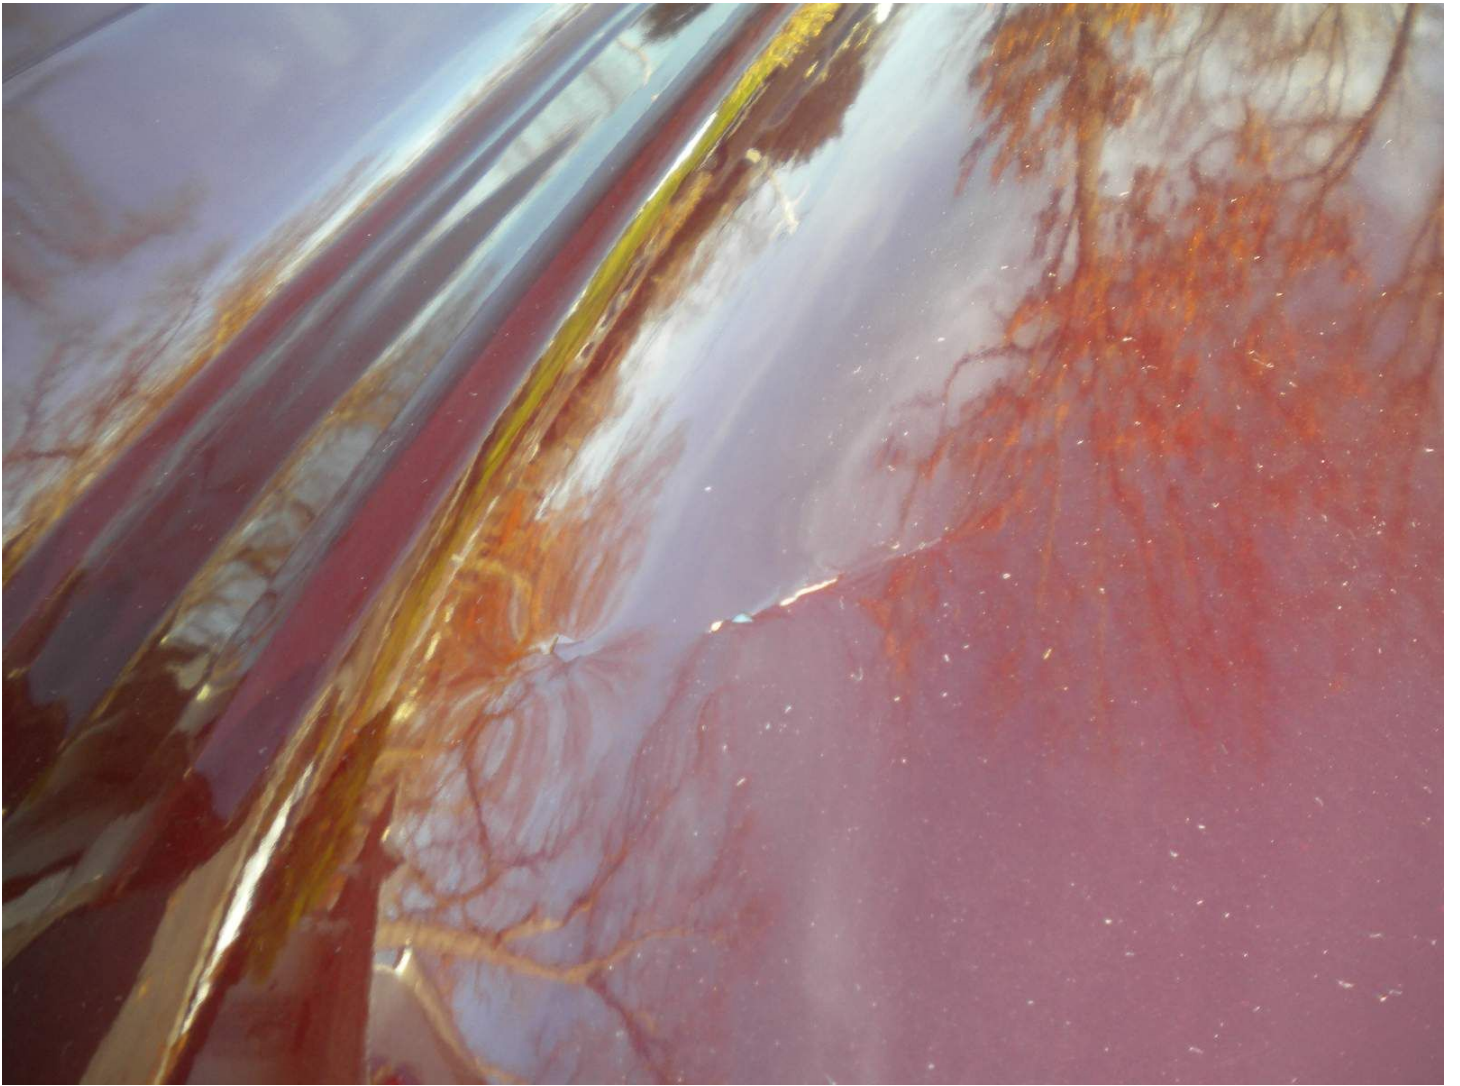
Issues
There are paint chips on the leading edge of the of the hood. There is a crack in the paint on the hood and there are no hood hinges.	
Doors

hood damage

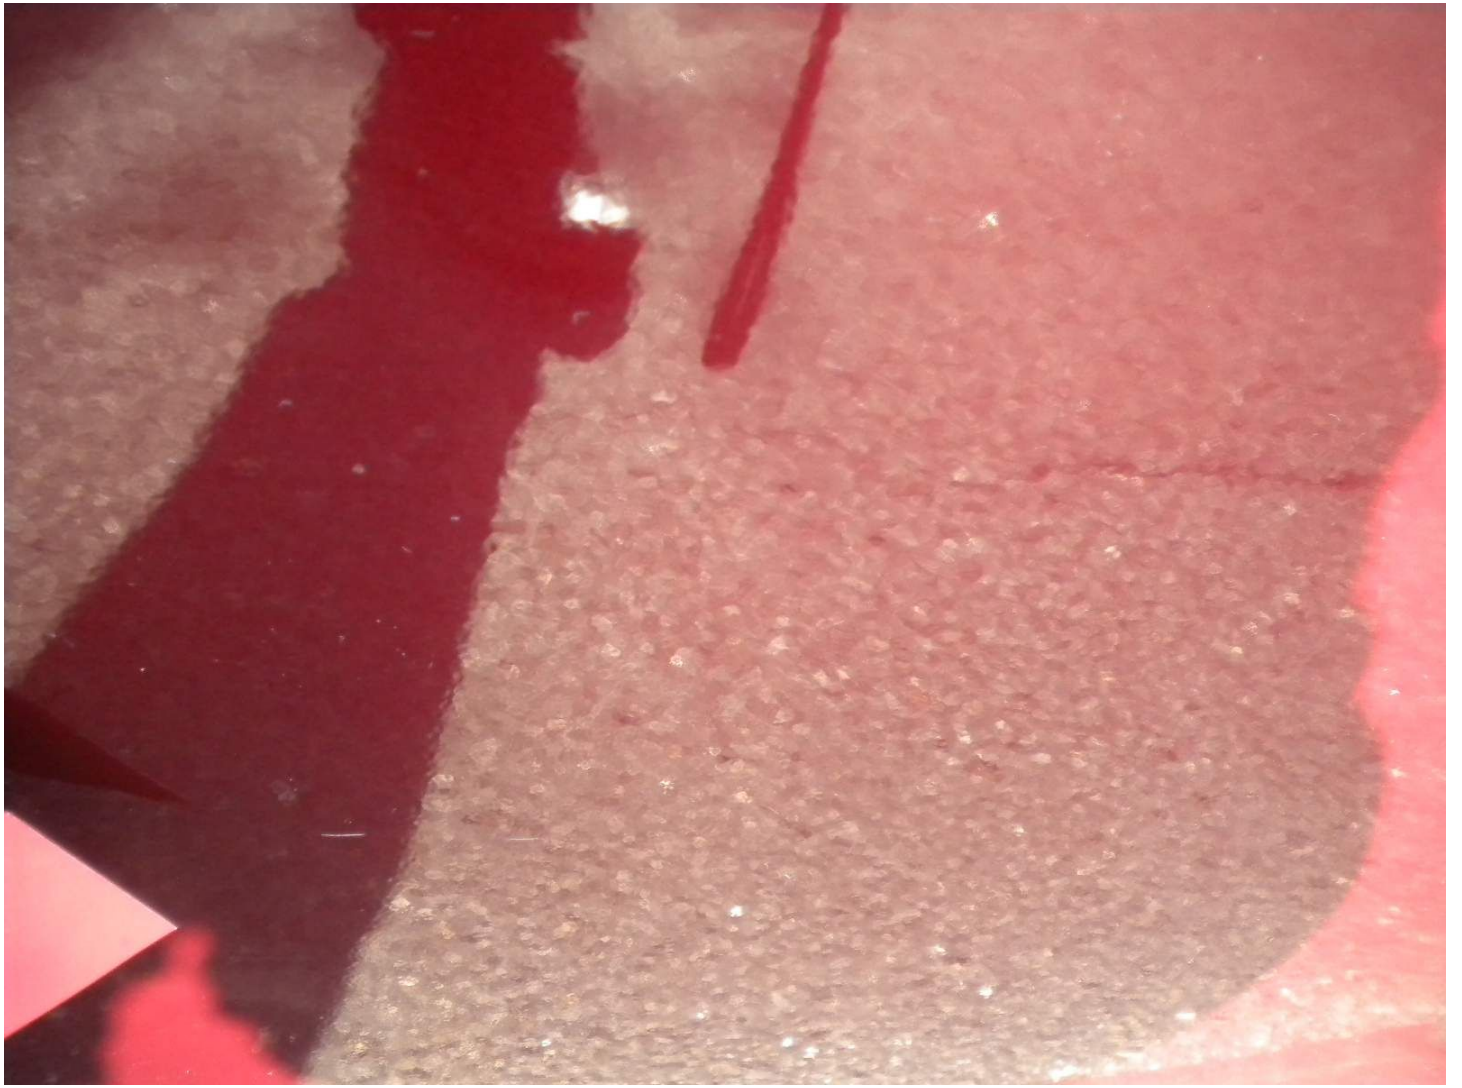
**bubble in paint about 2 inches**

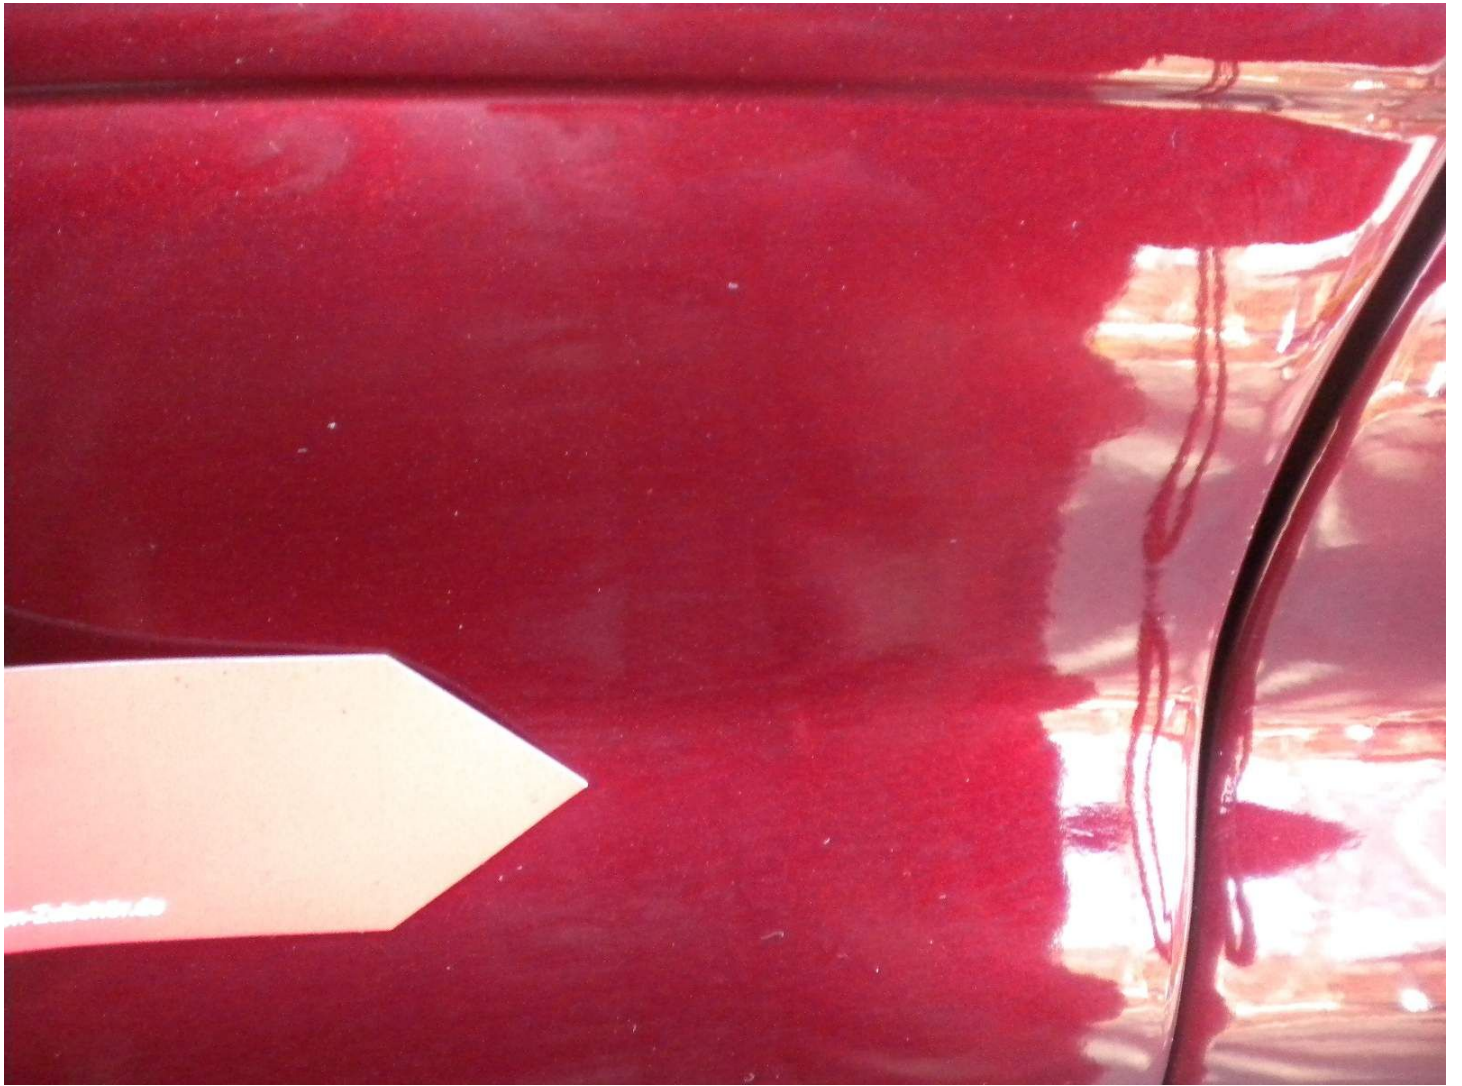
paint chips passenger door

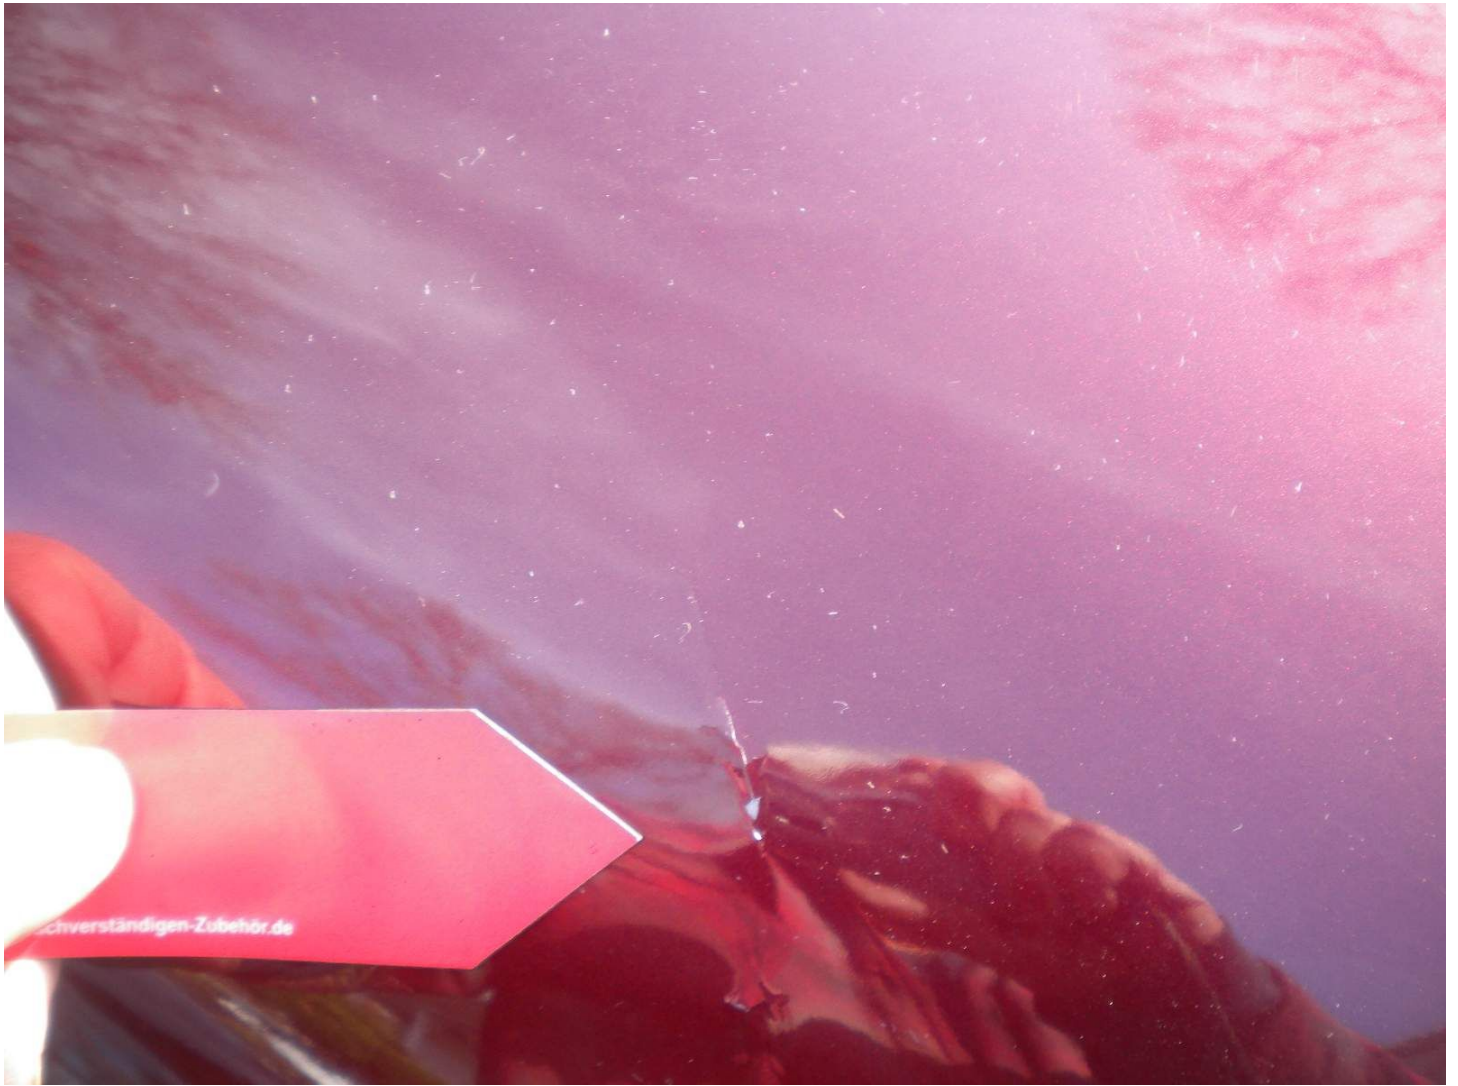
crack in work of hood

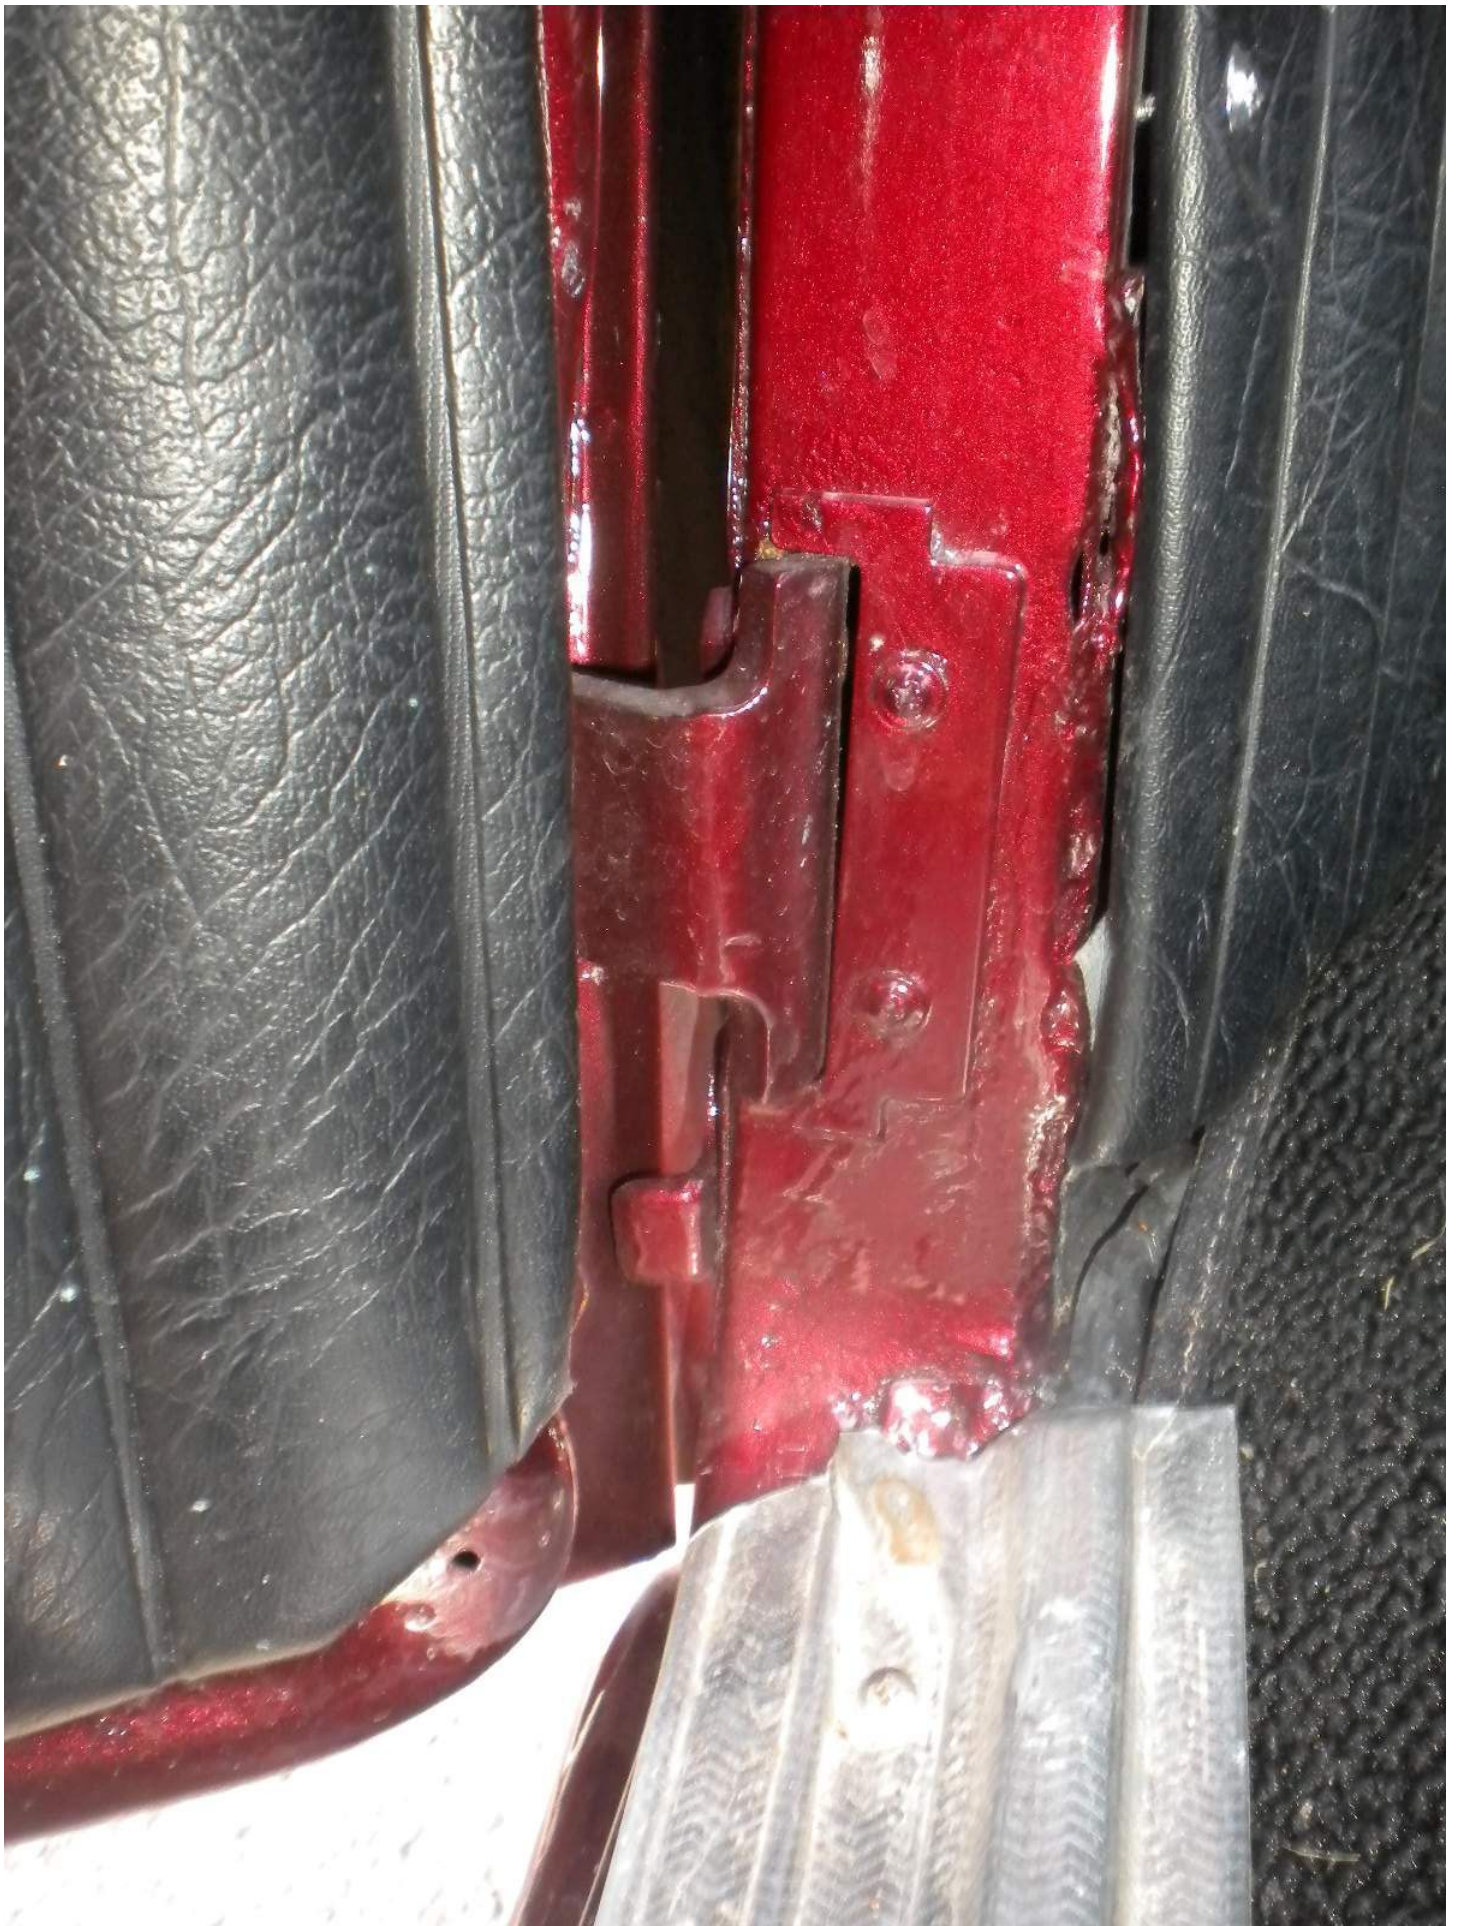
drivers door post prior work

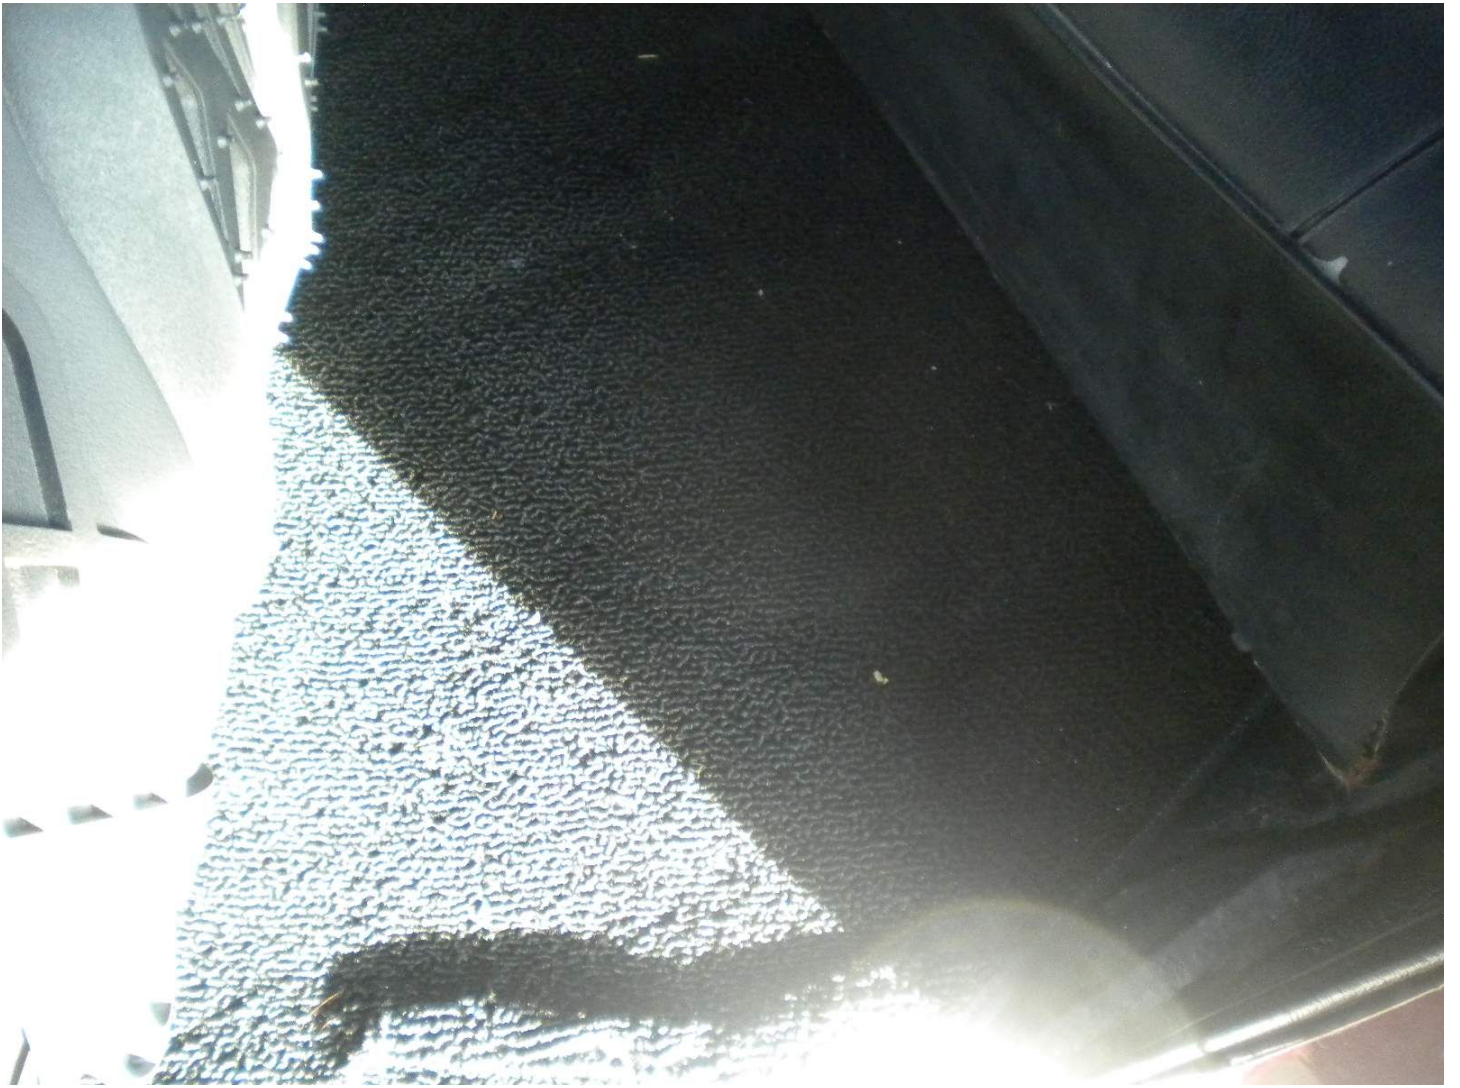
carpet pieced together

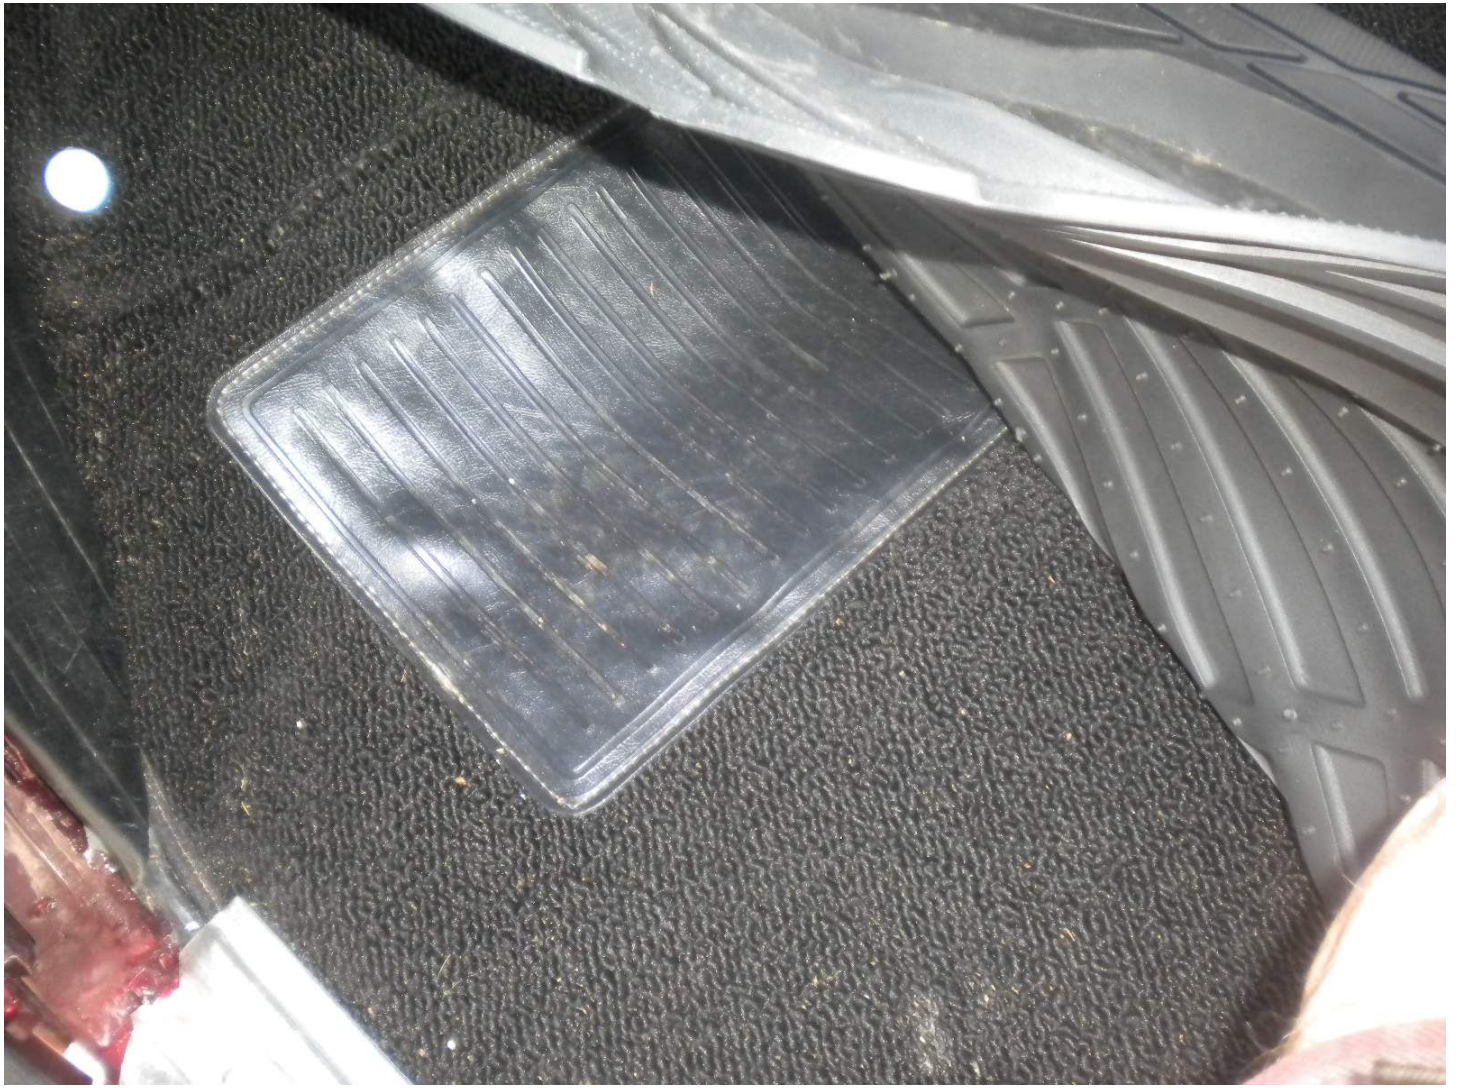
carpet not fitted to the car
