Report #460093

## 1951 Chevrolet Fleetline

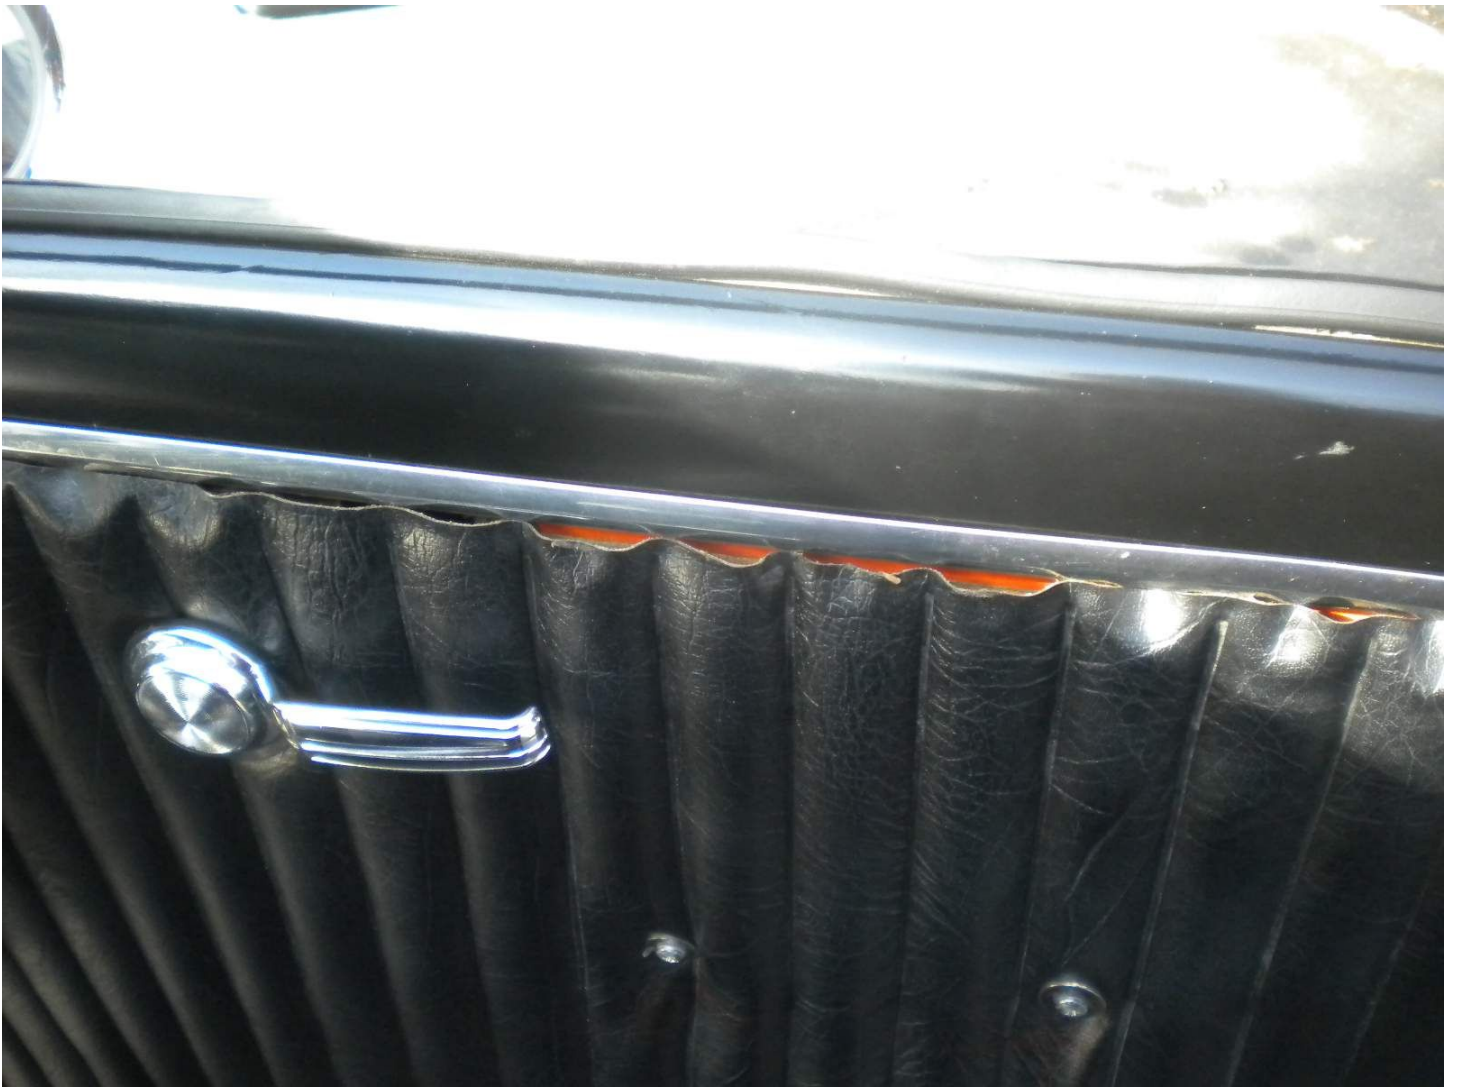
passenger dooe panel loose
