Lemon Squad Nationwide Used Car Inspection

1989 Dodge Dakota Sport Convertible

Summary

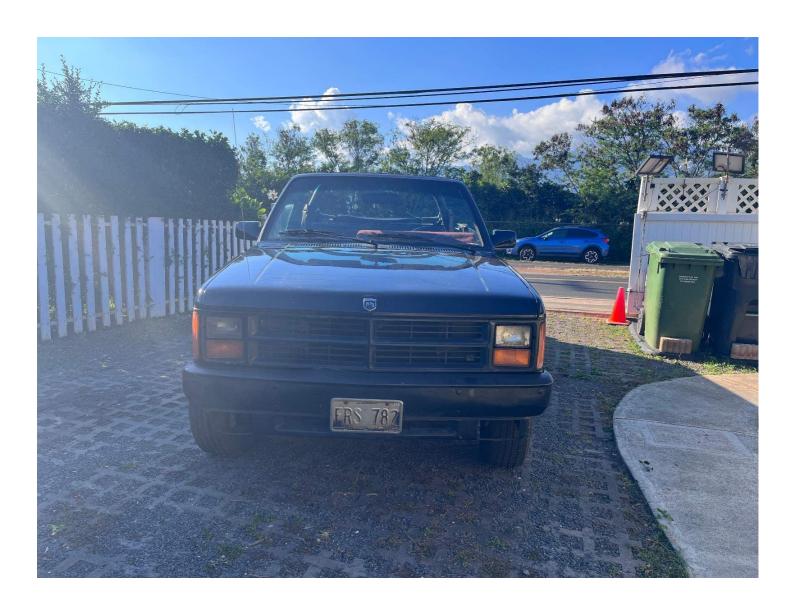
Aftermarket rack
