1988 Mercedes-Benz 560SL

Vehicle Info	
Year - 1988	
Make - Mercedes-Benz	
Model - 560SL	
Mileage - 93976	
Transmission - Automatic	
VIN Number - wdbba48d7ja084235	
Interior - Leather	
Interior Color - Tan	
Body Color - Gold	
Engine - 8 Cylinder	
Drive Type - Rear Wheel Drive	
Fuel Type - Gas

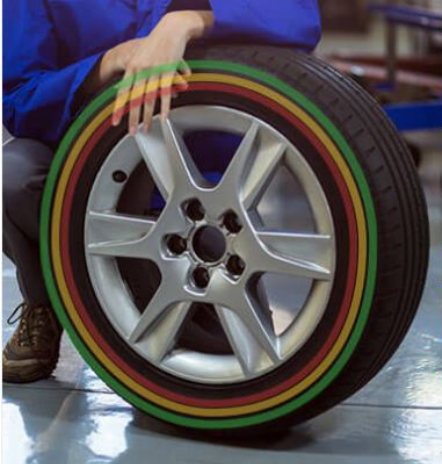
Driver's Rear - Pirelli
Passenger's Rear - Pirelli
Tire Size
Driver's Front - 205/55/18
Passenger's Front - 205/55/18
Driver's Rear - 205/55/18
Passenger's Rear - 205/55/18
Tire Condition
Driver's Front - No Issues
Passenger's Front - No Issues
Driver's Rear - No Issues
Passenger's Rear - No Issues
Wheel Condition
Driver's Front - No Issues
Passenger's Front - No Issues
Driver's Rear - No Issues
Passenger's Rear - No Issues
Tire Tread
Driver's Front - 9/32
Passenger's Front - 9/32
Driver's Rear - 9/32
Passenger's Rear - 9/32

10/32 OR MORE
Tires have plenty of tread! (standard)
8/32 OR MORE
Tires have plenty of tread! (low profile)
5/32 TO 7/32
Tires will need replacement soon!
4/32 OR LESS
Tires need replacement!
