1973 Chevrolet C10

Today I inspected a very nice white 73 Chevrolet c10. This truck is definitely a head turner. Don't miss your chance to make this your daily driver, or even a full show truck.

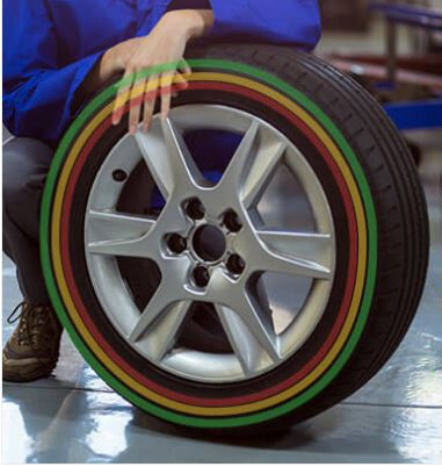
10/32 OR MORE

Tires have plenty of tread!
(standard)

8/32 OR MORE

Tires have plenty of tread!
(low profile)

5/32 TO 7/32

Tires will need replacement soon!

4/32 OR LESS

Tires need replacement!
