CORAKI QUARRY

2016 ANNUAL REVIEW

10 OCTOBER 2016 TO 31 DECEMBER 2016

Prepared for:
Quarry Solutions Pty Ltd

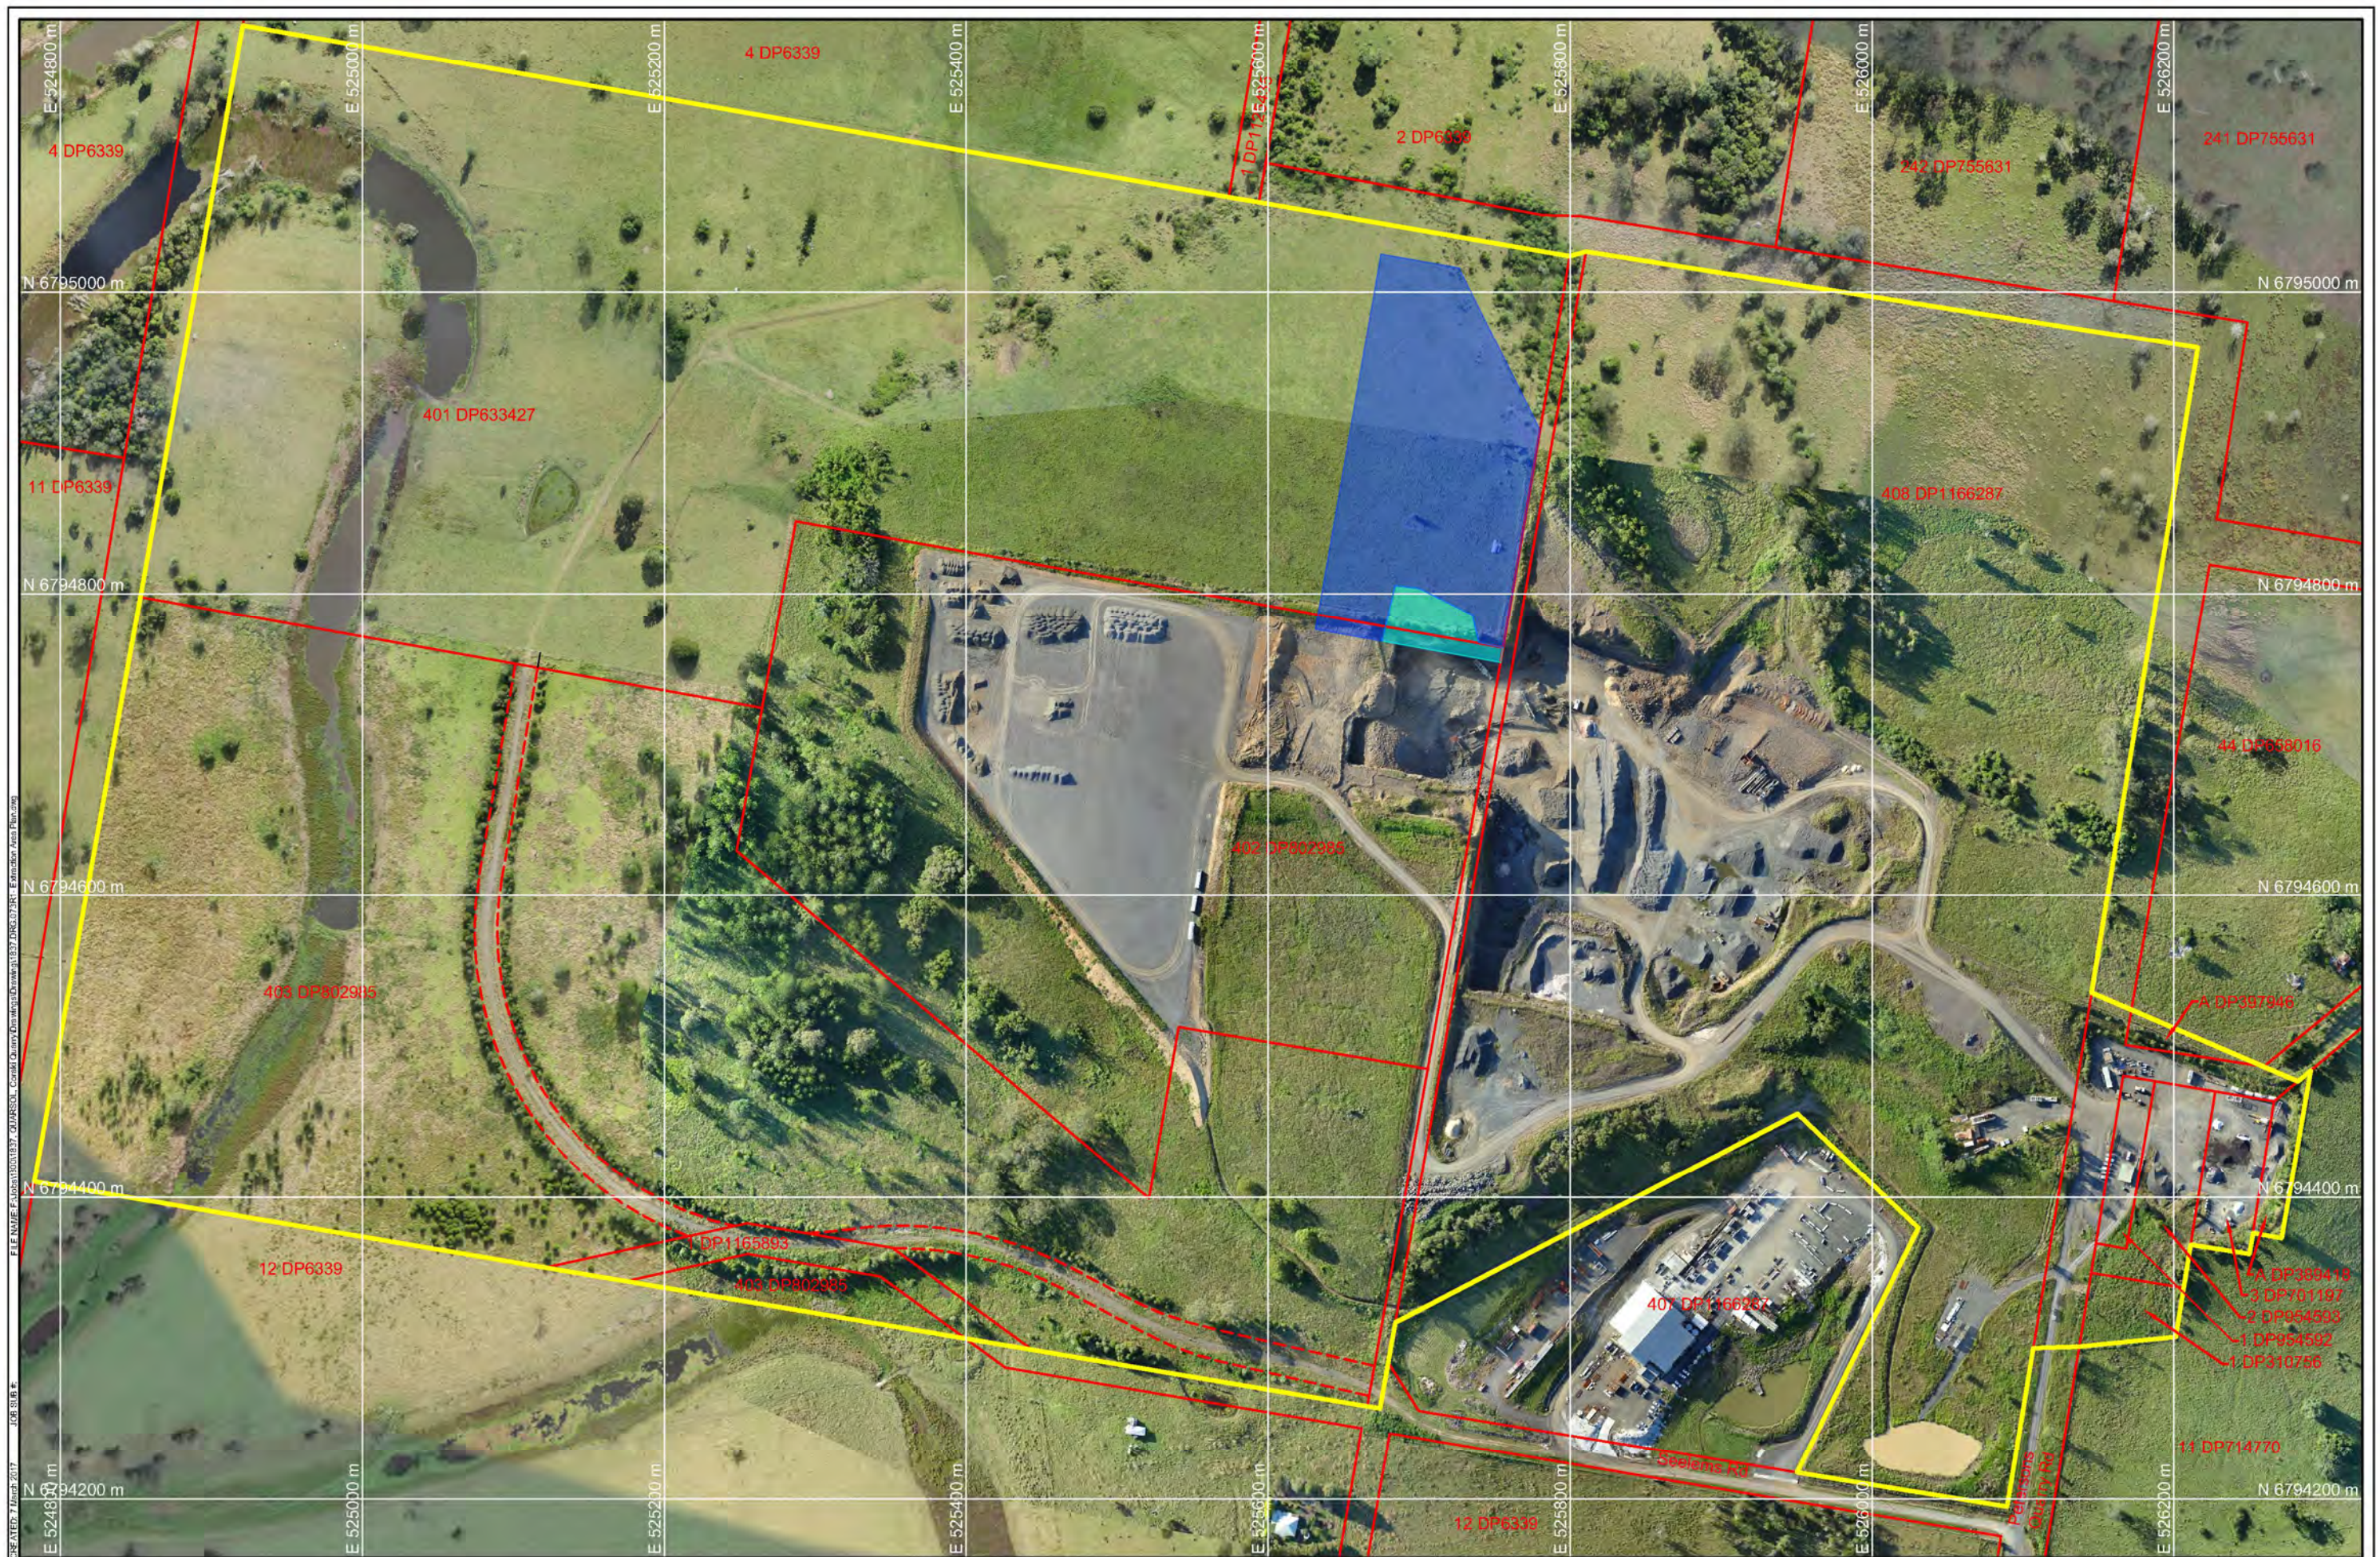
Extraction undertaken during 2016 and the proposed development of the quarry pit in 2017 is shown on Figure 1 – Extraction Area Plan. Extraction is proposed to be undertaken to a design depth of 18m AHD, developing to the north and west, during the upcoming 12 month period.

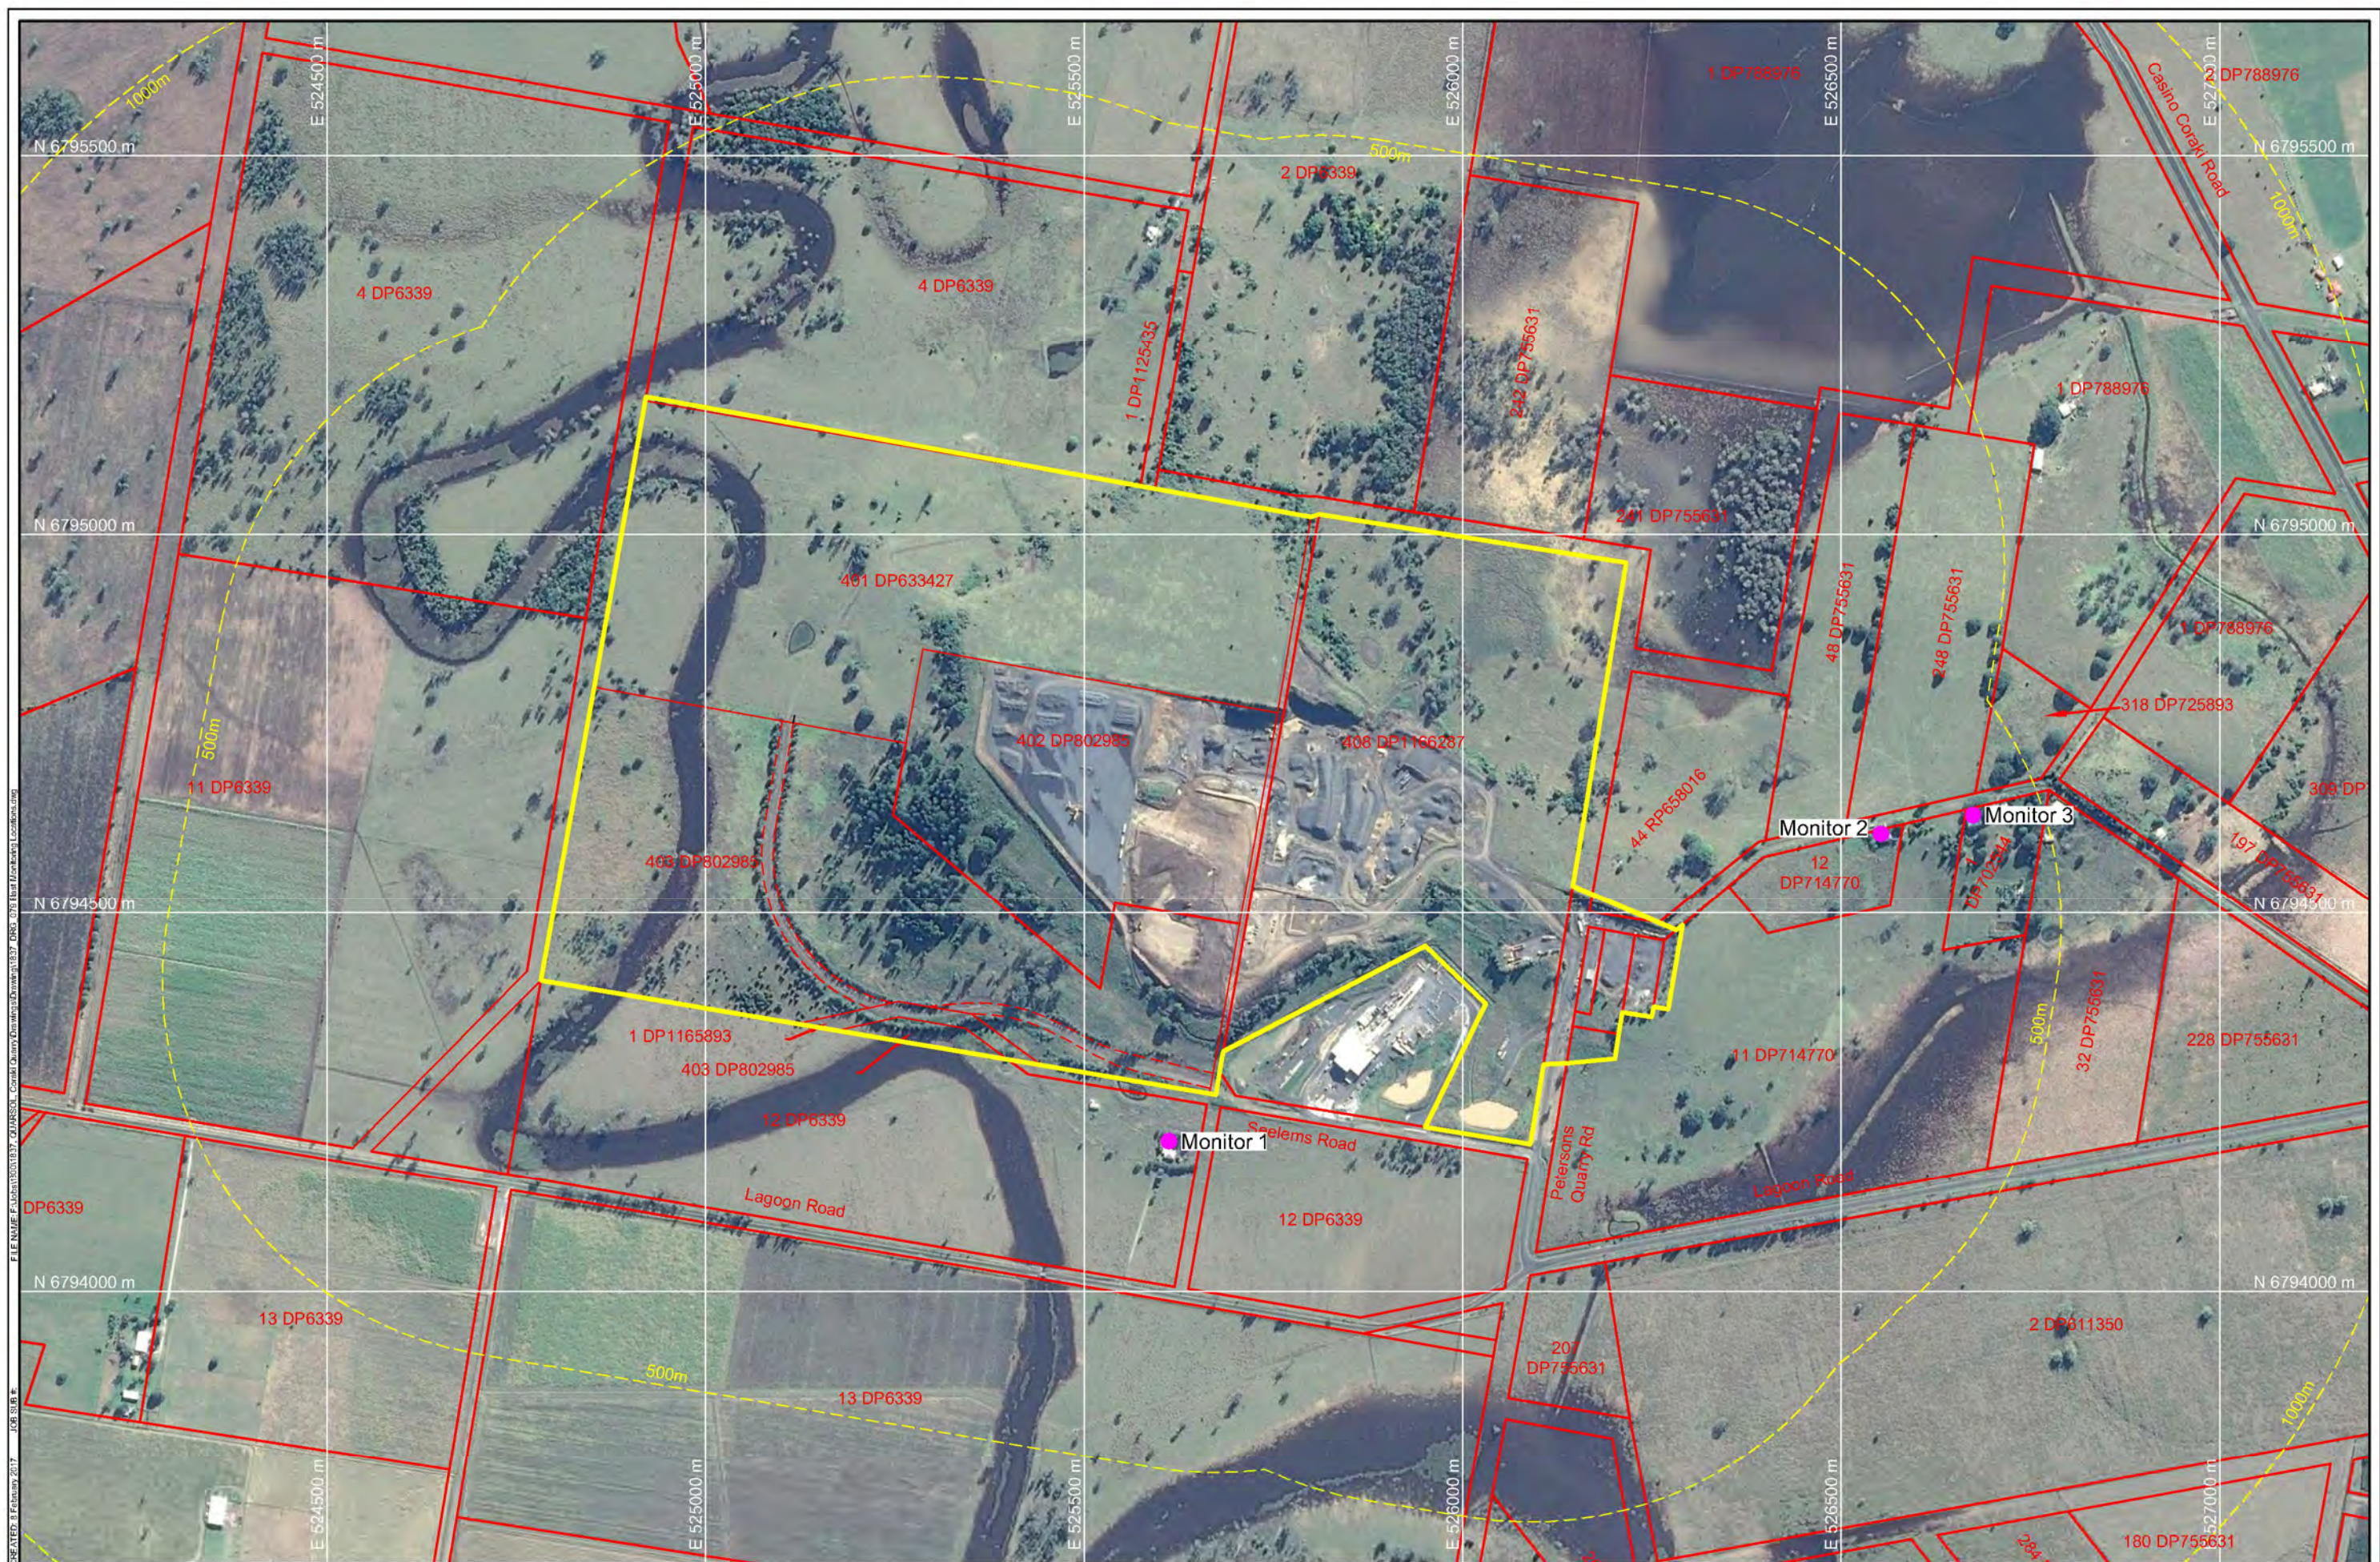
Figure 2 - Blast Monitoring Locations		SCALE: 1:8,000 0 160m	DRAWING NUMBER: 1837.DRG.079	REVISION:
GROUNDWORK plus	DATE: 8 February 2017 PRINTED: 10 February 2017	DRAWN: JS CHECKED: MD	DATUM: HORIZONTAL / VERTICAL / ZONE MGA / AHD / 56

Blasting within the assessment period occurred on 10 October, 21 November, 9 December and 16 December 2016. Blast monitoring was undertaken at three (3) locations, refer to Figure 2 – Blast Monitoring Locations. All blasts complied with the blasting criteria.

Date	Monitor 1	Monitor 2	Monitor 3
10 October 2016	114.2 dB(L)	111.5	<88 dB(L)
21 November 2016	<88 dB(L)	No trigger	No trigger
9 December 2016	115 dB(L)	114 dB(L)	97.5 dB(L)
16 December 2016	109.3 dB(L)	109.9 dB(L)	96.88 dB(L)

Date	Monitor 1	Monitor 2	Monitor 3
10 October 2016	1.656mm/s	1.308mm/s	0.542mm/s
21 November 2016	2.189mm/s	No trigger	No trigger
9 December 2016	2.3mm/s	1.024mm/s	0.813mm/s
16 December 2016	0.999mm/s	0.839mm/s	0.762mm/s

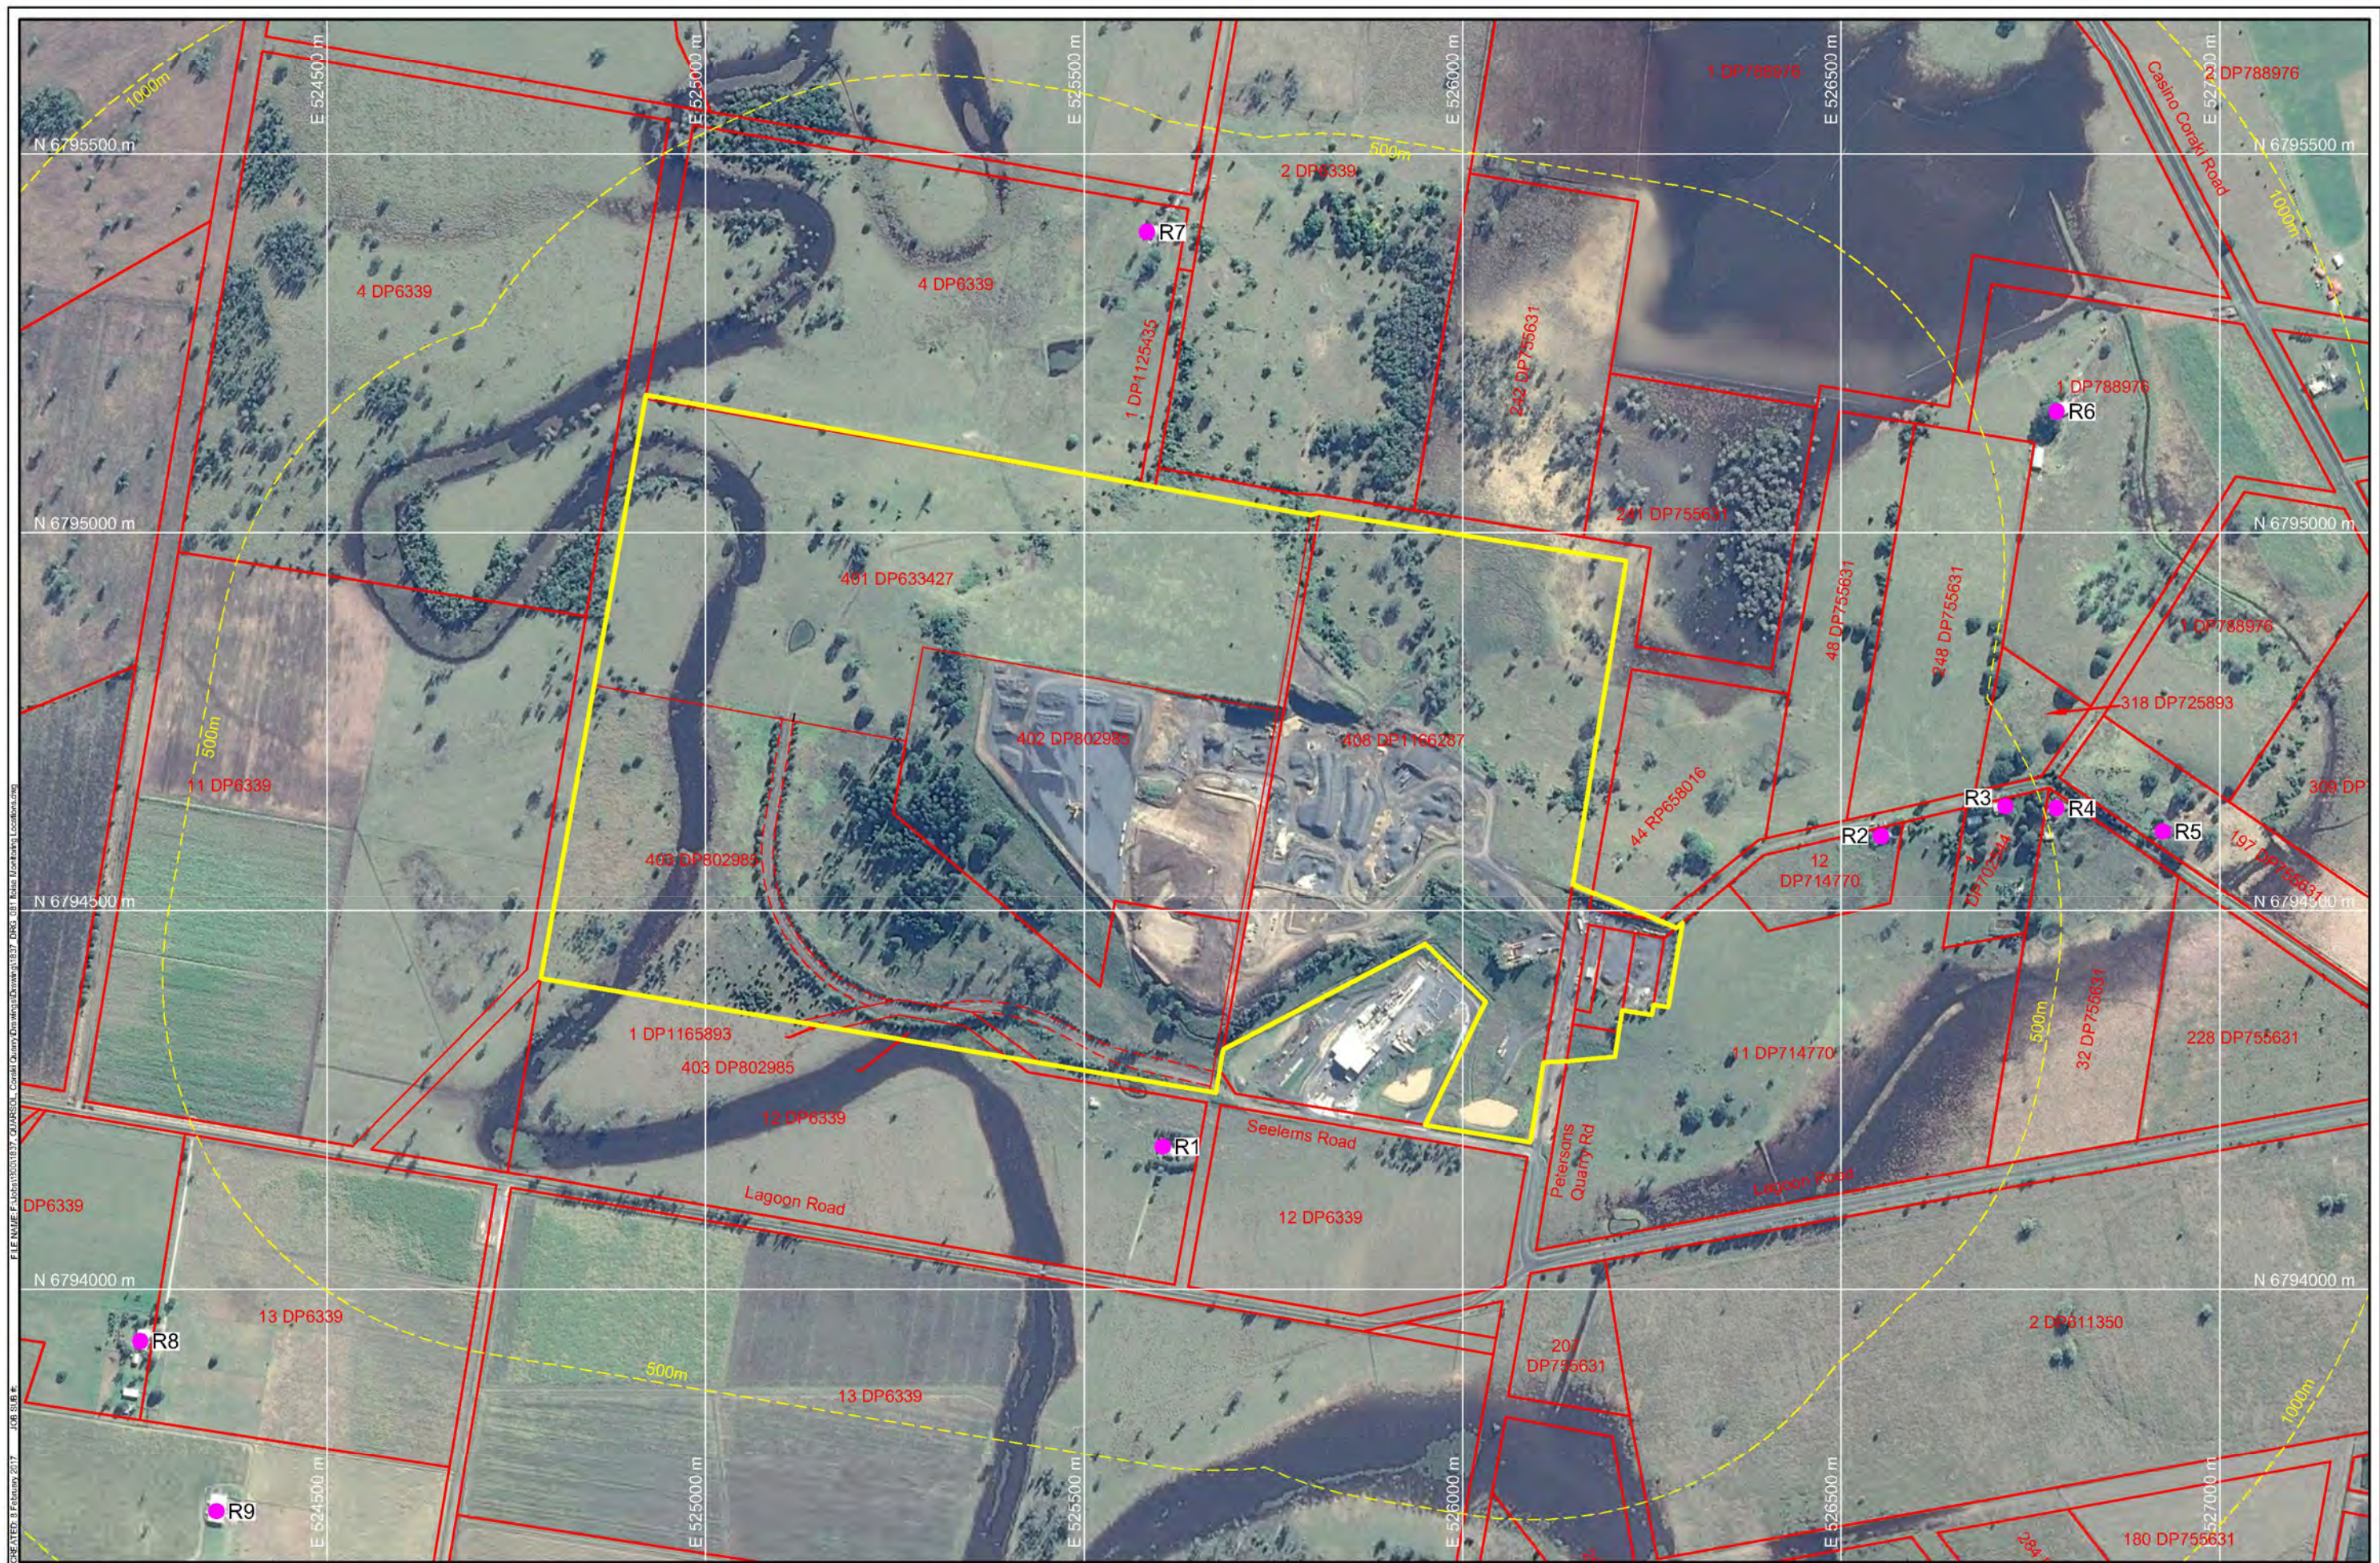
Figure 3 - Noise Monitoring Locations		SCALE: 1:8,000 0 160m		DRAWING NUMBER: 1837.DRG.081	REVISION:
GROUNDWORK plus		DATE: 8 February 2017 PRINTED: 10 February 2017	DRAWN: JS CHECKED: MD	DATUM: HORIZONTAL / VERTICAL / ZONE MGA / AHQ / 56

A Noise Compliance Review was undertaken on 2 December 2016 in accordance Condition 7 of the Development Consent and the Noise Management Plan. Noise monitoring was undertaken at seven (7) locations, refer to Figure 3 – Noise Monitoring Locations. The Noise Compliance Review report stated that quarry noise was assessed to be compliant with the noise limit specified in Condition 4 of the Development Consent Schedule 3 and Condition L4 of the EPL at residences R1, R2, R3, R6 and R7 considering the 5 dB(A) exceedance allowed for within agreements with the relevant landowners.

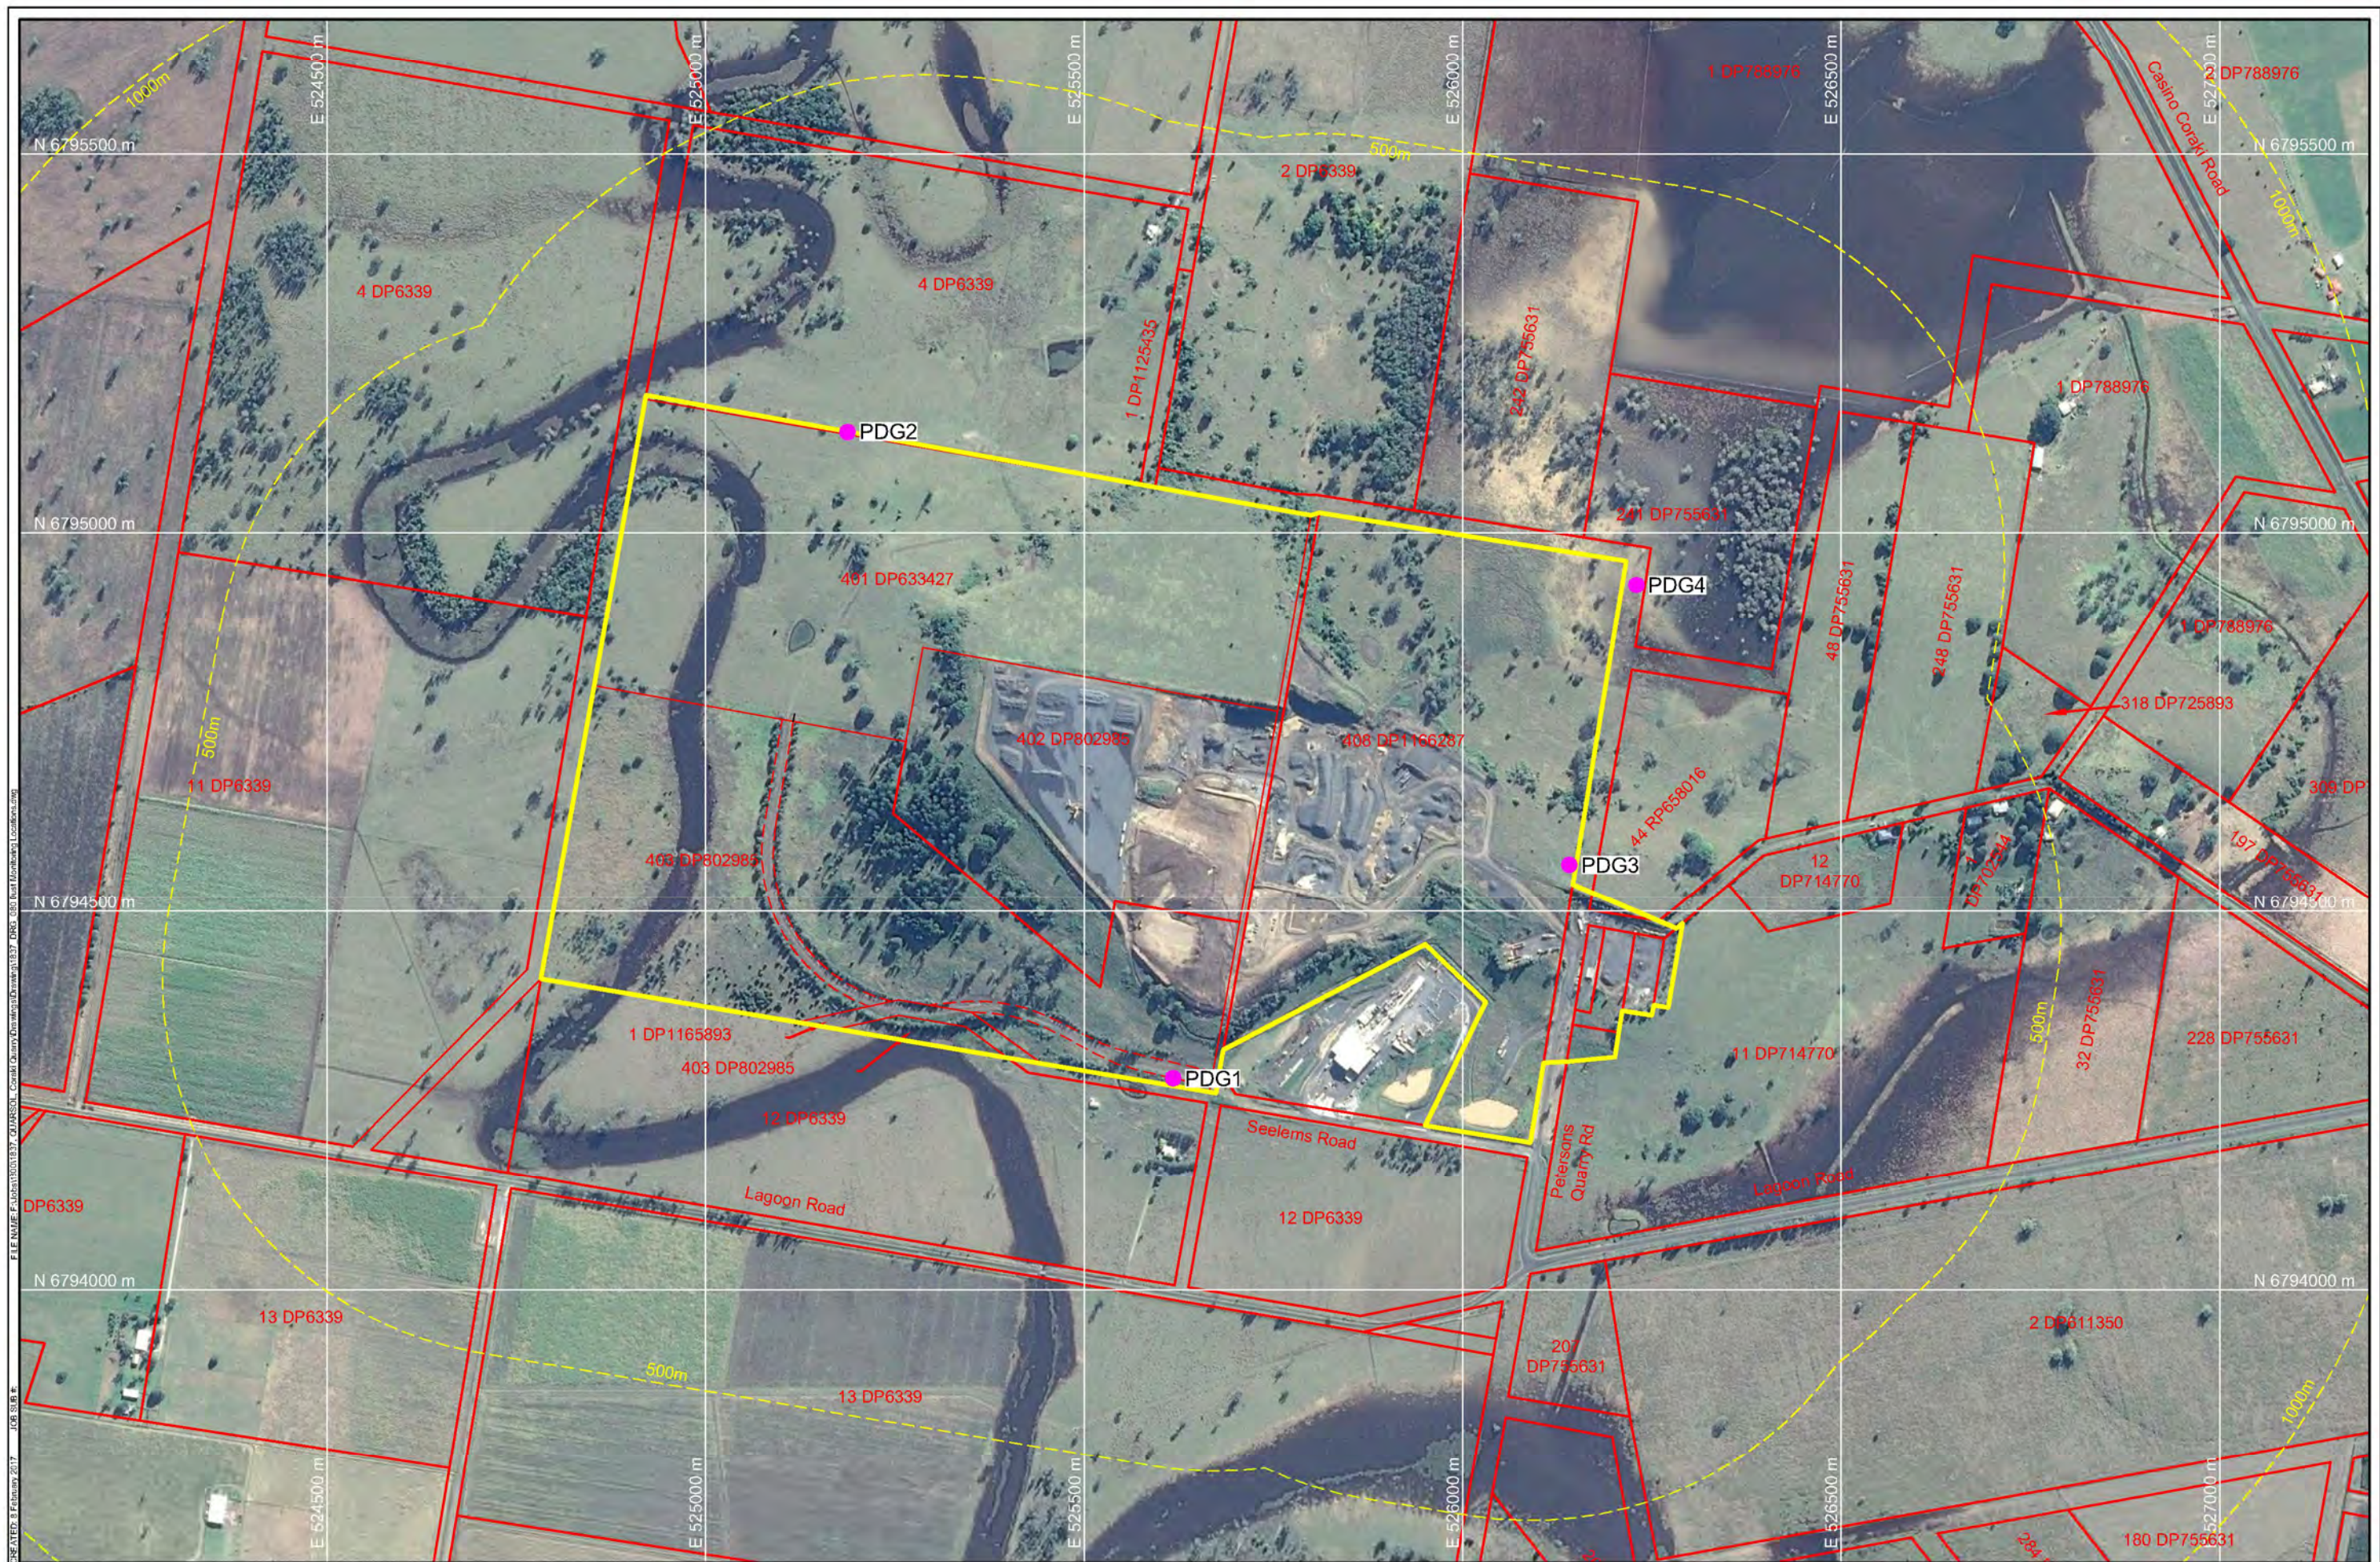
Figure 4 - Dust Monitoring Locations

Dust deposition monitoring has been undertaken at four (4) locations, refer to Figure 4 – Dust Monitoring Locations. Dust monitoring was undertaken from September 2016 to December 2016.

Dust deposition monitoring recorded high monthly levels of Total Insoluble Matter and Ash Content at PDG3 during two (2) months including 6 September to 10 October, and 11 October to 10 November 2016, however, deposited dust criterion limits are an annual average therefore these results must be averaged over the 12 months of operation. The results average over the three months indicate that Total Insoluble Matter was 3.533 g/m²/month.

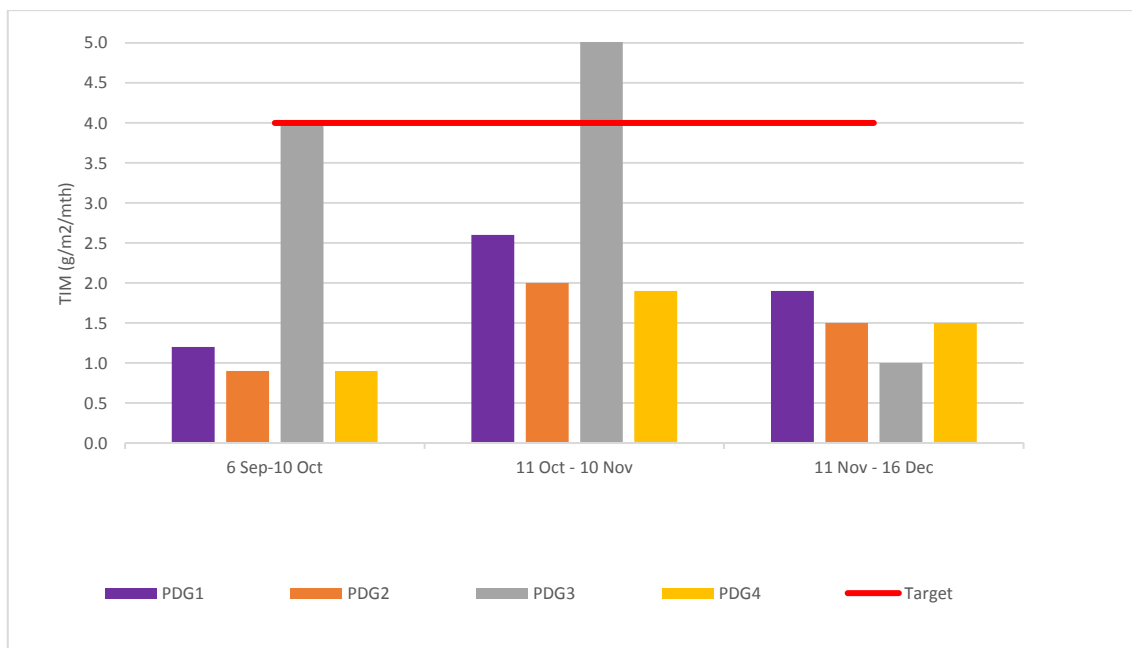
Graph 1 – Total Insoluble Matter October 2016 – December 2016

Results are summarised below in Table 3 – Dust Deposition Monitoring Results and have been graphically presented in Attachment 1 – Dust Deposition Graphs.

As the site has not been in operation for 12 months, there has been no exceedance for deposited dust, however, if the high monthly dust results continue, it is likely that an exceedance of the annual cumulative limit (4g/m²/month) for deposited dust will occur in 2017.

Action		Priority
1	It is recommended that dust monitoring results continue to be reviewed monthly to ensure they are within the limits of the Development Consent. Should elevated dust levels continue to be observed at dust monitoring location PDG3 it is recommended that a dust audit be undertaken to review site practices, identify sources of dust on site and ensure that all reasonable and practicable dust mitigation measures are employed to reduce deposited dust level.	<i>Medium</i>
2	Airblast overpressure was recorded at the limit of 115 on one (1) occasion at the Monitor 1 location. Blast management practices should be monitored closely to ensure airblast overpressure does not exceed the licensed limit.	<i>Medium</i>

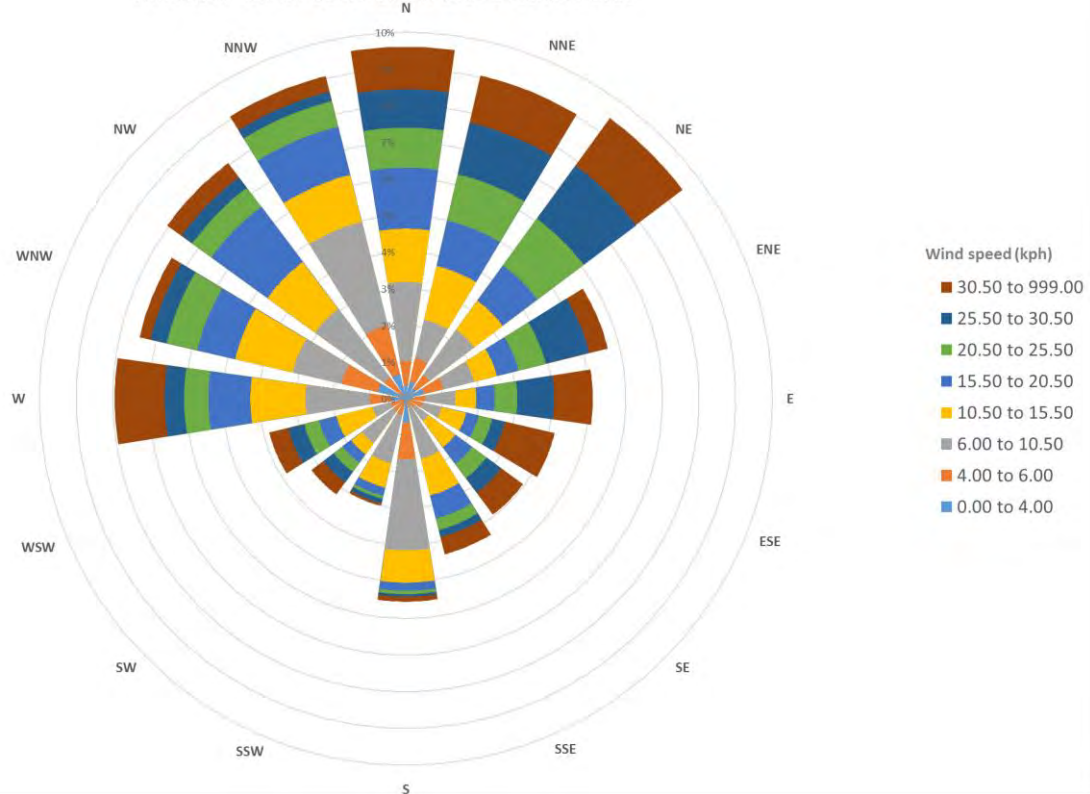
Wind Rose - Coraki 11 November to 10 December 2016

The weather station was installed on site on 29 September 2016 and indicated that the wind recorded between September and December 2016 was predominately from the west to north east, refer to Attachment 2 – Wind Roses. Dust monitor PDG3 is to the east, south east predominately downwind of the extractive activities which indicates that the dust monitored was likely to be coming from the increased extraction activity on the site. The wind roses also show that the wind has become more variable from September to December, which is typical of summer months. The dust monitored at PDG3 in December was considerably less than the previous months.

To assess the incremental impact of deposited dust, it is likely that the dust monitored at PD4 would be considered background as it was predominately upwind of the site during September to December 2016 refer to Attachment 2 – Wind Roses. The results of the background (PDG4) Total Insoluble Matter have been subtracted from the Total Insoluble Matter results recorded downwind (PDG3) which are presented in Table 4 – Incremental Dust Deposition Monitoring Results (PDG3 – PDG4). Whilst this shows elevated results for the 6 September to 10 October 2016 period and the 11 October to 10 November 2016 period, the average of the three months recorded to date is only slightly above the limit of 2g/m²/month.
