1958 Ford Thunderbird

Vehicle Info	
Year - 1958	
Make - Ford	
Model - Thunderbird	
Mileage - 61945	
Transmission - Automatic	
VIN Number - h8yh106773	
Interior - Leather	
Interior Color - Black	
Body Color - Black	
Engine - 8 Cylinder	
Drive Type - Rear Wheel Drive	
Fuel Type - Gas

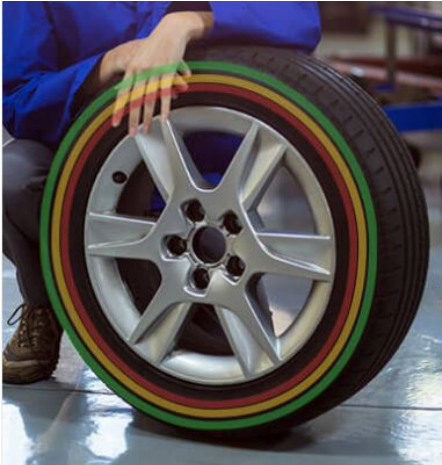
10/32 OR MORE

Tires have plenty of tread!
(standard)

8/32 OR MORE

Tires have plenty of tread!
(low profile)

5/32 TO 7/32

Tires will need replacement soon!

4/32 OR LESS

Tires need replacement!
