1959 Toyota FJ-25

This 1959 Toyota FJ-25 is in fair running and driving condition with flaws to note.

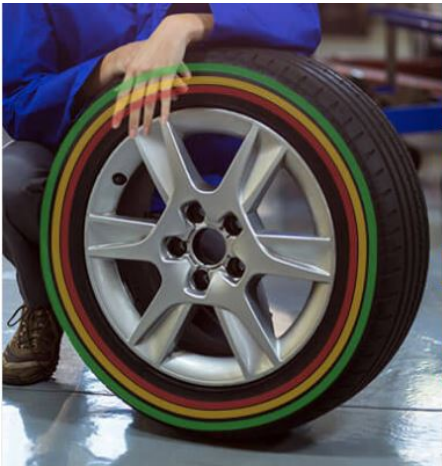
10/32 OR MORE
Tires have plenty of tread! (standard)
8/32 OR MORE
Tires have plenty of tread! (low profile)
5/32 TO 7/32
Tires will need replacement soon!
4/32 OR LESS
Tires need replacement!

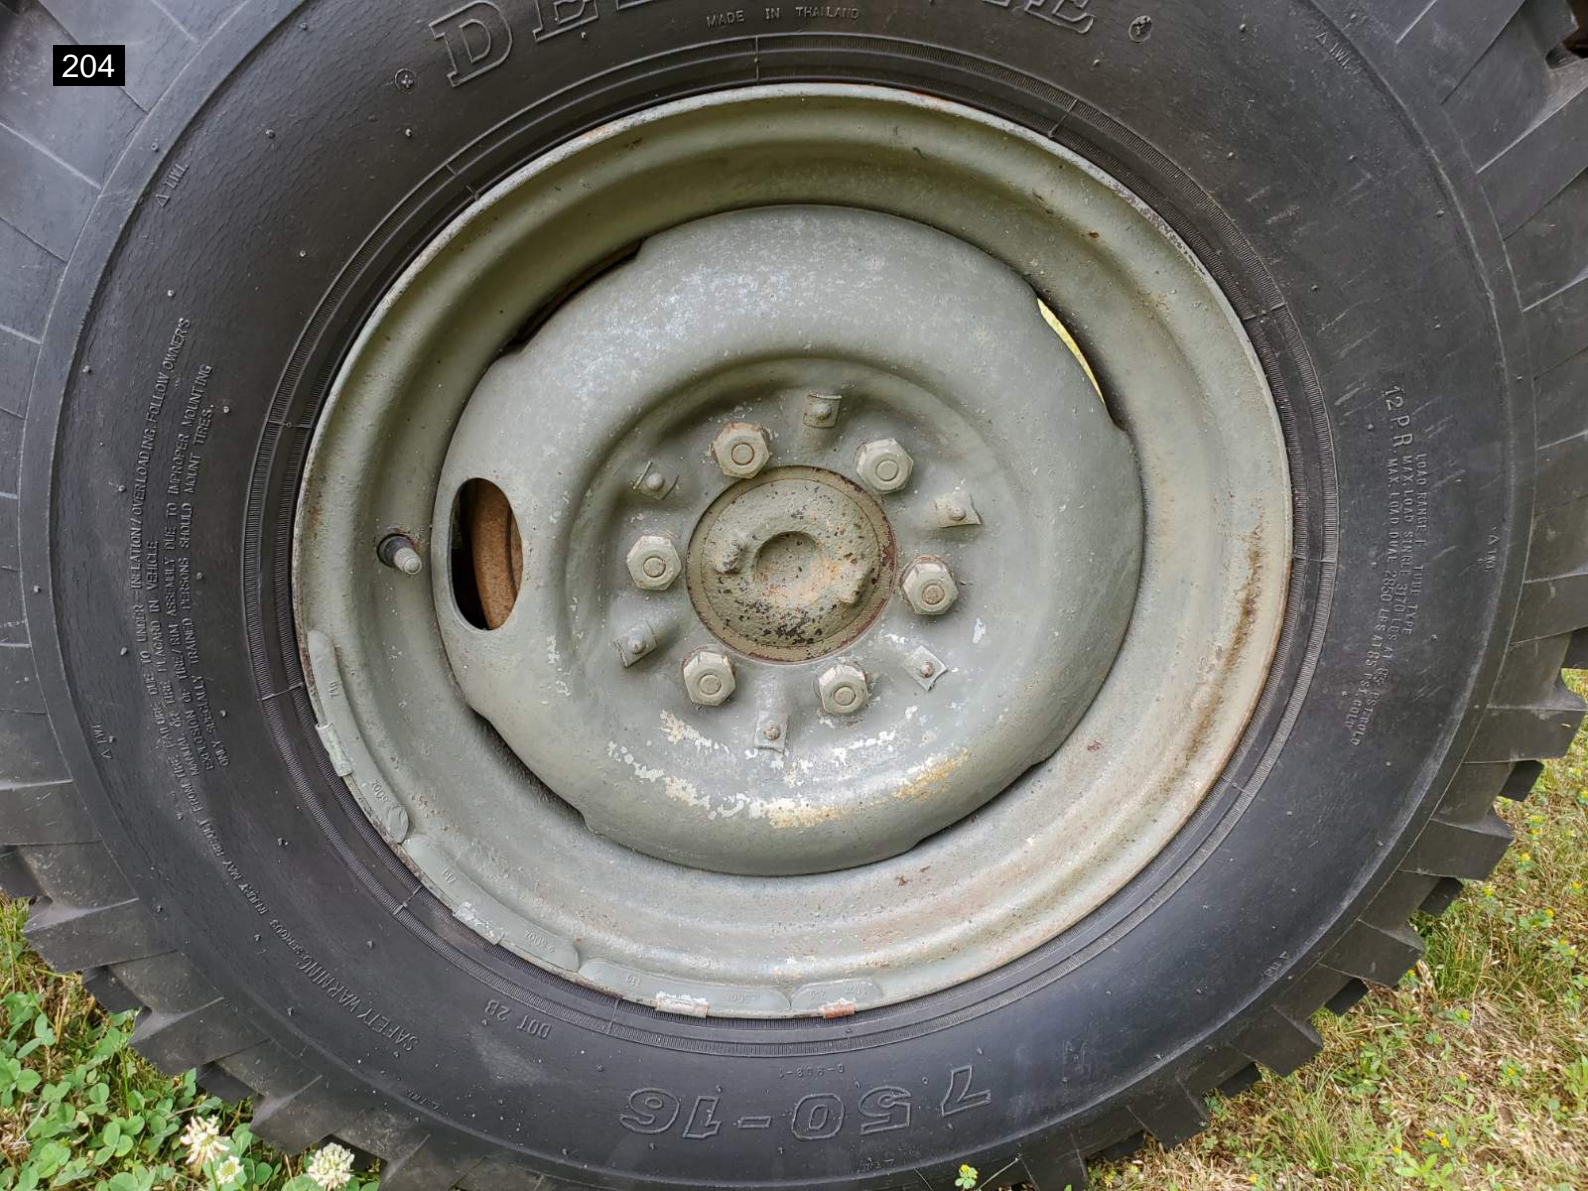
12 P.R. MAX. LOAD SINGLE SITE 2850 LBS. (1300 KG)
LOAD RANGE 1, TUBE TYPE

7.50-16

DOT 28

Driver's Front - Dry Rot
Passenger's Front - Dry Rot
Driver's Rear - Dry Rot
Passenger's Rear - Dry Rot
