1956 Chevrolet Bel Air Station Wagon

Vehicle Info	
Year - 1956	
Make - Chevrolet	
Model - Bel Air Station Wagon	
Mileage - 1691	
Transmission - Automatic	
VIN Number - VB56L-039428	
Interior - Cloth	
Interior Color - Grey	
Body Color - Red	
Engine - 8 Cylinder	
Drive Type - Rear Wheel Drive	
Fuel Type - Gas

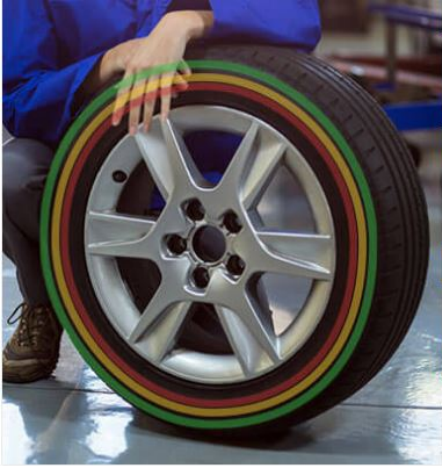
10/32 OR MORE

Tires have plenty of tread!
(standard)

8/32 OR MORE

Tires have plenty of tread!
(low profile)

5/32 TO 7/32

Tires will need replacement soon!

4/32 OR LESS

Tires need replacement!

Driver's Front - 5/32

Passenger's Front - 6/32

Driver's Rear - 6/32

Passenger's Rear - 6/32

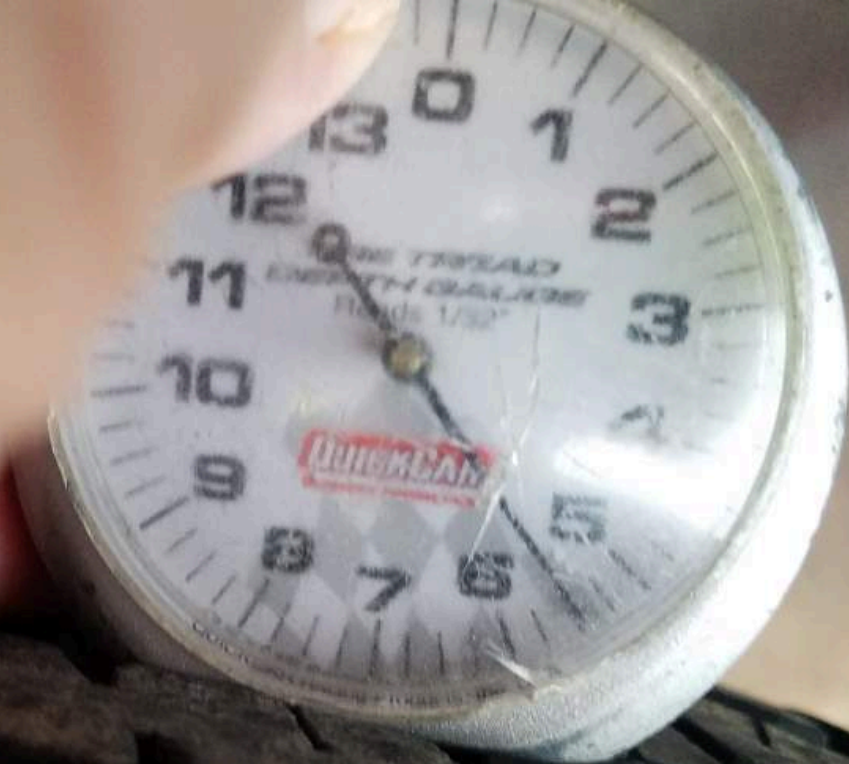
P 235/45 R17 87H

TIRES/WHEELS	
Spare Tire	✗
No spare tire found with vehicle.	
Tire Manufacturer	
Driver's Front - B.F. Goodrich	
Passenger's Front - B.F. Goodrich	
Driver's Rear - B.F. Goodrich	
Passenger's Rear - B.F. Goodrich	
Tire Size	
Driver's Front - 235/45R17	
Passenger's Front - 235/45R17	
Driver's Rear - 275/40R17	
Passenger's Rear - 275/40R17

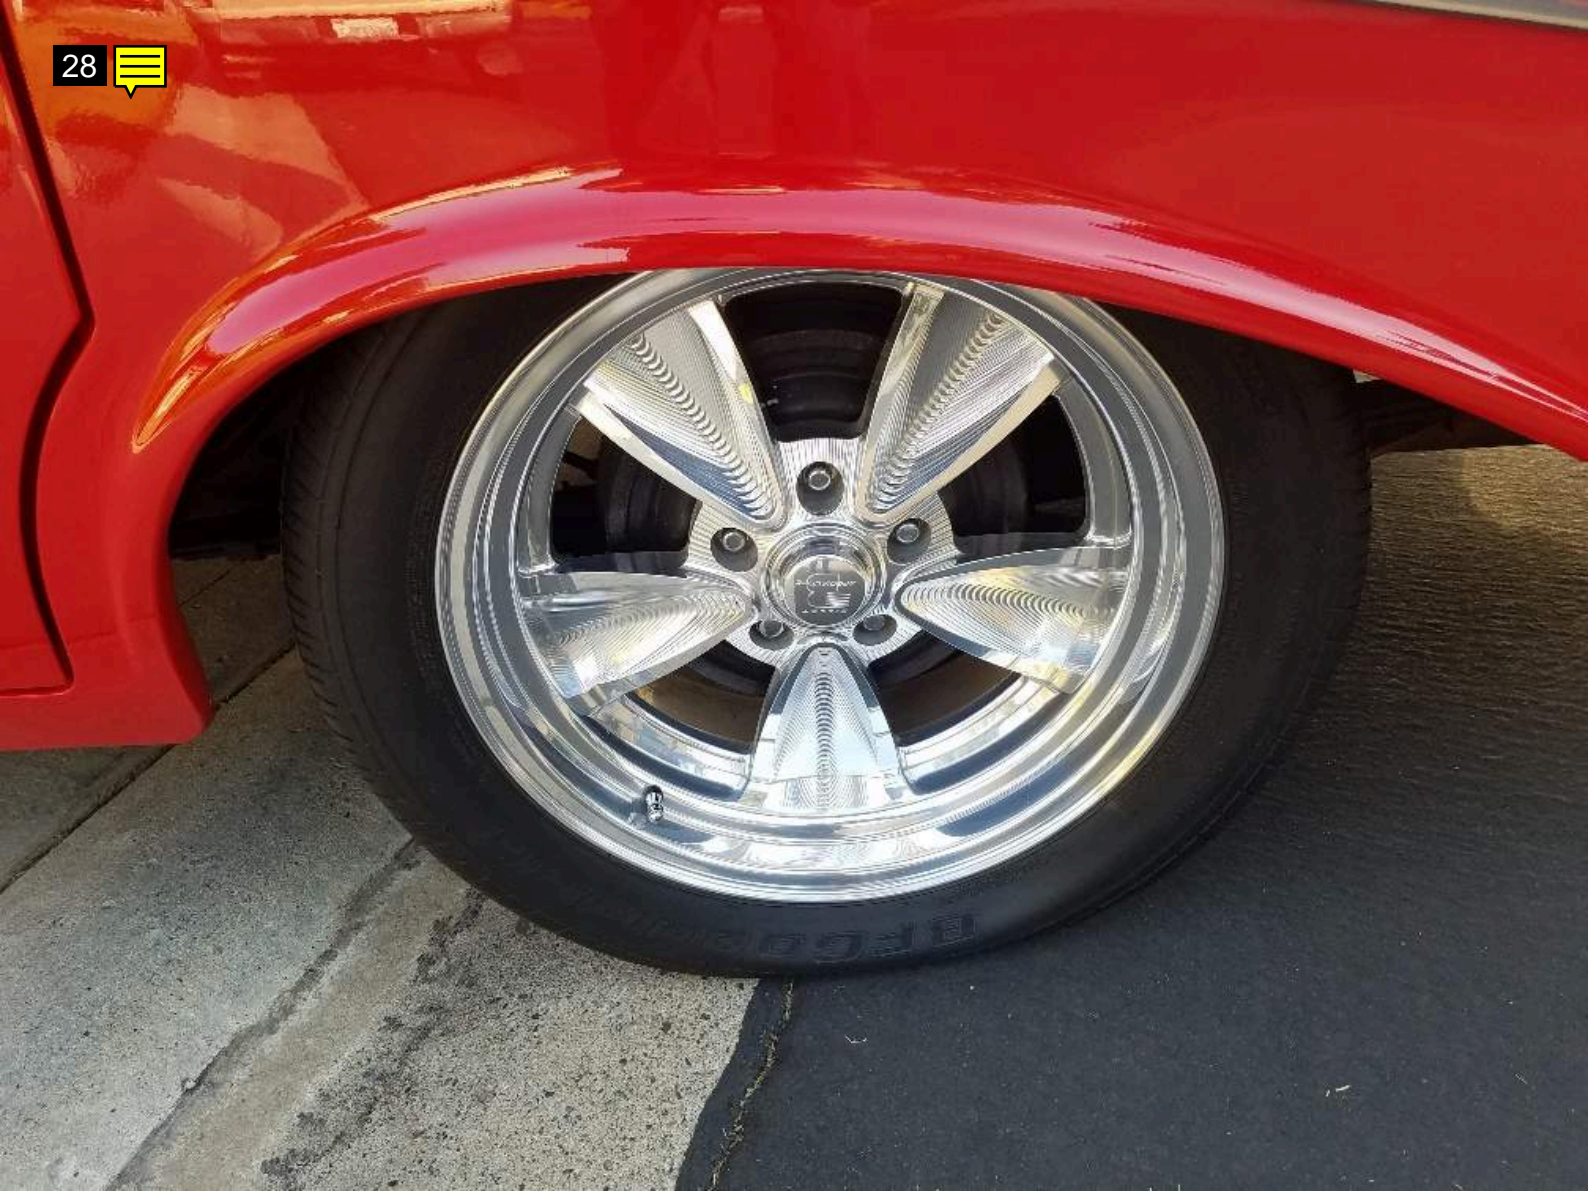
P 275/40R17 9

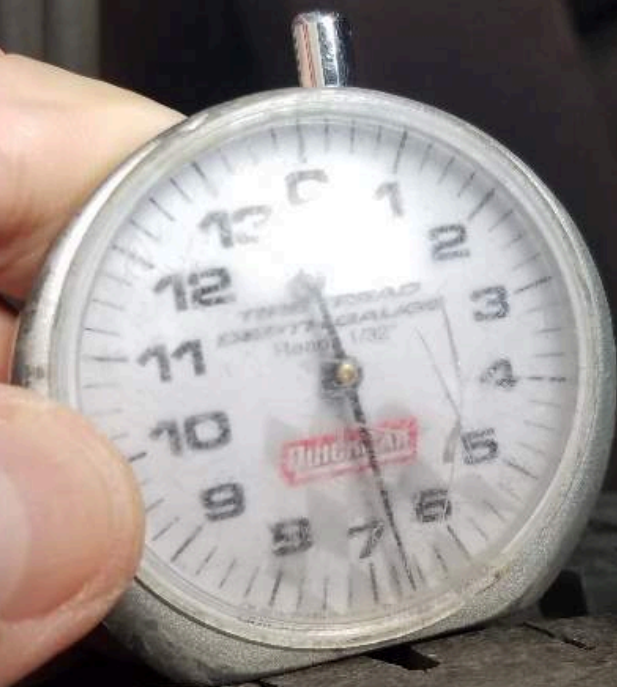
P 235/45 R17 87H
