1968 Chevrolet Impala

Vehicle Info	
Year - 1968	
Make - Chevrolet	
Model - Impala	
Mileage - 58459	
Transmission - Automatic	
VIN Number - 166478Y100009	
Interior - Cloth	
Interior Color - Black	
Body Color - White	
Engine - 8 Cylinder	
Drive Type - Rear Wheel Drive	
Fuel Type - Gas

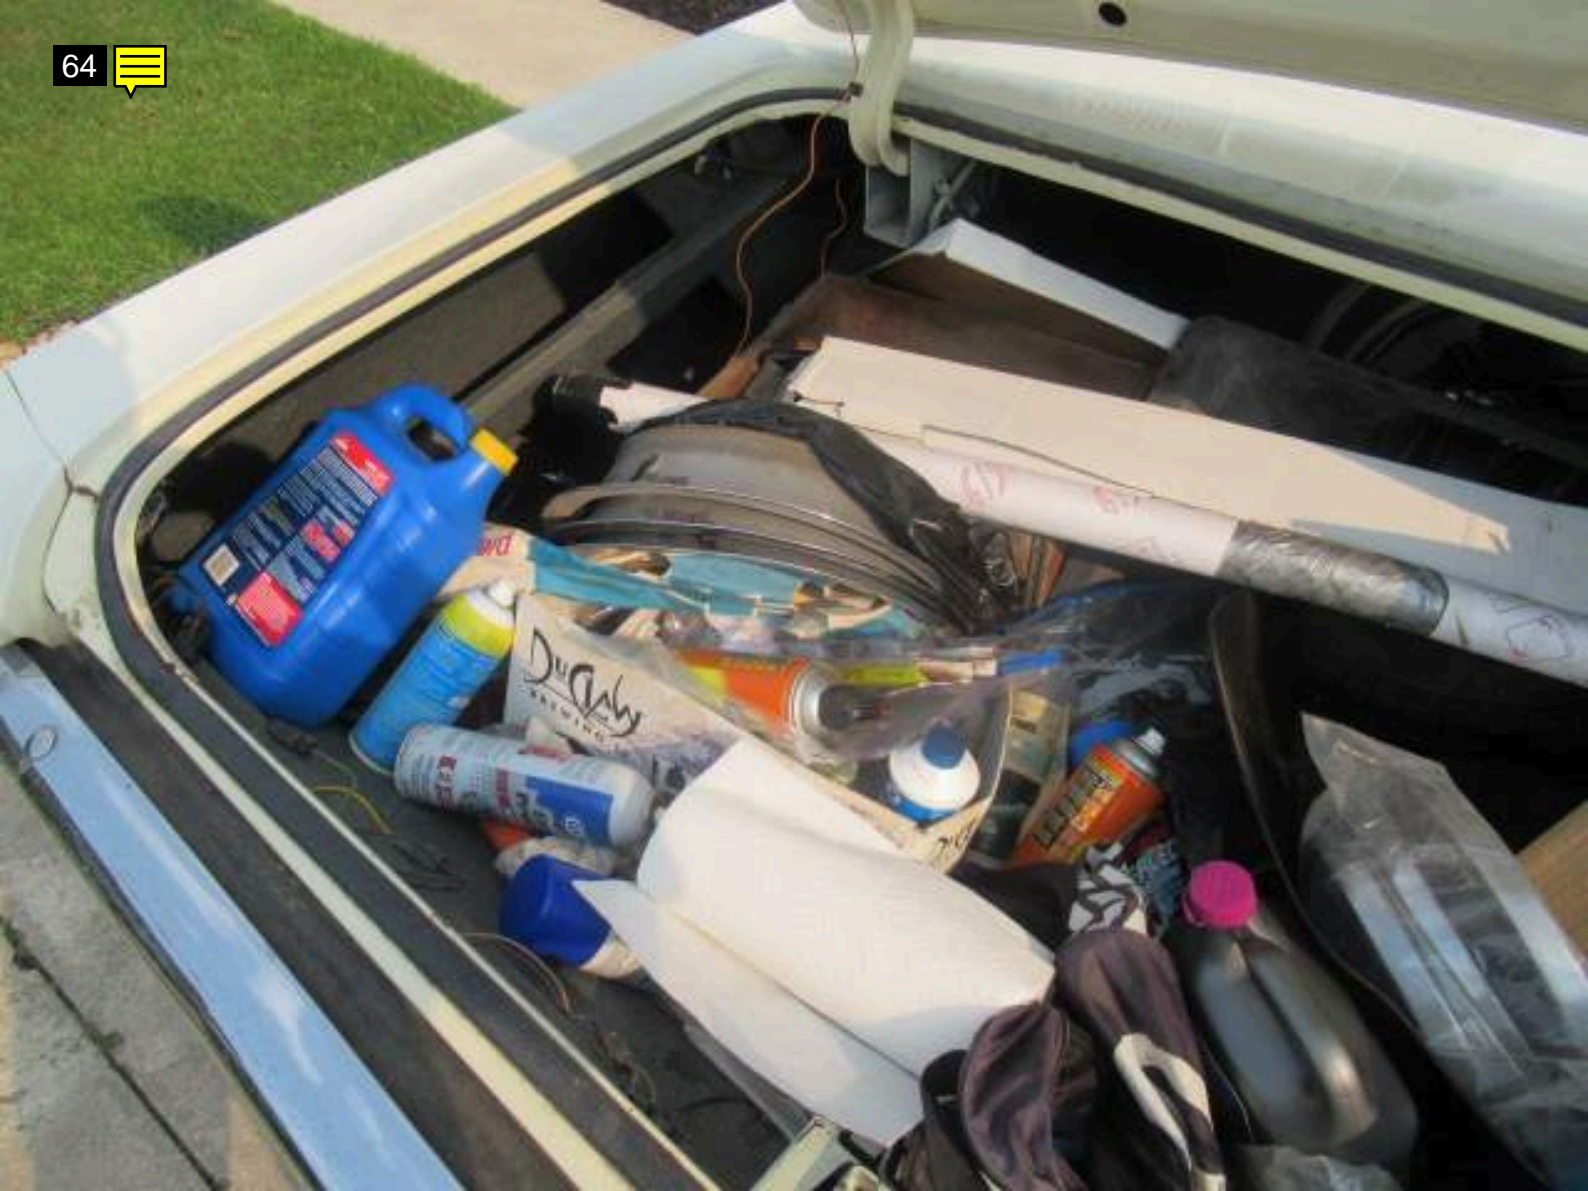
JACKING INSTRUCTIONS

CAUTION: APPLY PARKING BRAKE, BLOCK
DIAGONALLY OPPOSITE WHEEL. DO
NOT GET UNDER CAR WHILE JACK IS
BEING USED.

JACK LOCATION FRONT: INBOARD OF
BUMPER JOINT AT BUMPER NOTCH

JACK LOCATION REAR: OUTBOARD
OF BUMPER JOINT AT BUMPER
NOTCH

WHEEL REMOVAL: REMOVE HUB CAP WITH
WHEEL WRENCH. LOOSEN, BUT DO NOT
REMOVE WHEEL NUTS BEFORE USING JACK.
