1968 Chevrolet Corvette Convertible

I inspected the 1968 Chevy Corvette at the sellers home.

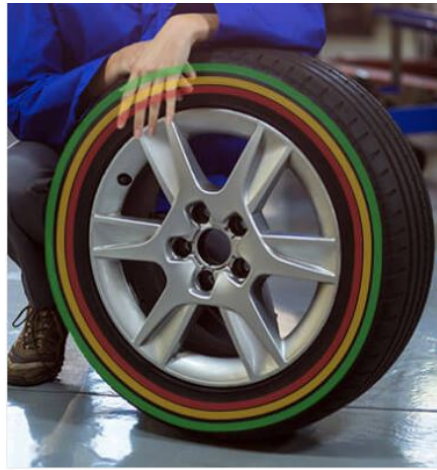
10/32 OR MORE

Tires have plenty of tread!
(standard)

Tires will need replacement soon!

Tires need replacement!
