## 1966 Chevrolet C10 Pickup 1/2 Ton

Vehicle Info	
Year - 1966	
Make - Chevrolet	
Model - C10 Pickup 1/2 Ton	
Mileage - 88076	
Transmission - Automatic	
VIN Number - C1546F160871	
Interior - Cloth	
Interior Color - Grey	
Body Color - Red	
Engine - 8 Cylinder	
Drive Type - Rear Wheel Drive	
Fuel Type - Gas

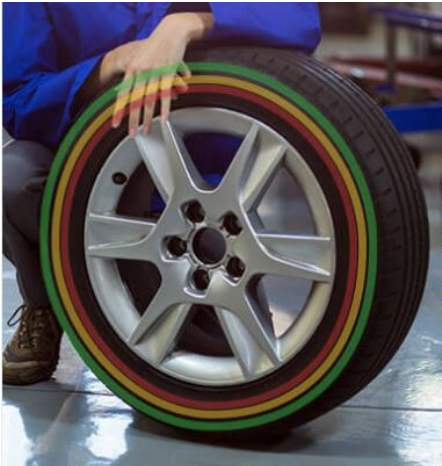
10/32 OR MORE

Tires have plenty of tread!  
(standard)

8/32 OR MORE

Tires have plenty of tread!  
(low profile)

5/32 TO 7/32

Tires will need replacement soon!

4/32 OR LESS

Tires need replacement!
