Report #477477

1983 Porsche 930

Summary

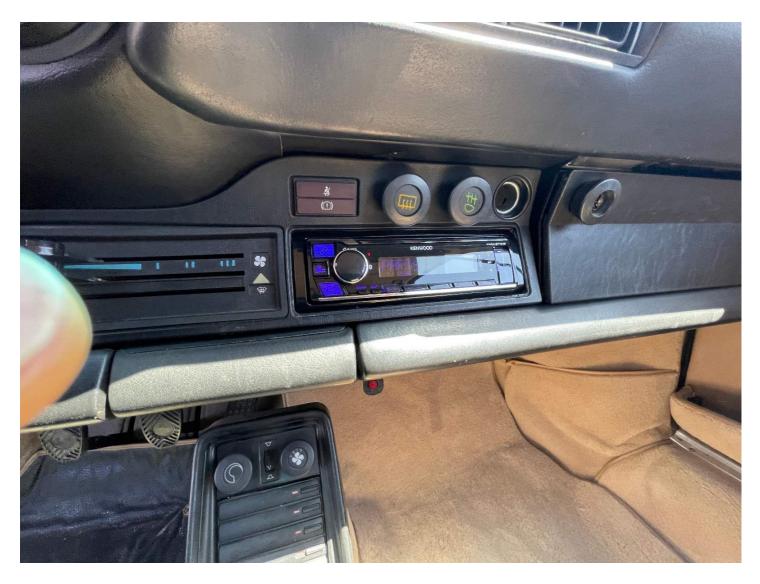
After market radio
