Report #460093

## 1951 Chevrolet Fleetline

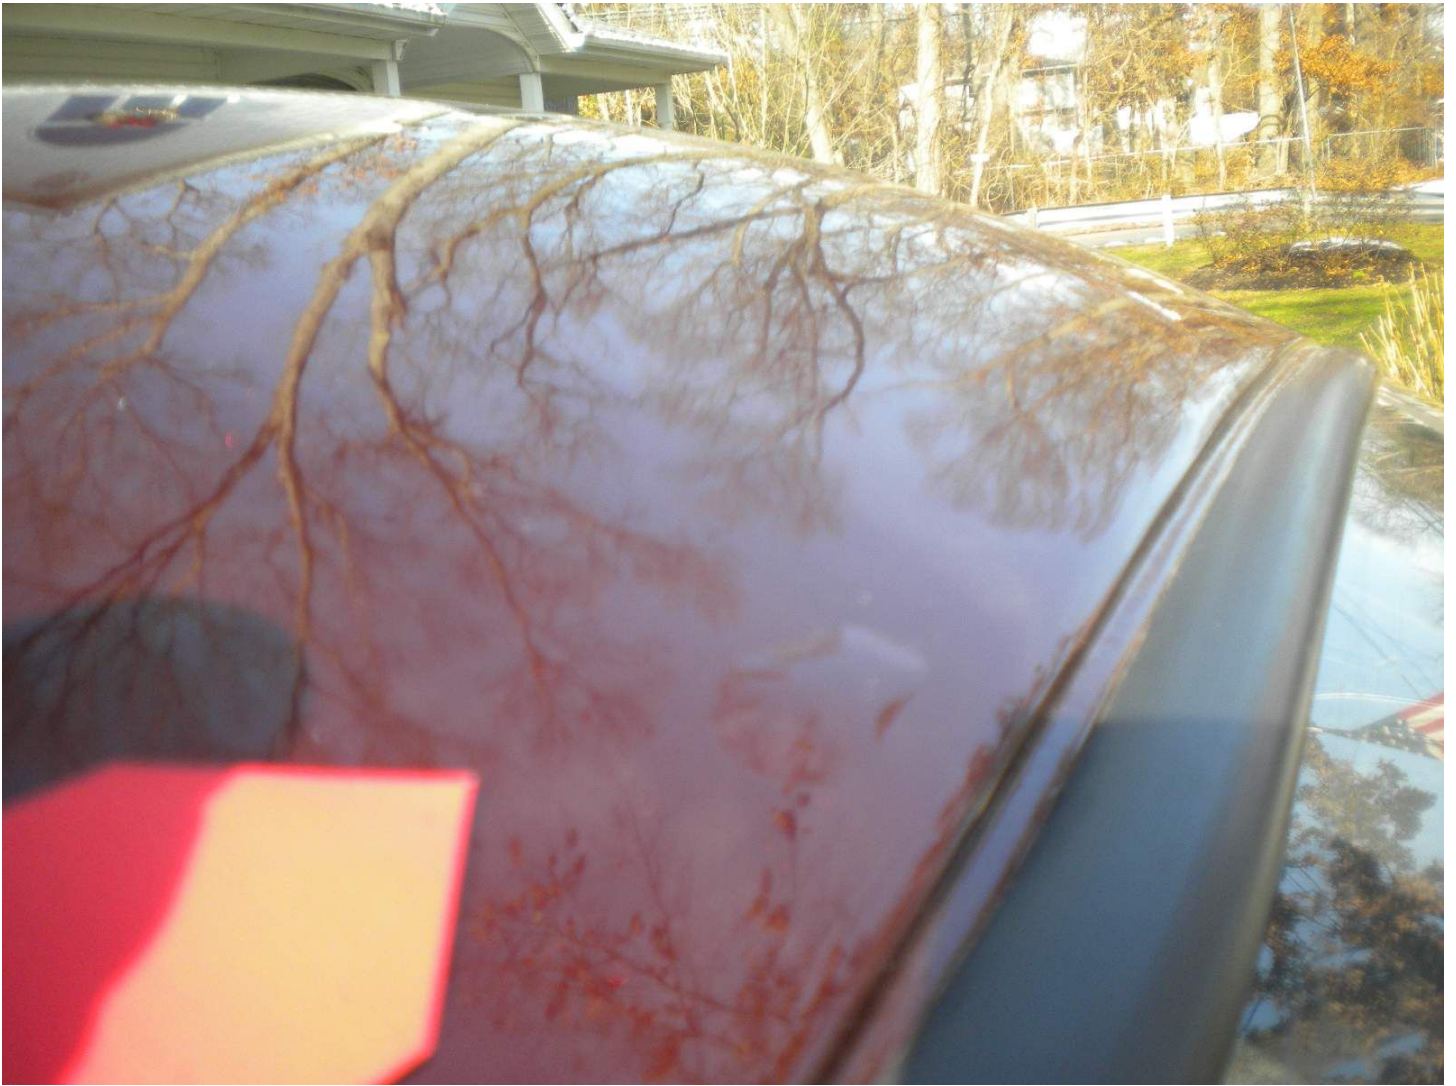
**bubble in paint about 2 inches**

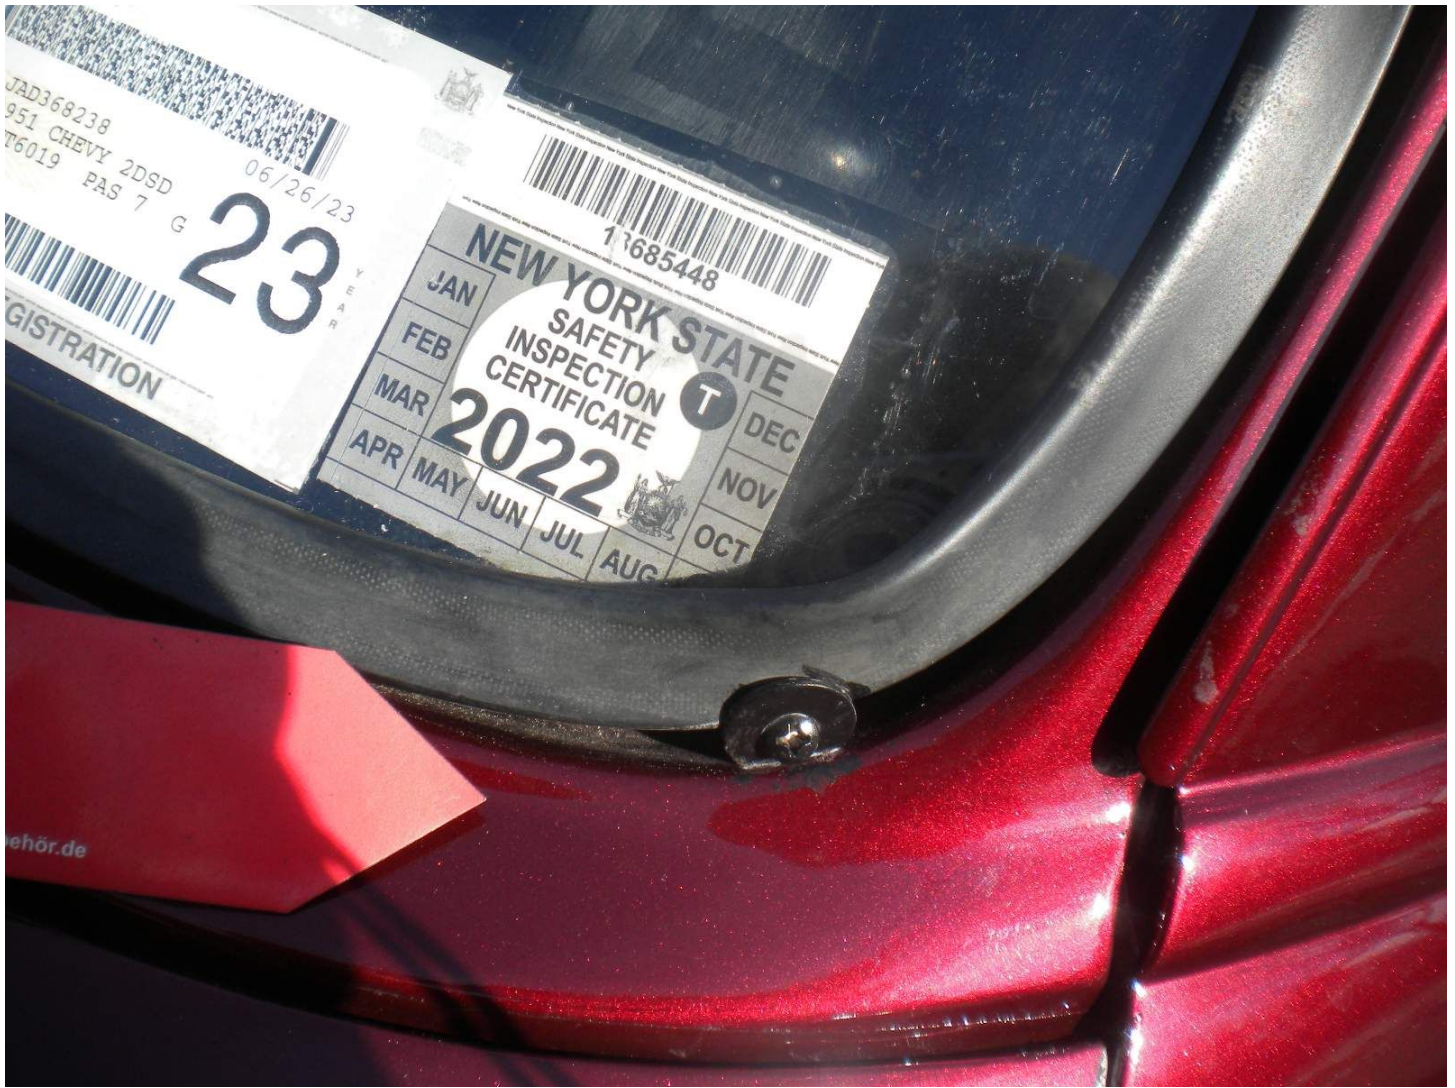
screw by windshield

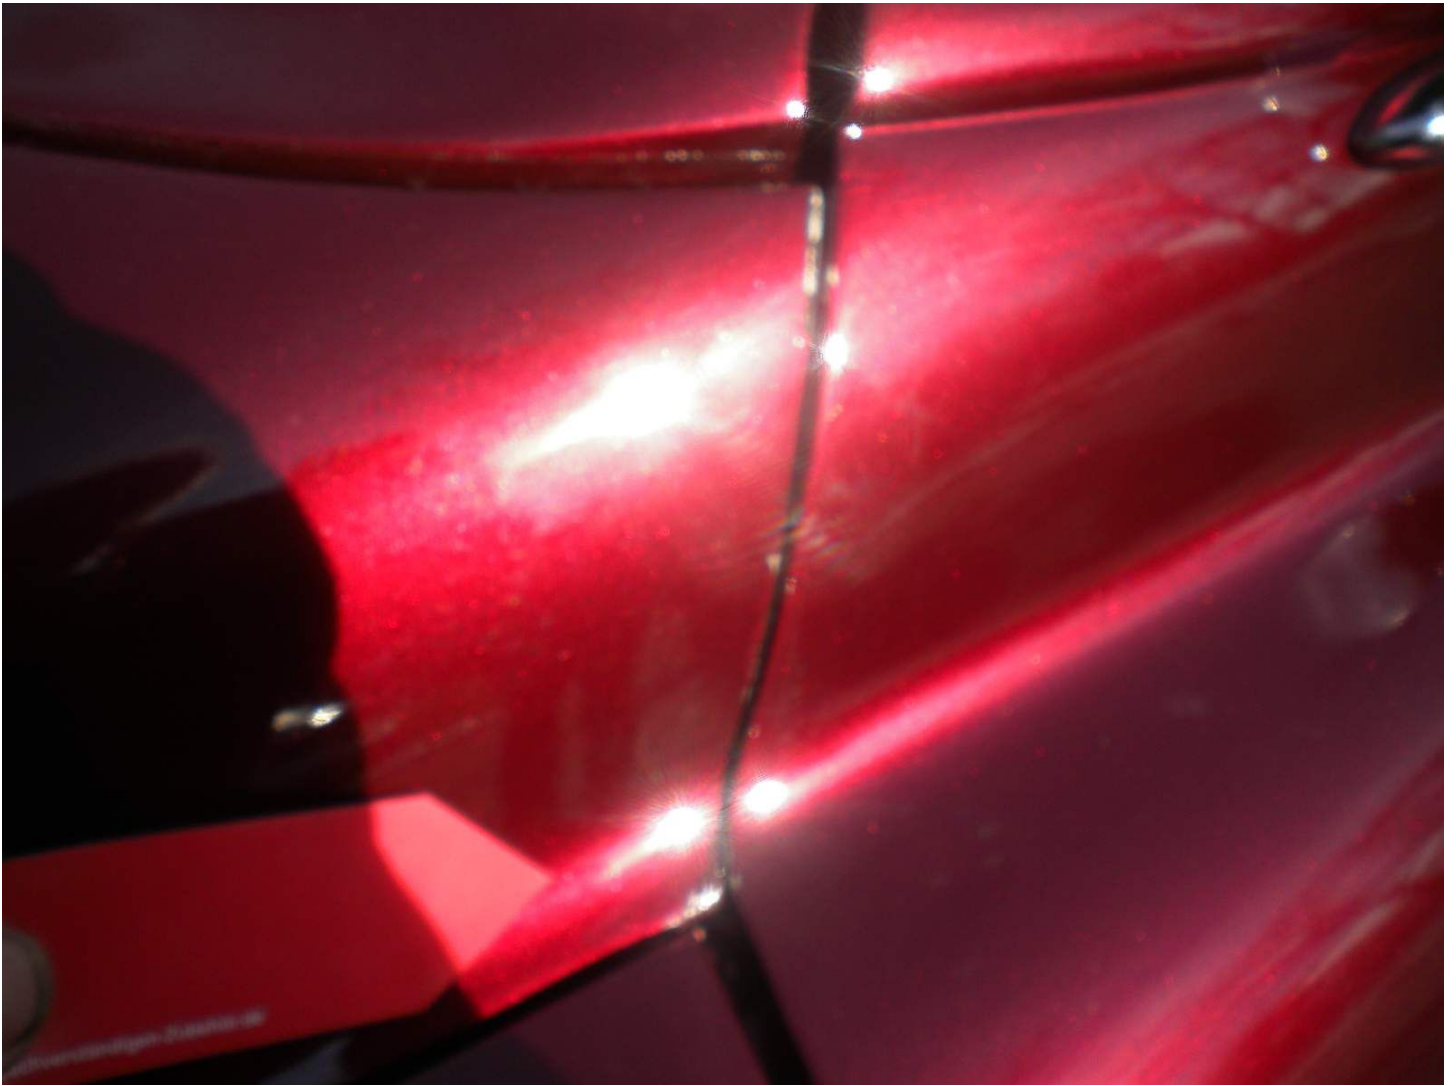
paint chips

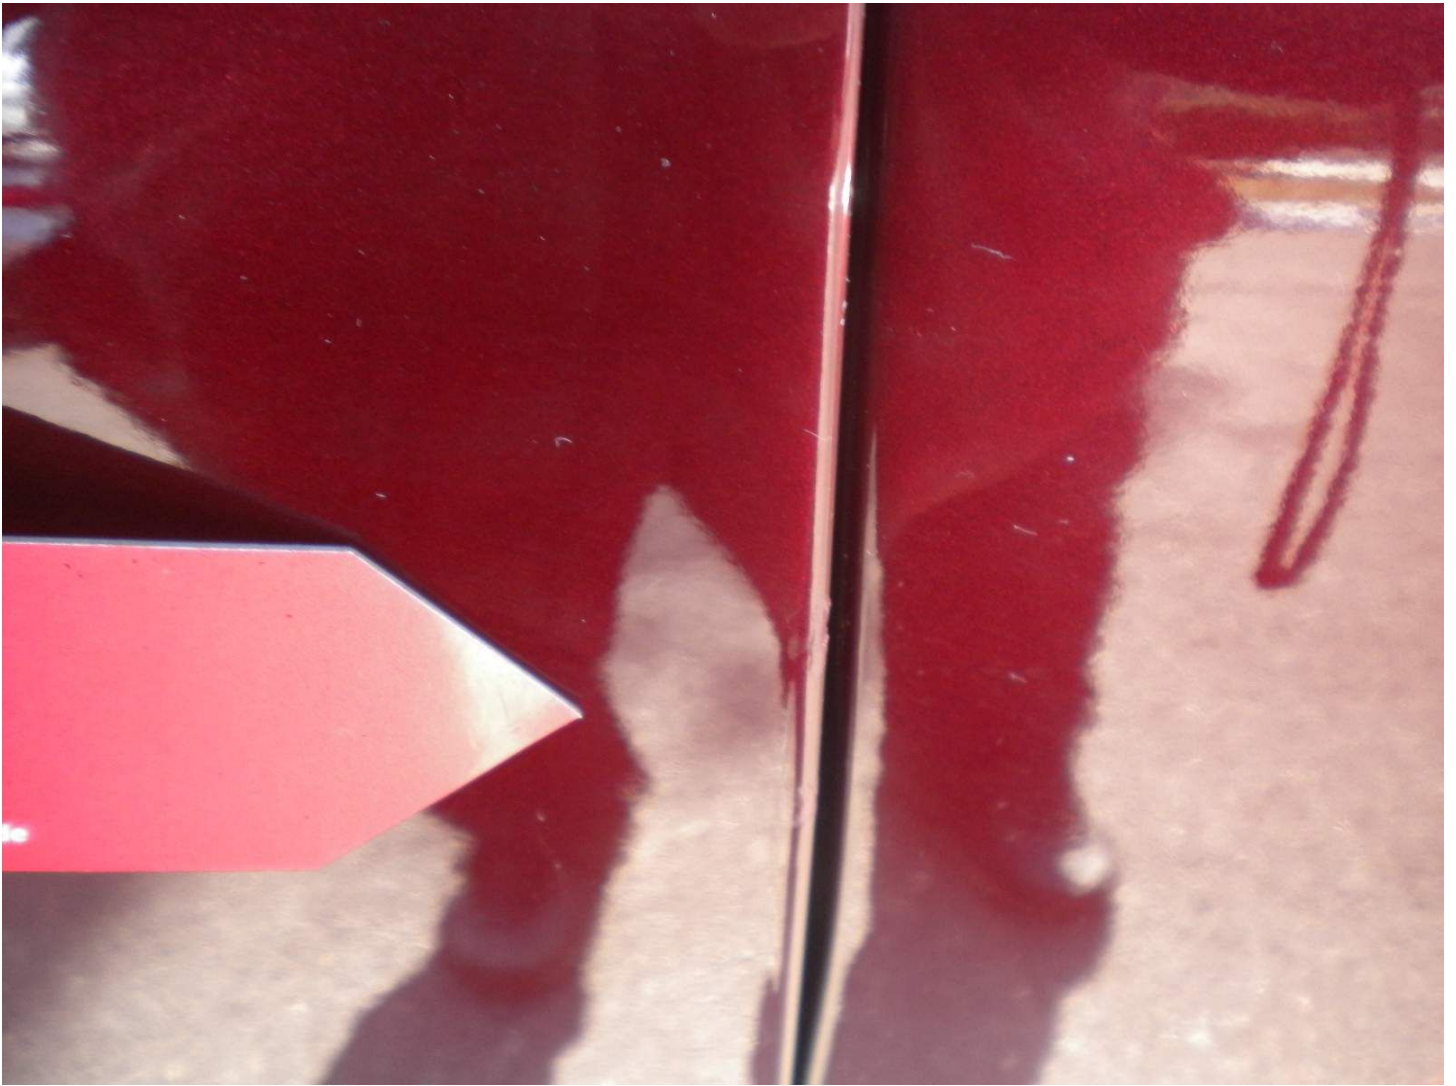
chips on door edge

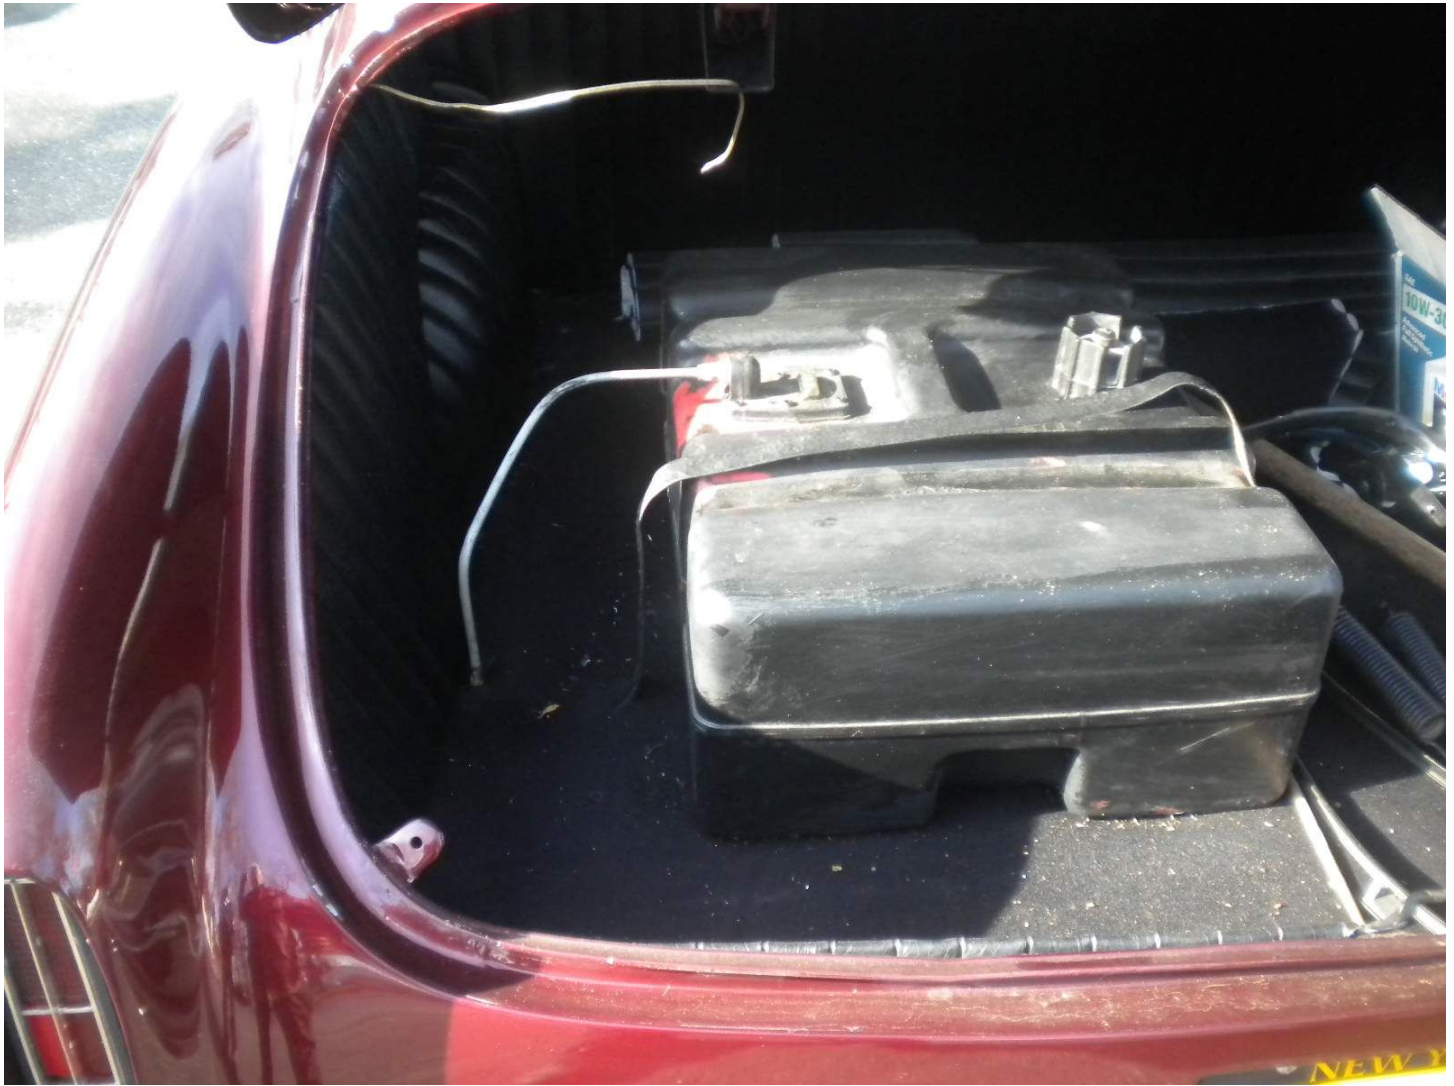
**fuel tank**

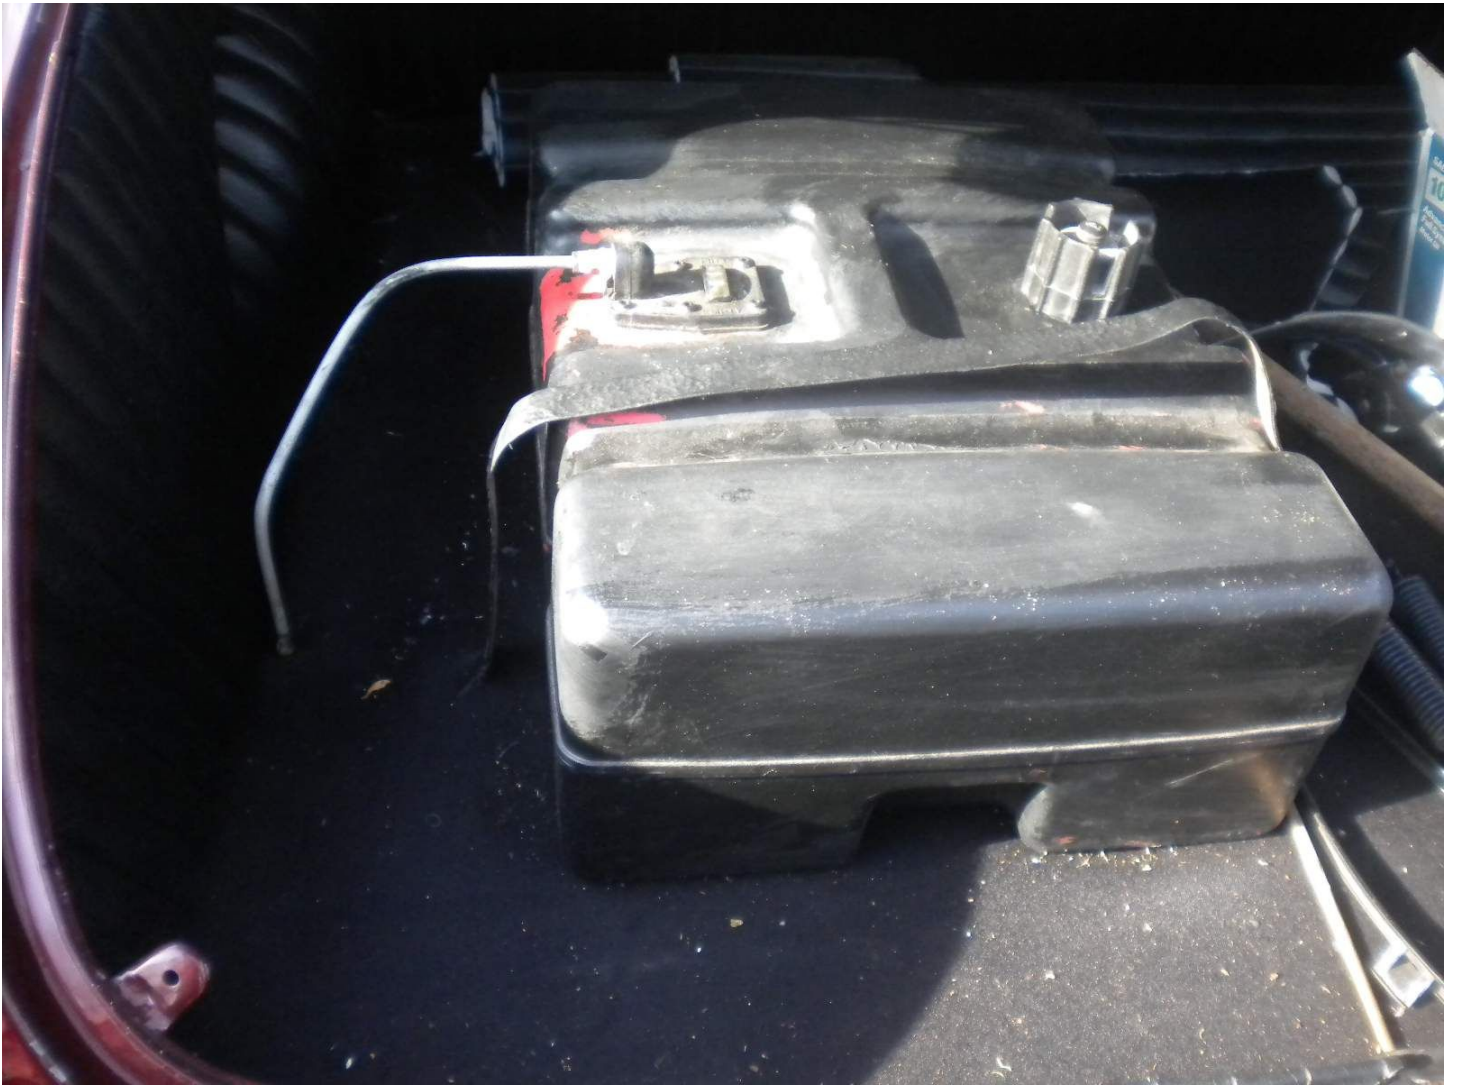
**fuel tank in trunk**

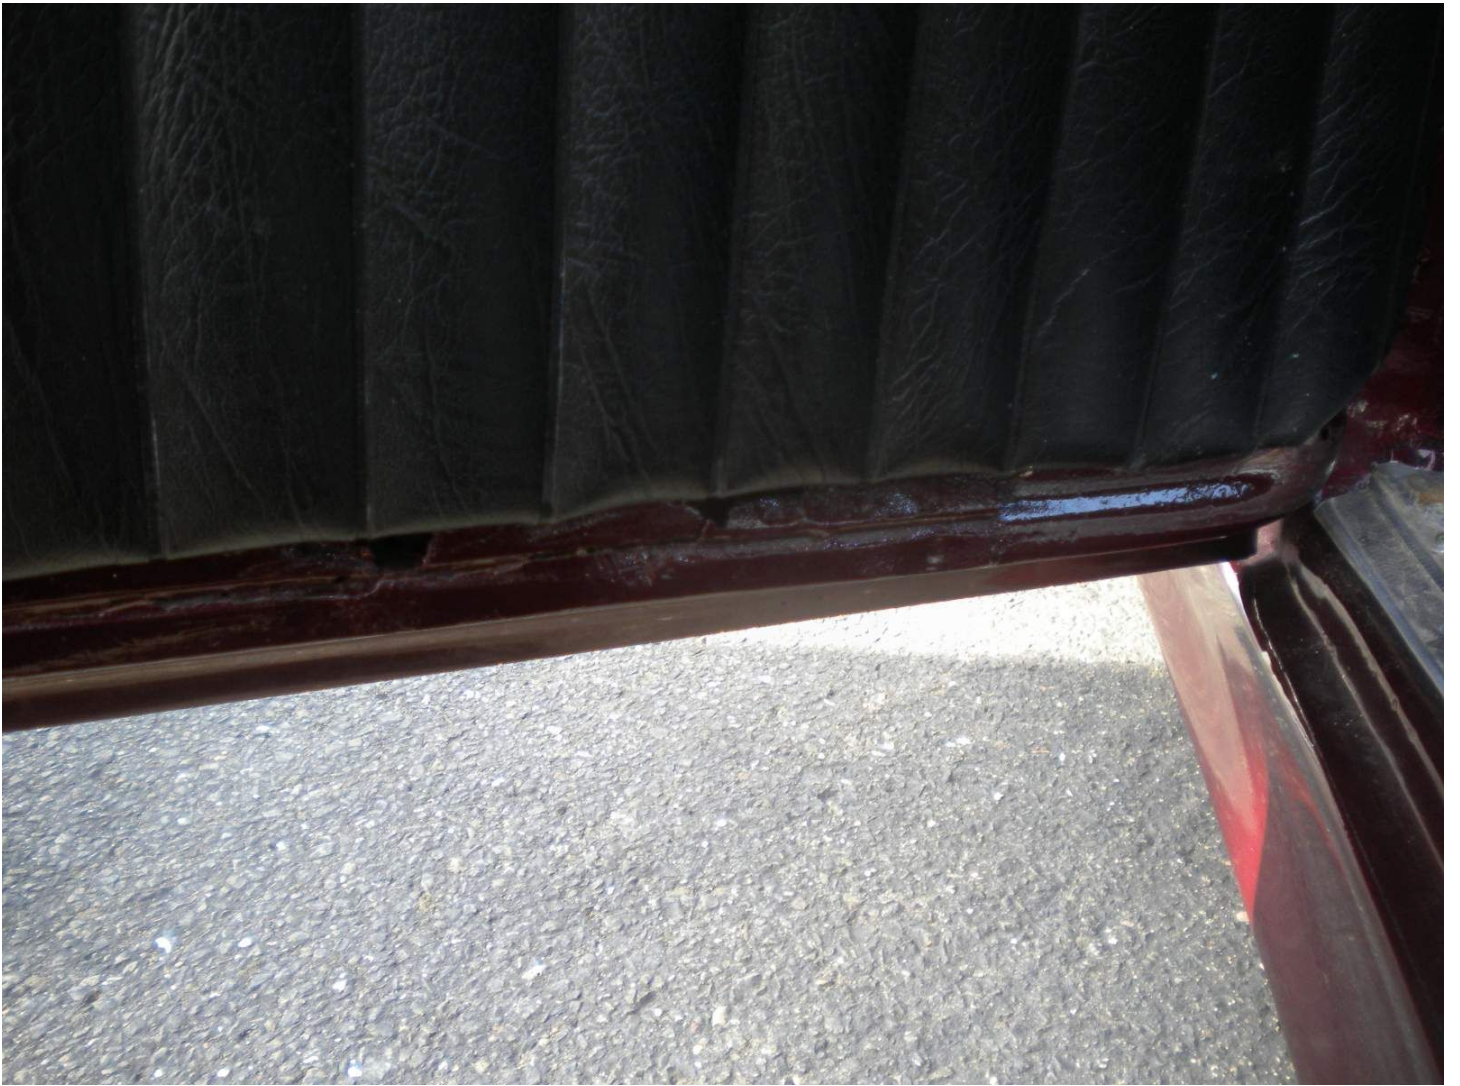
**bottom of drivers door**

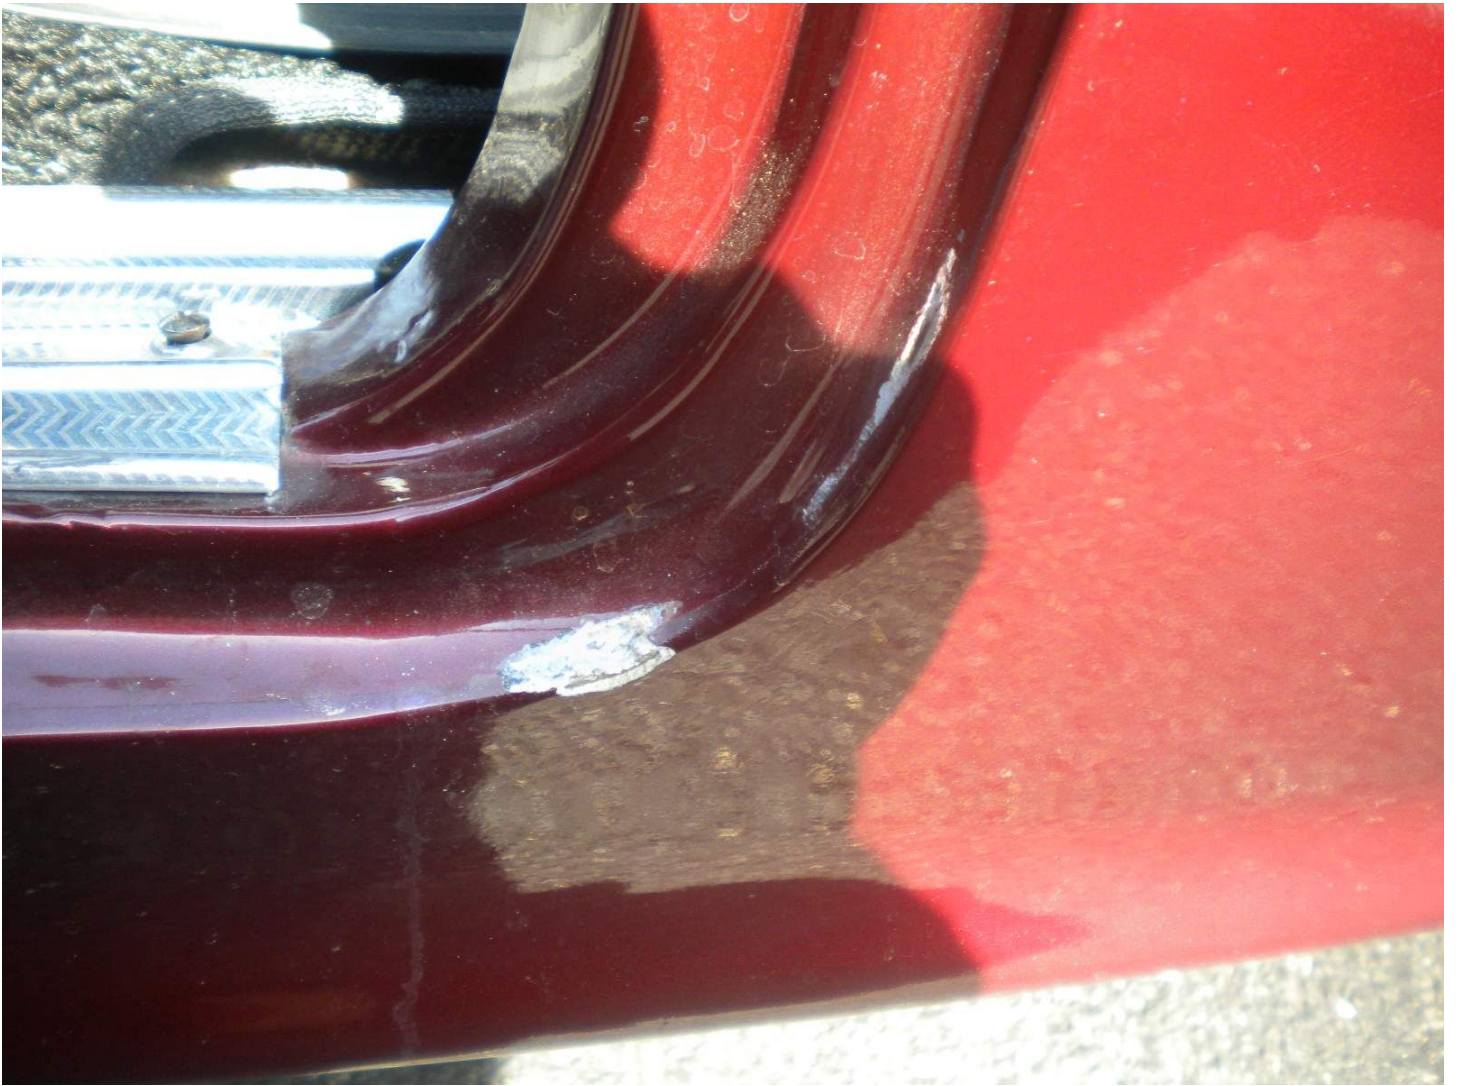
chips on drivers door jan

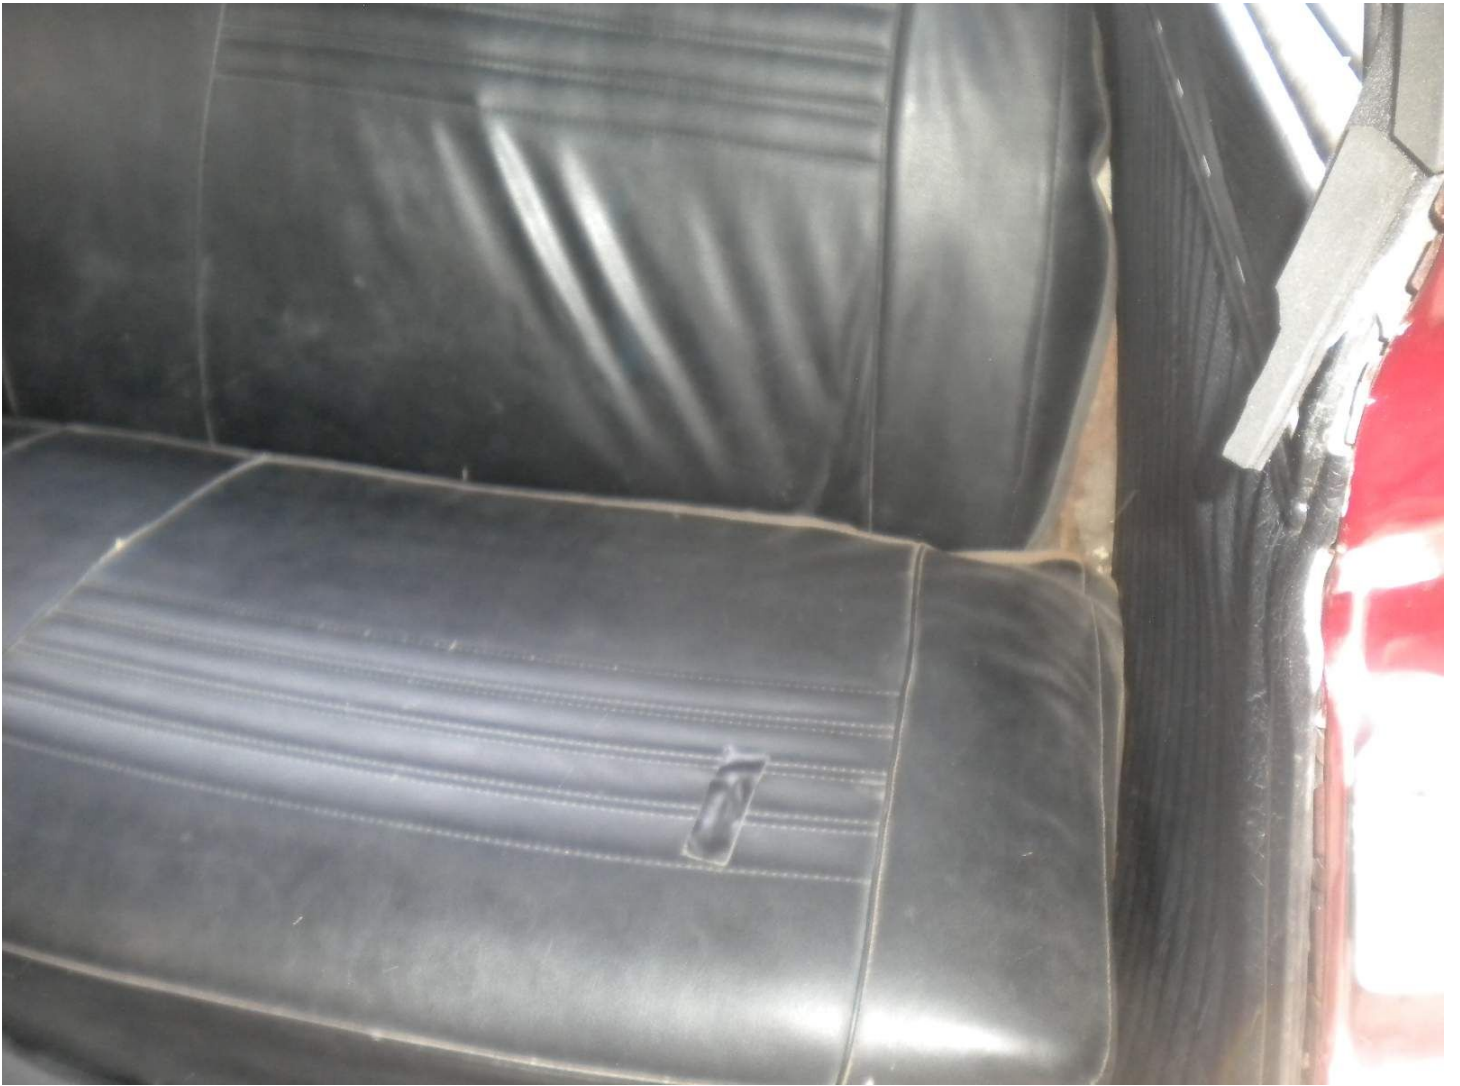
tape on back seat

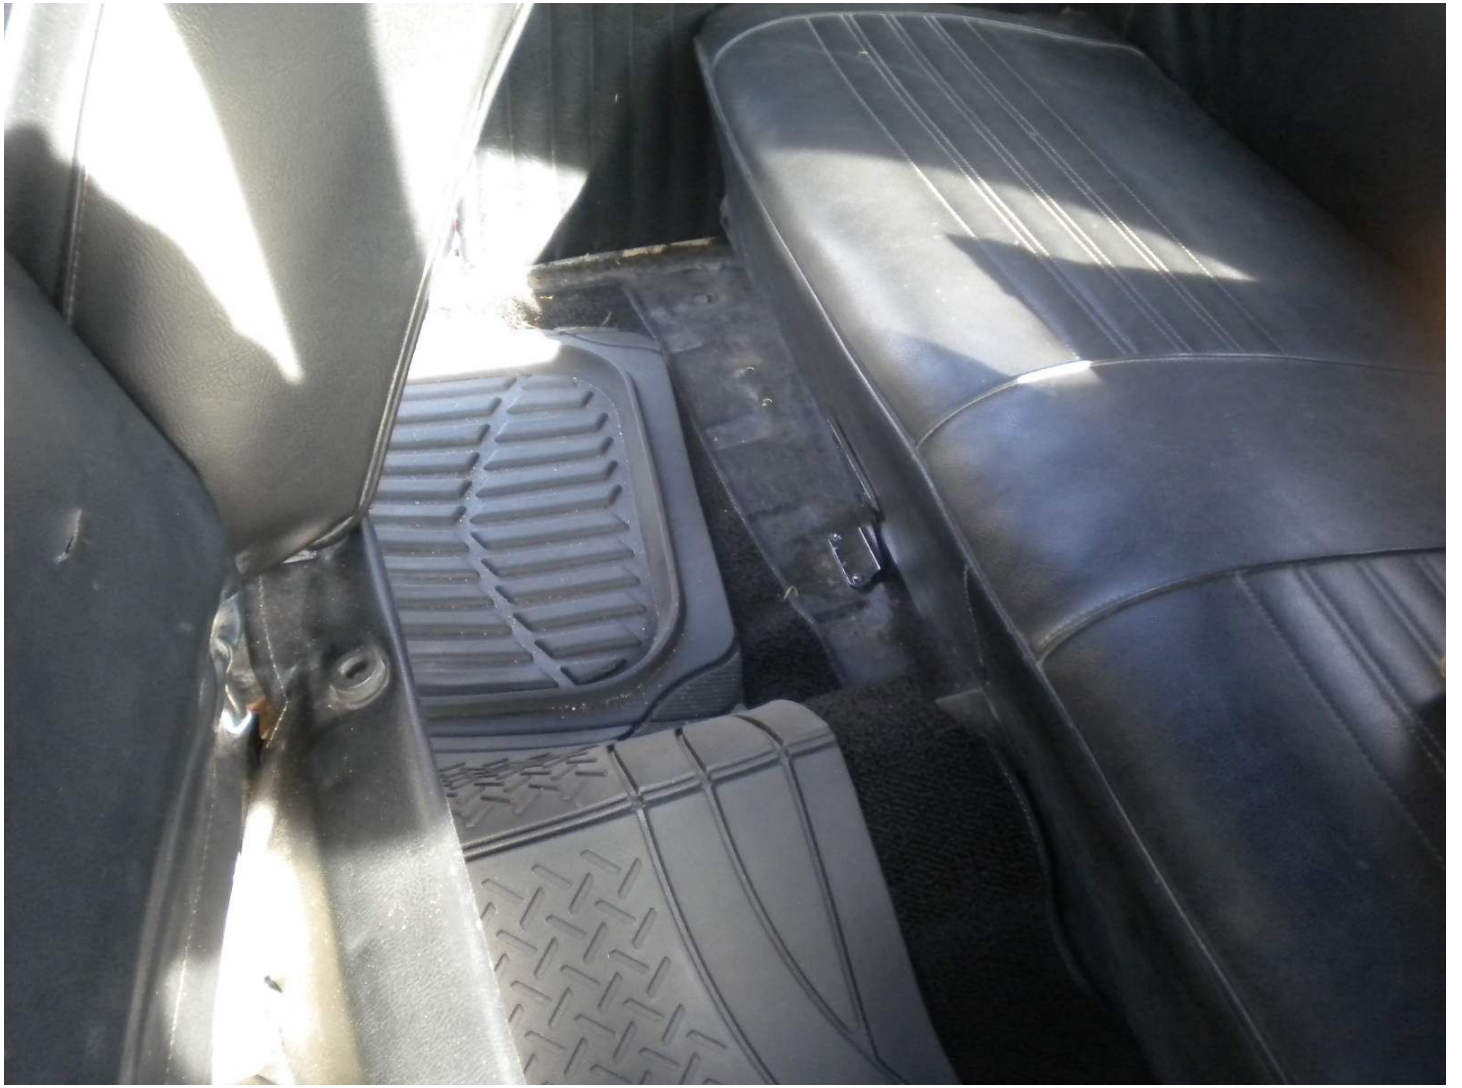
Issues
The carpet shows normal wear consistent with age.	
Floor Mats

carpet pieced together

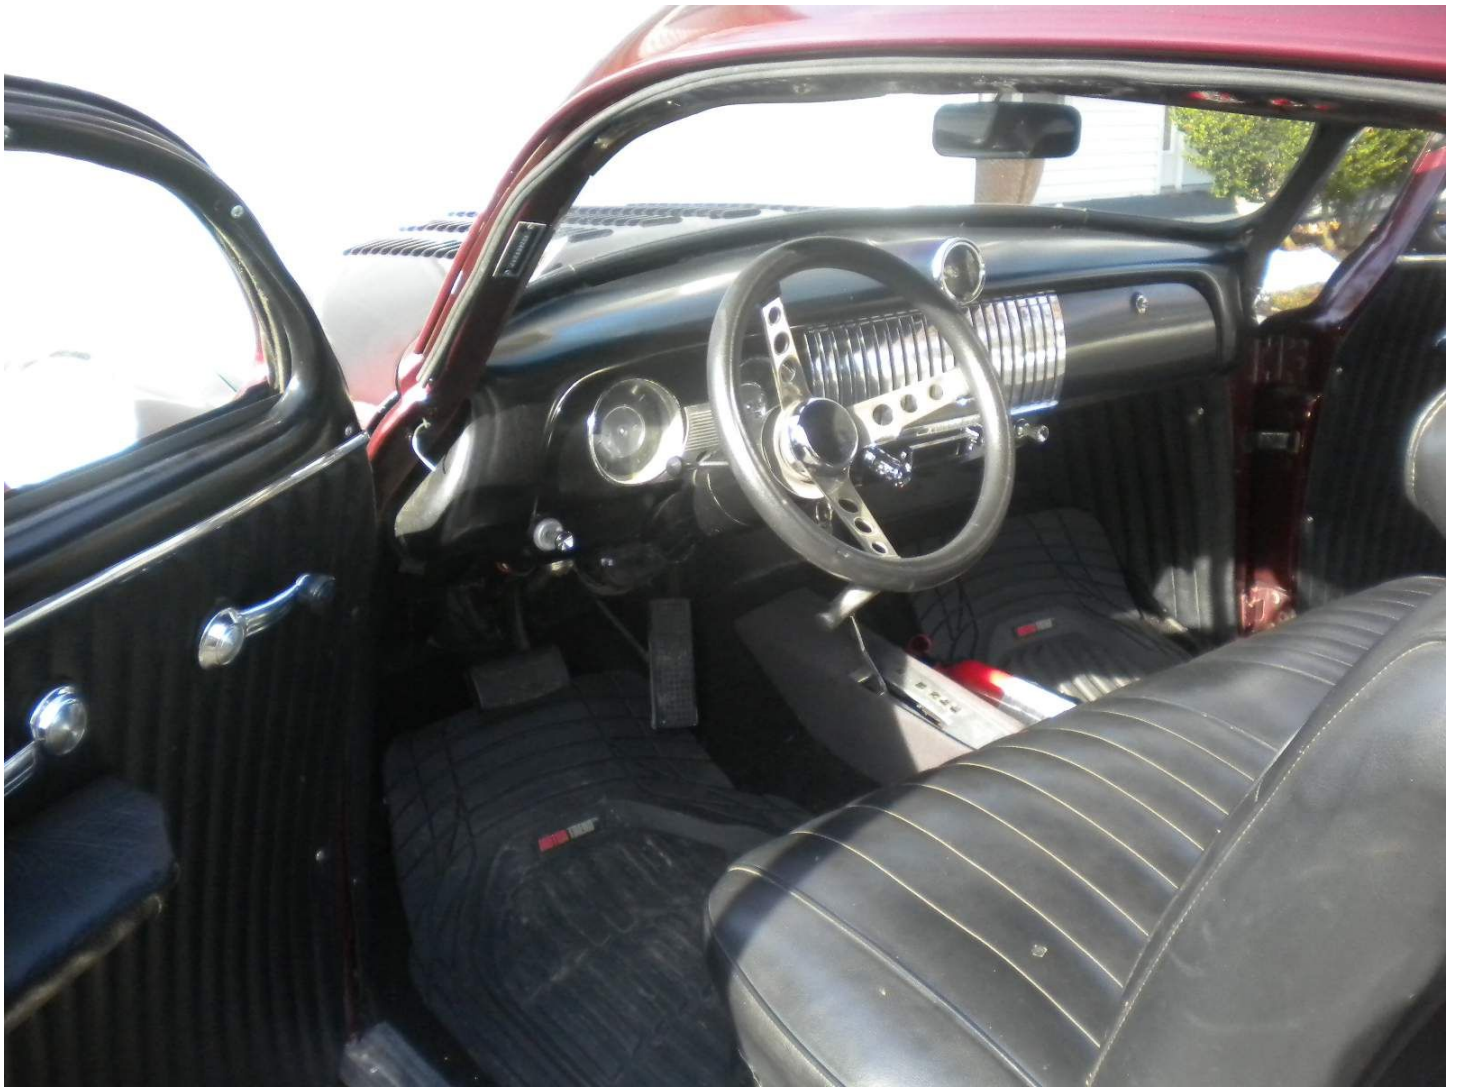
carpet not fitted to the car

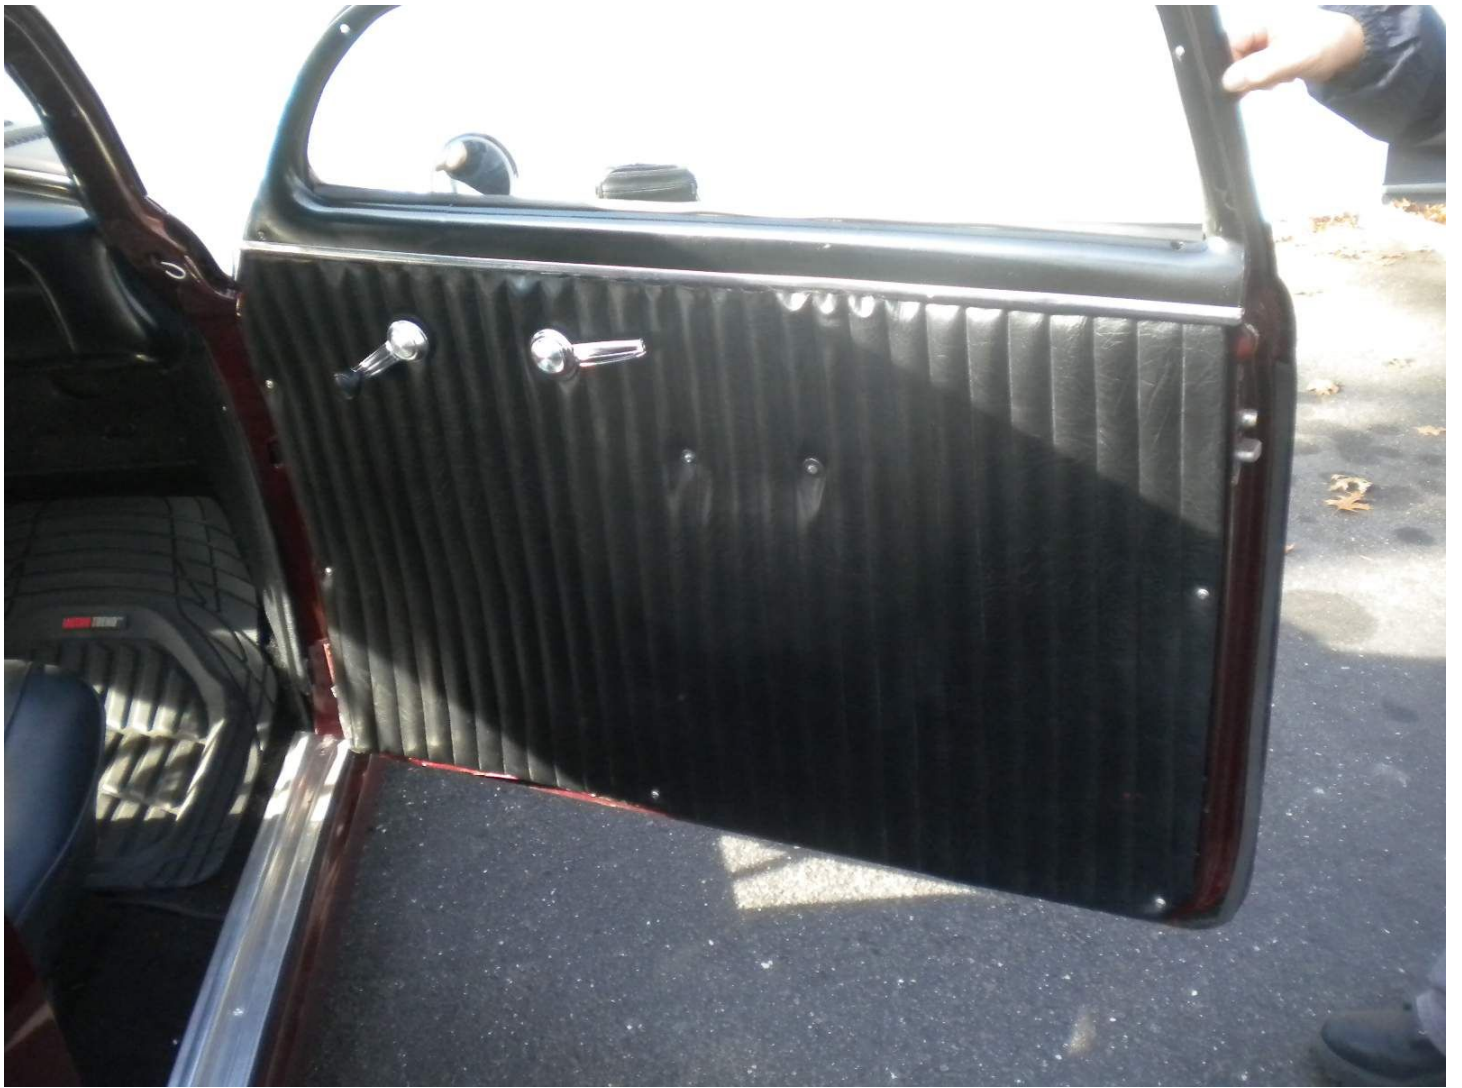
passenger dooe panel loose
